SIGNIFICANT RIVER ICE PROBLEMS CAN OCCUR EVEN
IN SOUTHERN BRITISH COLUMBIA

by
P.F. Doyle¹

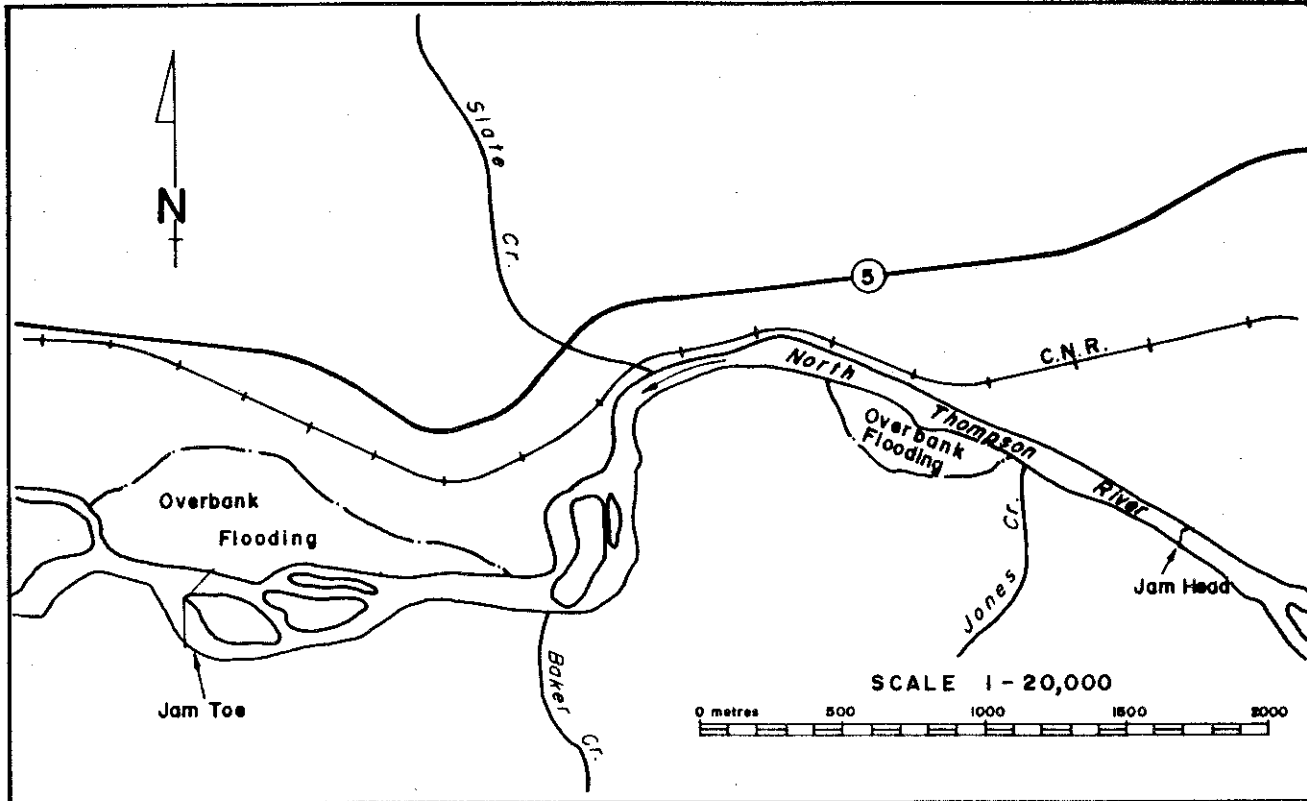
- (2) the jam was about 4 km long. Figure 2 is a schematic diagram showing the position of the jam.
- (3) the intact ice extended about 3 km downstream of the jam. Downstream of the intact ice cover, the river was open for many kms and upstream of the jam the river was open for at least 10 km. The intact ice appeared competent although open leads along the thalweg were common.
- (4) the greatest dimension of the largest floes at the toe did not exceed 10 m. Most of the ice even at the toe was badly fragmented and ground up. Upstream of the immediate toe area all of the ice was mush.
- (5) water had overflowed the right bank from the toe upstream for some distance and overflowed a low area on the left bank near the head.
- (6) the right bank overflow emptied back into the channel downstream of the jam via several old flood channels.

Observers¹ reported that on December 18, the water level at the toe peaked at a stage about 0.6 m higher than it had been during the aerial reconnaissance the previous day and that there had been a consolidation of the jam in the meantime which stacked the jammed ice in piles up to 8 m high at the toe. The following day they reported that water levels on the left bank near the head had risen about 0.6 m as well and that levels were steady at the toe. On December 22 another report indicated a gradual decrease in water levels as well as failure of the downstream end of the intact ice cover and some additional movement at the toe. Eventually water levels returned to normal.

A long overdue ground investigation aided by local observers¹ revealed the peak water level at the toe was approximately 1 m over banktop or about 3 m above the open water stage. The thickest floes at the toe were reported to be 1.5 m thick with clear ice comprising only about 0.3 m of this thickness. Some flows had large cobbles imbedded in the ice.

Perhaps the most important practical piece of data gathered was that the peak water level during the jam exceeded the estimated 200 year flood level by about 1 m. No doubt the height of backwater due to the jam was unusual. Local residents can recall no ice jams approaching the severity of this one.

Figure 2. Location of December 1980 ice jam on the North Thompson River upstream of Clearwater.

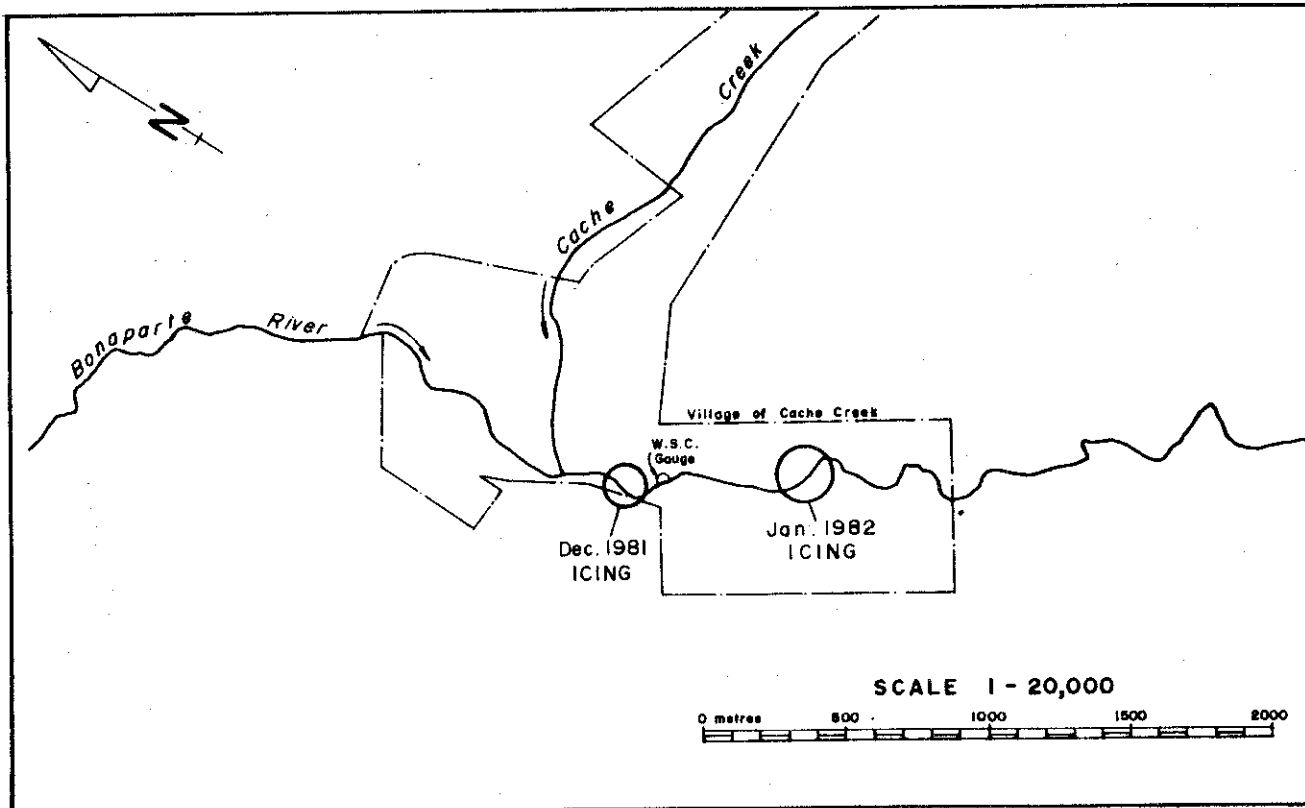
A local observer² at the downstream icing site states that the icing at this location has developed in the same manner in each of the past three winters. Each year the icing gradually extended upstream from a complete ice cover in a certain spot. Inspection of both aufeis reaches during open water revealed that each reach was a steep cobble reach between flatter, deeper reaches - the downstream icing reach exhibited the more pronounced difference. At the downstream icing location, the initial complete ice cover formed in the flatter, deeper reach downstream.

At its maximum, the downstream icing was about 200 m long and over 1 m thick. The upstream icing was similar but smaller. The peak water level in the downstream icing was over the low bank but still 0.5 m below the high left bank and the top of a small dyke on the right bank protecting a mobile home park. The peak water level in the upstream icing crept to within about 0.3 m of overtopping the low right bank also occupied by a mobile home park.

Figure 3. Location of two icings on the Bonaparte River in the Village of Cache Creek during winter of 1981-82.

The return of warmer weather in each case alleviated the icing problem. Prolonged cold might well have aggravated the situation. A longtime Cache Creek resident³ recalled that a bulldozer was required to clear the channel at the downstream icing location about a dozen years ago when a severe aufeis problem developed.
