EXTREME FRAZIL AND BOTTOM ICE FORMATION CAUSING ICE PROBLEMS IN A REGULATED RIVER

Randi Pytte Asvall¹

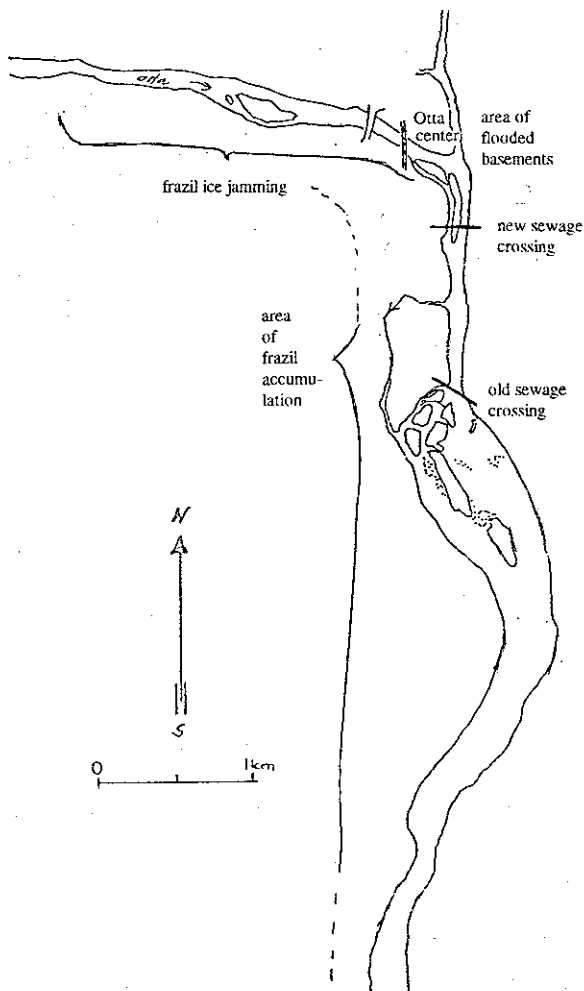
Fig. 2 indicates the main areas of ice jamming, flooding, sewer pipe crossings, and frazil accumulation.

Fig 2. Sketch of the confluence area of the rivers Otta and Lågen. The slope in Lågen is fairly gentle, and the ice formation starts in this river with surface ice cover. Somewhat later an ice cover of frozen frazil will normally develop in Otta. Close to the confluence with Lågen the slope in Otta is less than higher up, but steeper than in Lågen. Throughout the winter frazil will accumulate under the ice cover both in Lågen and Otta.

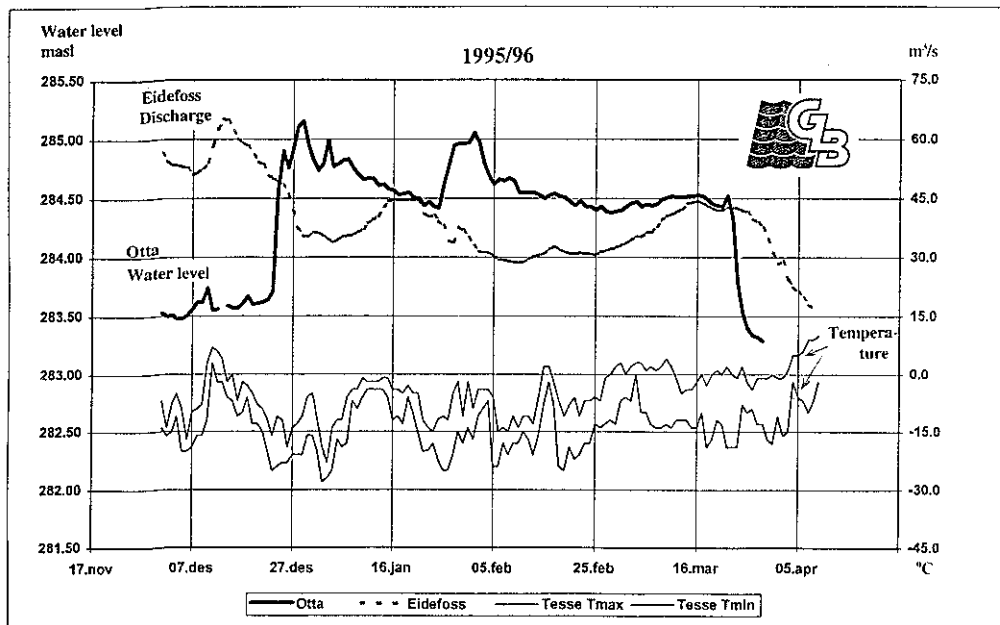
Some years the ice situation have been more critical than others, but no serious damage was caused for a long period. On December 25, 1995 there again was a sudden increase in water stage, and on January 1, water was overflowing the ice on Lagen, downstream Otta center. The situation was very similar to what happened in 1981. The discharge had been reduced already at the end of the mild period and before the rise in water level. It was then decreased further until the water level decreased and then stabilized. One was afraid that a slight unfavorable change in the meteorological situation would initiate another increase of the water stage that could then easily pass the level of damage. The water level remained generally high until the end of the ice forming session (fig. 3).

Fig 3. Water level and discharge in Otta 1995/96. Note that the water level increases very rapidly when the air temperature drops below -15°C .
