## **Manasan Ice Control Structures**

**Philip D. Wang**

*Manitoba Hydro, Civil Engineering Department*

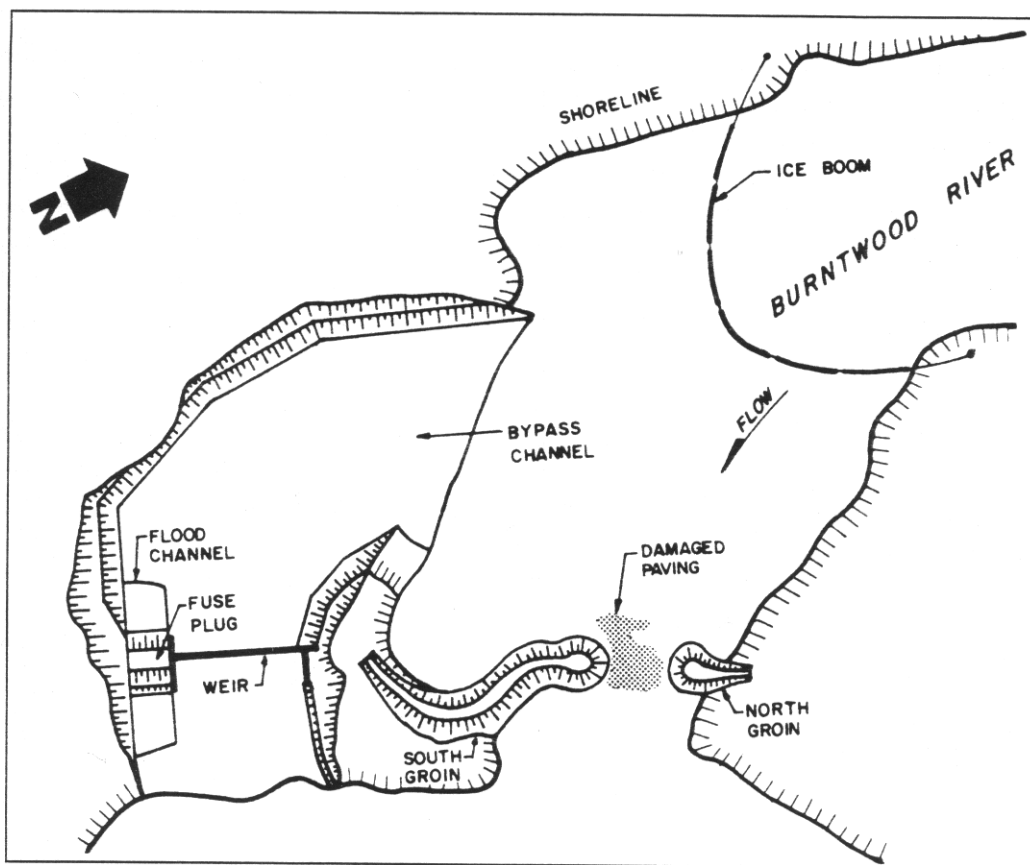
Figure 1 Manasan Control Structure Components

Inspections of the works after the spring breakup noted that six boom sticks had been carried away. Automatic water level recording in the pond indicated that water levels had been lowered by approximately 0.6 m (2 ft), suggesting that the groins and/or the riverbed paving had also been eroded. Field inspections determined that the groins were sound above the water. Bathymetric surveys around the groins were performed from a helicopter using an impulse radar technique. The resulting contours were compared with the original conditions, and it was found that the riverbed paving in the gap and just upstream had been lowered. The shaded area on Figure 1 shows this zone.

Planning for future development of the Burntwood River introduces the possibility of flood flows exceeding the capacity of the groin structure gap. Thus, an additional bypass channel around and on the south side of the groins was constructed as Stage III Construction in 1988, as shown in Figure 1. The same physical model was used to refine the bypass discharge capacity of the 85 m (280 ft) long concrete weir. Also, a narrow and deep channel 27 m (90 ft) in width, blocked by an earth-fill fuse-plug, was developed as the final security feature guarding against structural damages from the 1:1,000 year flood of 1,700 m<sup>3</sup>/s (60,000 cfs).

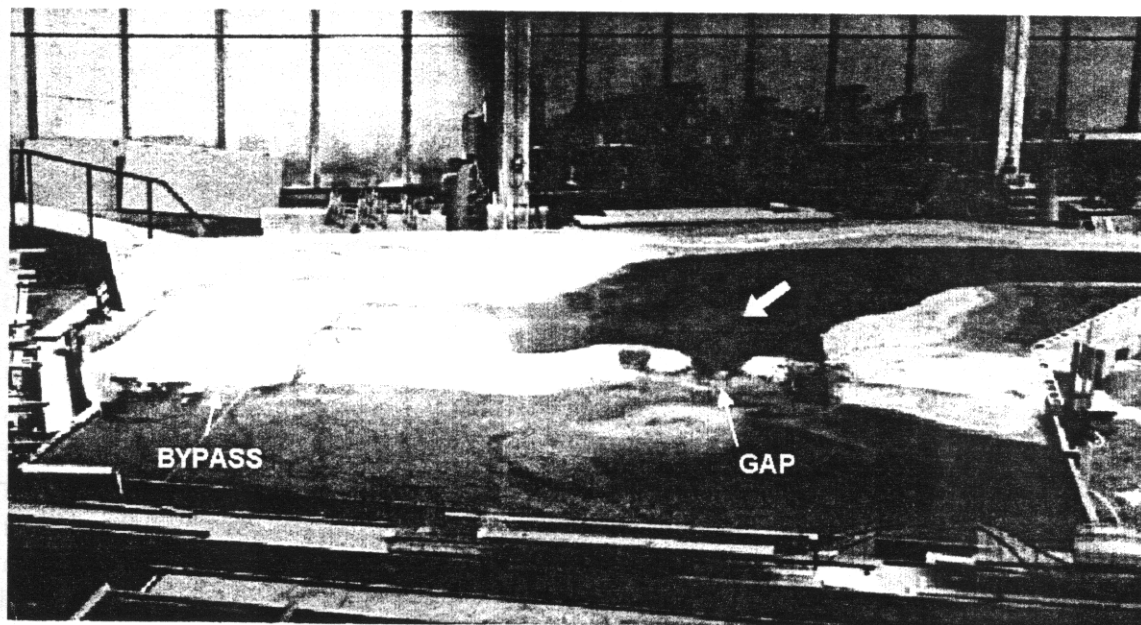
Figure 2 View of Hydraulic Model from Downstream

A physical model, shown in Figure 2, was constructed at the LaSalle Hydraulic Laboratory in Montreal to study the rehabilitation procedure of the damaged control structure. The 1985 bathymetric survey was used to provide the geometric conditions for

the model and successive testing was carried out over a range of discharge conditions until the model rating curve corresponded to that of the damaged structures. Placement of new paving rock in the field was to be achieved by cranes dropping appropriate sized rocks from the air in specified target areas. This rock placement process was studied in the model in terms of the rock release points in the air and the target areas on the riverbed. Careful study of the rock trajectories underwater was required in light of the rapidly changing current flow lines approaching and going through the gap. The quantities of rock and their dispositions were determined by their effects on the flow through the gap.

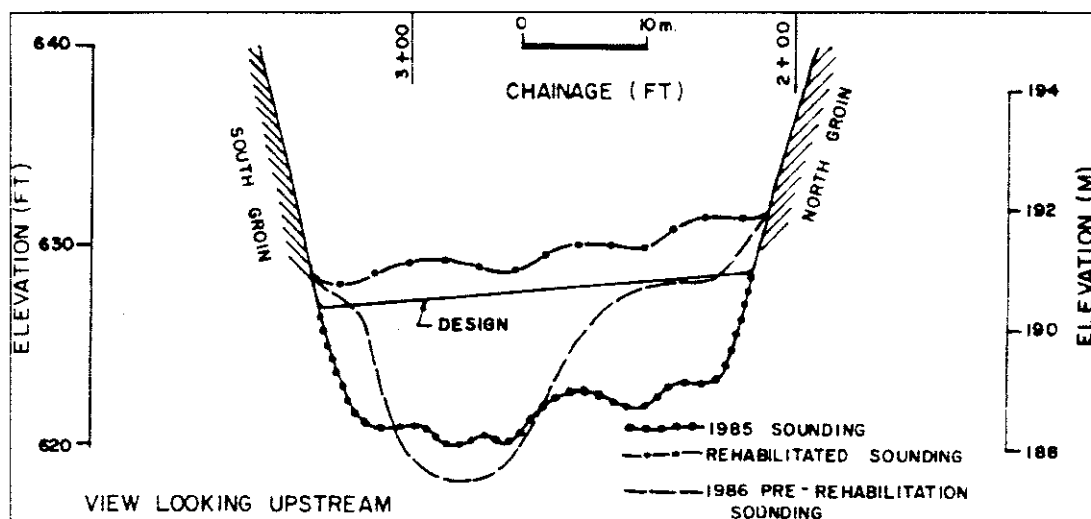
Figure 4 Gap Profile at Line 10

Prior to rehabilitation construction, additional soundings were taken using the crane and applying an accurate sounding technique that had not been available in 1985. The results showed some significant differences from those obtained in 1985 using the helicopter.

Therefore, the rock placement procedures and the required number of rocks had to be reassessed and adjusted. The knowledge gained from the model studies was applied to the actual field conditions of drop positions and the target placement zones. After rock placement trials were successfully completed, a large-scale operation was undertaken for the next twelve days, placing a total of 795 armour rocks to complete the repair of the eroded rock paving. Figure 4 shows the cross section at line 10 for the rock paving elevations before and after the rehabilitation. The Stage II rehabilitation construction also included strengthening the north groin with an upstream berm and re-building the excavated south groin nose.

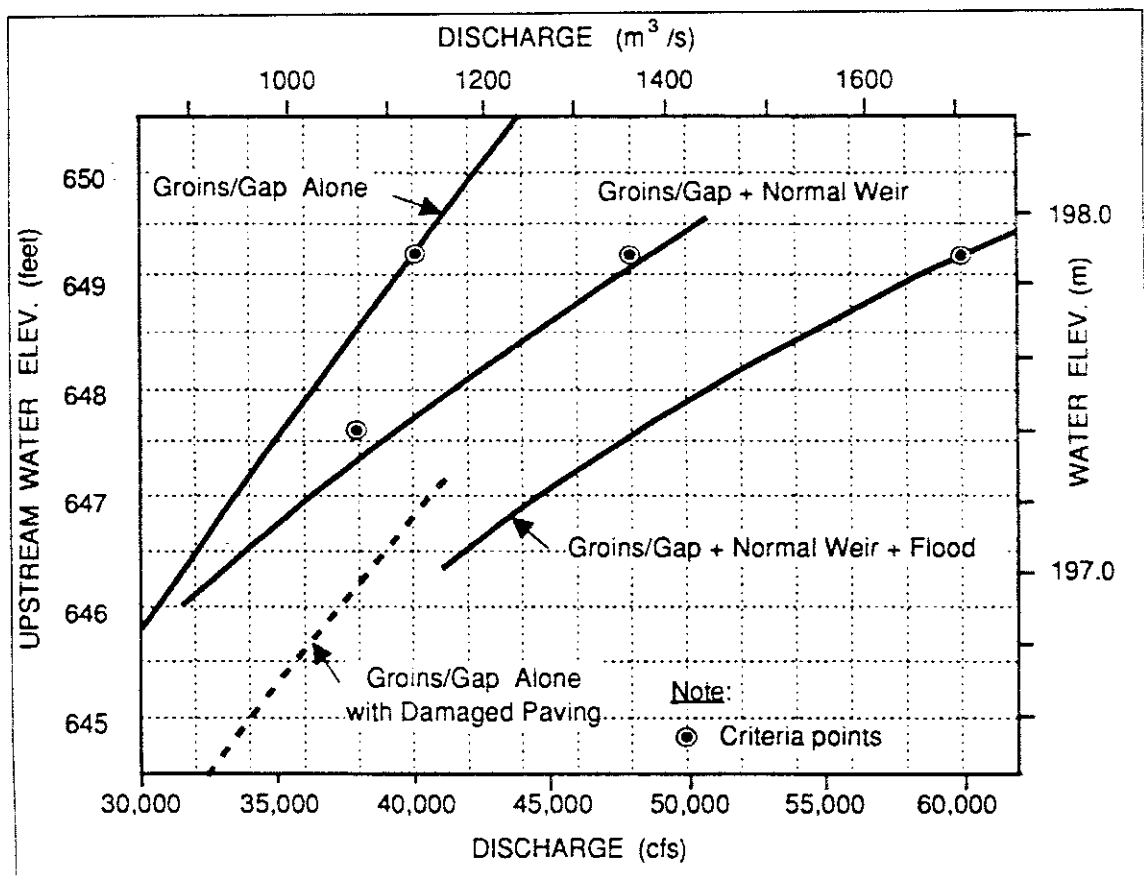
**Figure 5 Groins/Gap, Weir and Flood Channel Rating Curves**

The original groins/gap structures had been developed to operate with a discharge of  $850 \text{ m}^3/\text{s}$  (30,000 cfs). However, during the first nine years of operation, flows as high as  $1,130 \text{ m}^3/\text{s}$  (40,000 cfs) had been put through resulting in an upstream water level of 179.9 m (649.3 ft). Furthermore, future development of the Burntwood River may necessitate increased capacity for flood flows through the groin structure gap. A bypass comprising of a main overflow weir and a flood channel was therefore developed to accommodate increased flows. Figure 5 shows the rating curves for the groins/gap and bypass works. The limiting criteria include a maximum upstream water level of 179.9 m (649.3 ft) with three discharge levels, and a minimum water level at 197.4 m (647.6 ft) for a discharge of  $1,075 \text{ m}^3/\text{s}$  (38,000 cfs) to ensure the formation of an ice cover by the ice boom. The design criteria also considered construction costs. The same physical model at the LaSalle Hydraulic Laboratory was used to study various shapes and sizes of concrete weirs in the bypass channel and to determine appropriate dimensions for the flood channel. The model was also used to study the requirements for and the behaviour of a granular-material fuse plug within the flood channel. This erodable fuse plug blocked the flow through the flood channel until the limiting discharge is reached.

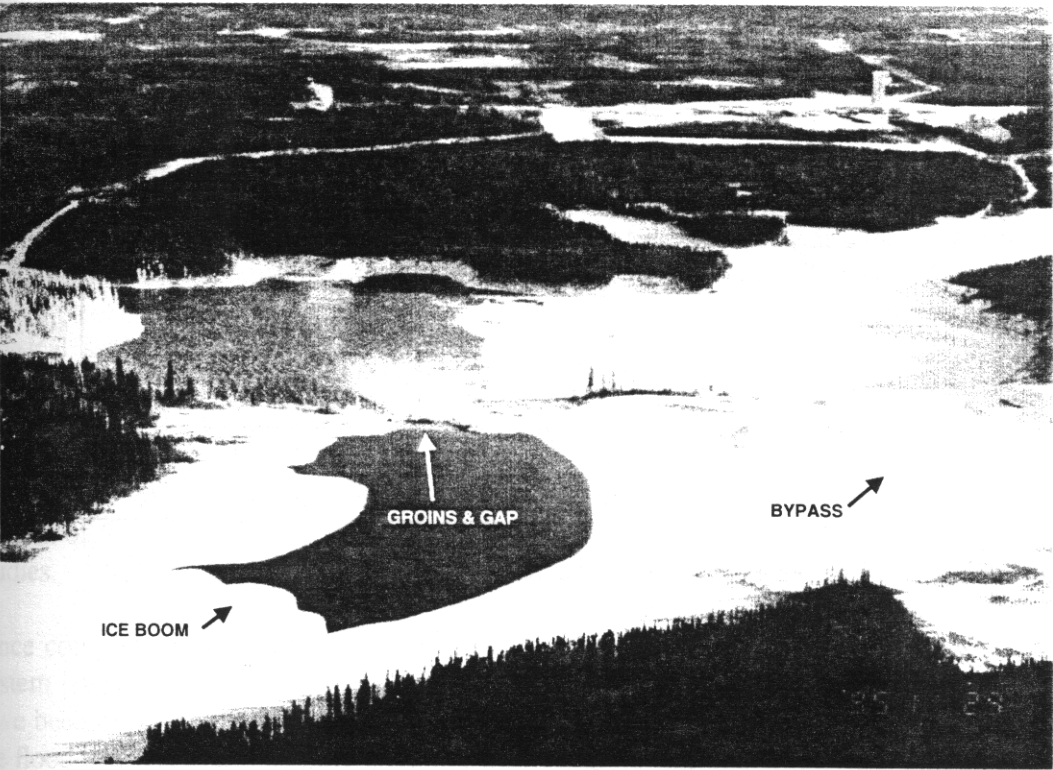
Figure 7 Manasan Control Structure in Winter (looking downstream)

While spring floods have generally been light, flooding in 1998 tested the bypass weir to its limit without breaching the fuse plug, with flows reaching approximately  $1,300 \text{ m}^3/\text{s}$  (46,000 cfs). However, pond level control by the groin satisfies the design condition, and the ice cover formation and retention by the boom have worked correctly each winter, as demonstrated in Figure 7.

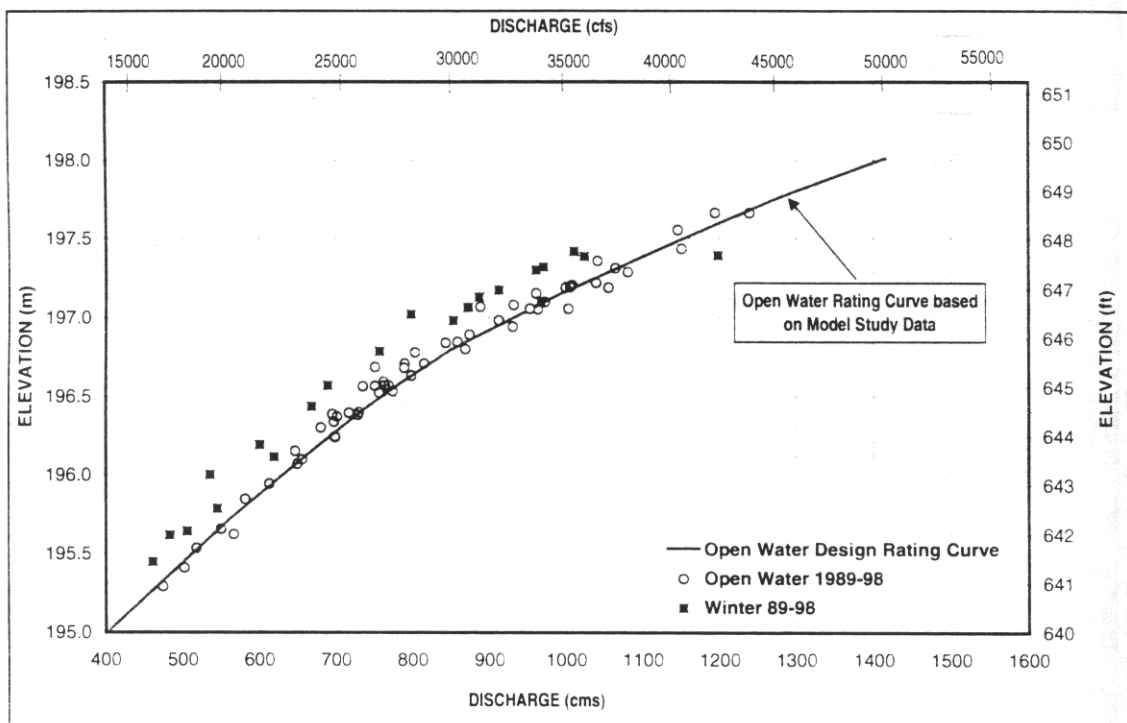
Figure 8 Open Water and Winter Rating Curves

Discharge ratings were defined as shown in Figure 8 for the open water and winter flow conditions. The open circles indicate the open water metered data and the solid squares indicate the winter metered data from 1989 to 1998. The hydrograph in Figure 9 shows the water levels upstream of the overflow weir in the bypass channel from 1989 to 1998. The bypass carries flow when the water level exceeds elevation 196.6 m (645 ft) and is indicated by lower edge of the shaded portion of the hydrograph. The upper edge of the shaded area marks the fuse plug crest elevation of 197.91 m (649.3 ft) in the flood channel. The maximum water level on record was 197.75 m (648.8 ft) in June of 1998.
