Ice-Run Destruction of Spencer Dam on Nebraska's Niobrara River

The breakup of an ice cover triggered a major ice run that destroyed Spencer Dam, a run-of-river hydropower dam on the Niobrara River in northern Nebraska, USA. The dam's destruction led to an investigation (under the auspices of the Association of State Dam Safety Officials) that yielded useful insights for the design and operation of similar dams located on rivers subject to dynamic ice-cover breakup and subsequent ice runs. The insights range from how rivers in the Northern Great Plains (NGP) form ice, how NGP weather patterns affect ice formation and ice-cover break-up, how morphologies of NGP rivers affect ice runs, and how infrastructure (dams, bridges, levees) need to be designed and operated with the mindset that ice runs can instigate catastrophic failures. The March 2019 destruction of Spencer Dam was not the first time that the dam had suffered a major failure owing to river ice, though records of the earlier failures had been inadequately maintained and lessons not learnt. This paper reviews the weather and ice-formation processes that led to the destruction of Spencer Dam and severely damaged several brid

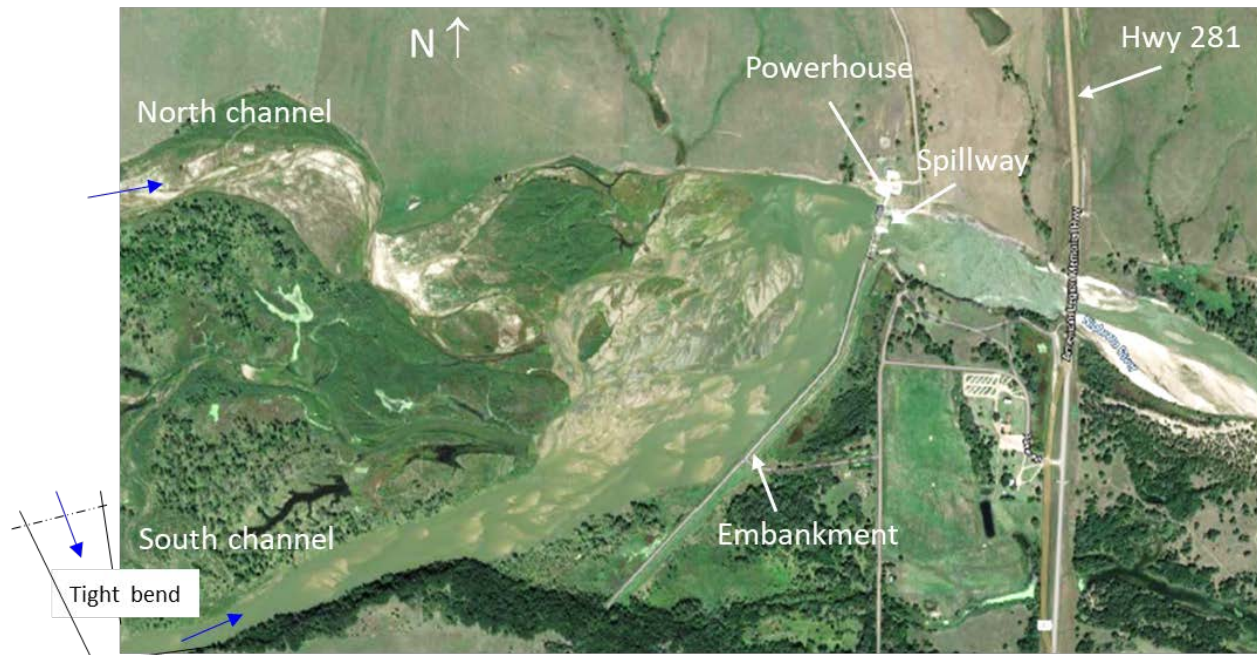
Figure 2. Layout of Spencer Dam and approach channels of the Niobrara River. The south channel included a tight bend bordered by a rock bank (Source: Google Earth)

- Tight bends in the river's braided reaches (e.g., Figure 2) were locations where the flow substantially narrowed such that ice rubble could congest, back-up flow, then burst as a surge of water and rubble.

- To reach the spillway section a major portion of the flow had to pass along the dam's arced embankment (Figure 2), which functioned as a guidebank, directing flow obliquely to the dam's spillway.

- The oblique angle at which the flow from the south approached the spillway, and the relative shallowness of the flow affect the spillway's capacity to pass flow and ice rubble (Figure 2).

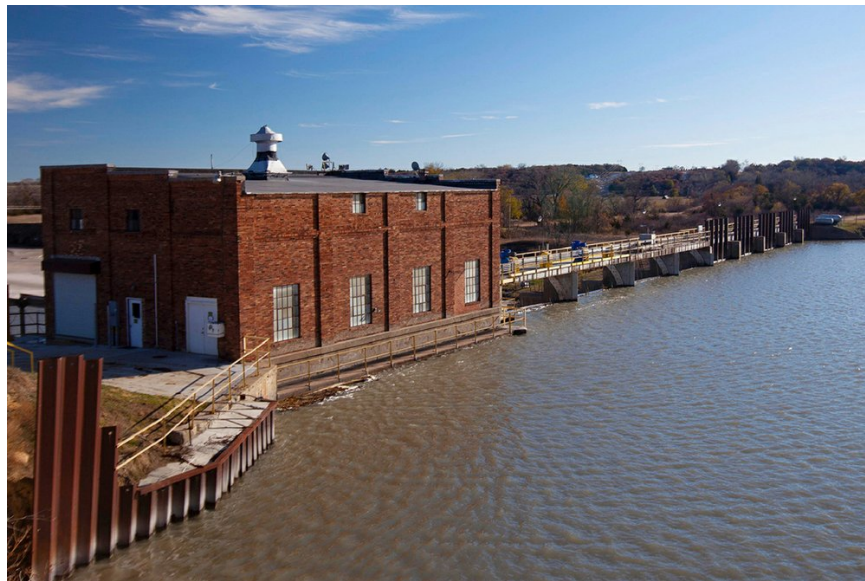
Figure 3. Photo of Spencer Dam powerhouse and spillway operating in November 2013 (Source: NPPD)

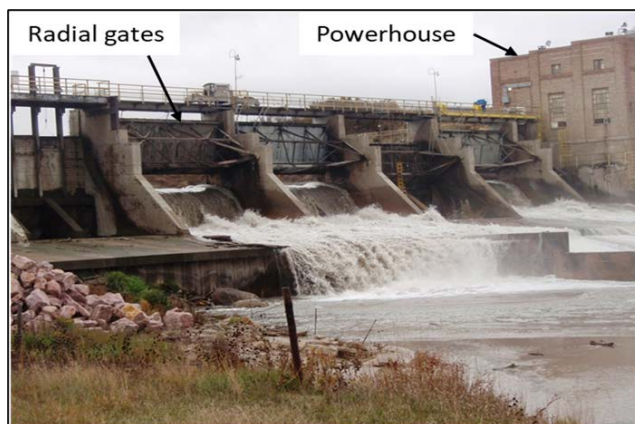
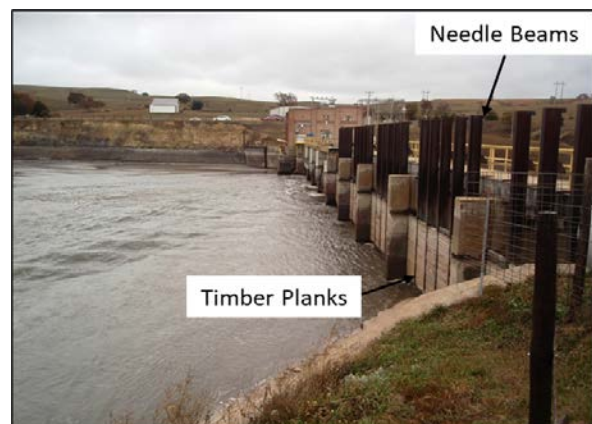
Figure 4. Views of the dam's spillway during flushing of sediment from the pool: (a) the four Tainter (radial) gates; and, (b) the five stoplog bays with needle beams and timber planks. Note the antidunes angled to the radial gates (Source: NPPD)

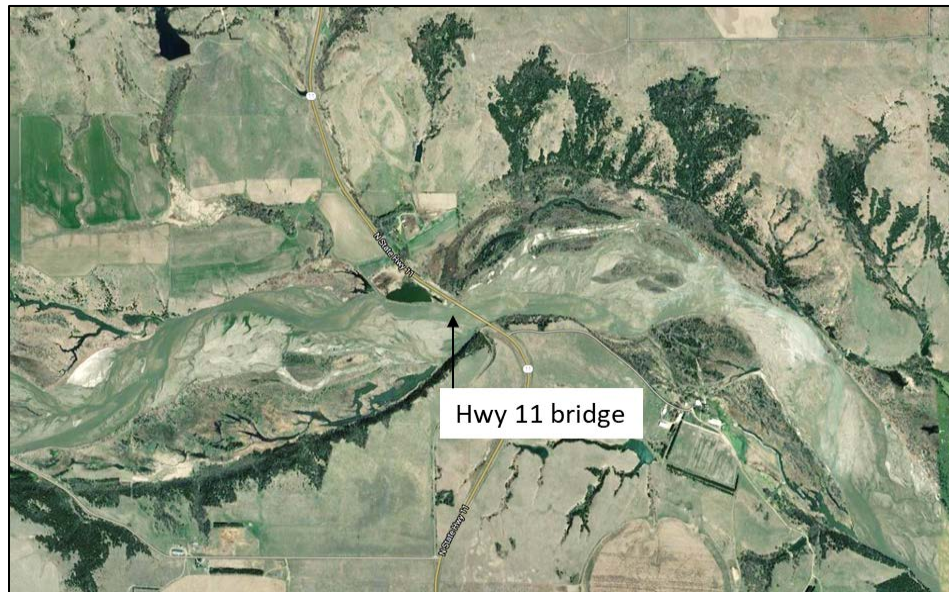
Figure 6. The Niobrara River at a reach including the Highway 11 Bridge, 8.5 km upstream of Spencer Dam. The river width here is about 153 m (Source: adapted from Google Earth)

- Also, bridge crossings were locations where the river narrowed (Figure 6) and ice rubble accumulated and backed-up flow, eventually creating a surge of water and ice when the bridge failed and (or) the river's bed scoured. Evidence, by way of ice rubble accumulations on bridge decks and the river's banks point to these locations as potential locations releasing surges.

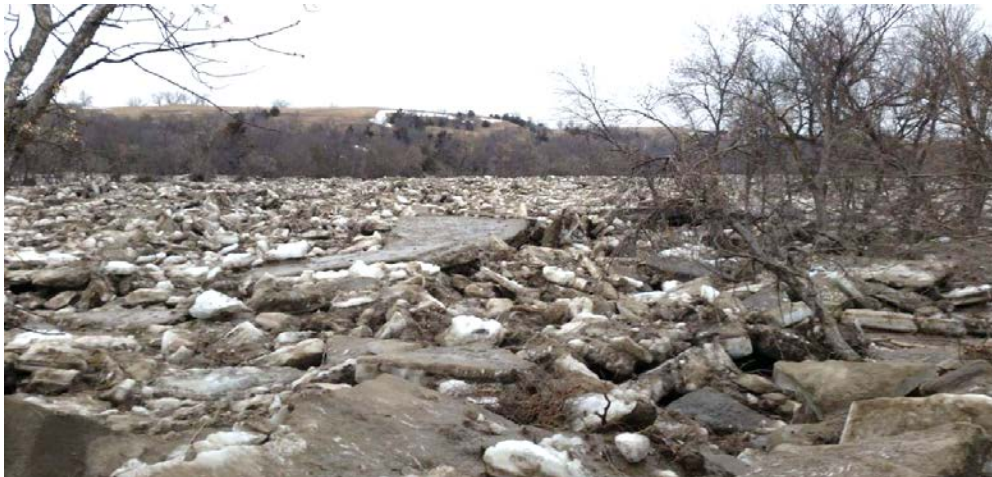
The relative shallowness of the Niobrara River and the presence of bars in the wider regions of the river, as well as sharp turns in flow paths, created locations where jams initiated. Moreover, larger pieces of ice rubble and clusters of ice are less likely to negotiate turns and bifurcations around bars. Once a jam forms it retards flow, backs up water and may then produce an untidy series of accumulation steps that involve ice rubble being shoved and compacted at a downstream location of greater constriction. Figure 7 shows ice rubble jammed in a reach of the Niobrara River.

Figure 7. Ice rubble jammed in a reach of the Niobrara River during March 2019 (Source: A resident living near the river)

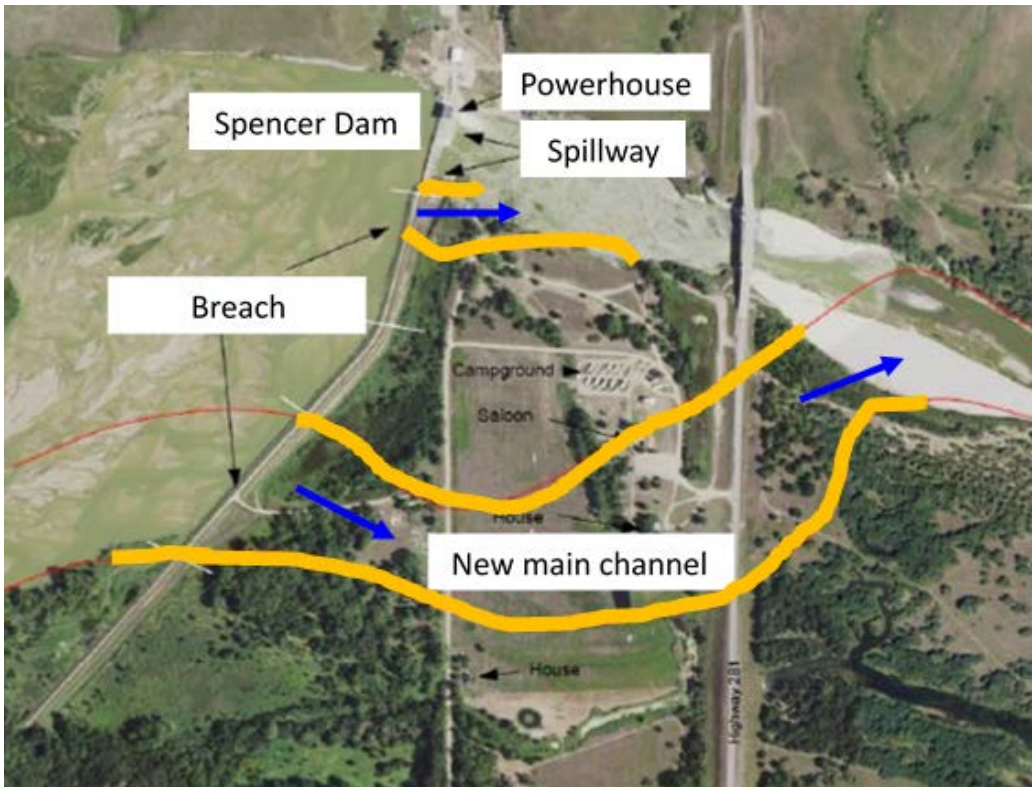
The embankment had breached in two locations: the north breach just south of the spillway was about 200 m wide; the south breach, near the embankment-access road was about 245 m wide. Most dam engineers and dam-safety professionals would probably picture an overtopping breach (with water only) much differently than one caused by mostly ice. In a normal situation, the embankment could not be expected to survive about 0.3 m (a foot) of overtopping considering the embankment shell material is sand. The sand on the downstream face would quickly erode leaving the steep clay core to either erode or collapse. It is believed that the overtopping initially was mostly by ice rubble. The rubble could have gouged the embankment, weakening it for water erosion, although gouging was not identified elsewhere on the intact crest. Erosion of the downstream face elsewhere along the embankment was observed. An indication of the level of pressures exerted through the ice mass accumulated at the dam, which may have failed the weakened embankment, was evident from the deformations of the steel beams of the Highway 11 Bridge and the steel beams and gates of the dam's spillway.

Once the ice run had passed the extent of Spencer Dam's destruction could be assessed. Figure 9 indicates where the two breaches formed through the dam's embankment. The series of photos in Figures 10a-e show the destroyed dam and the altered adjacent areas. The photos attest to the power that an ice run can muster.

Figure 9. Details of dam site and adjacent area showing breach locations and the new main channel after the event (Source: adapted from Google Earth)

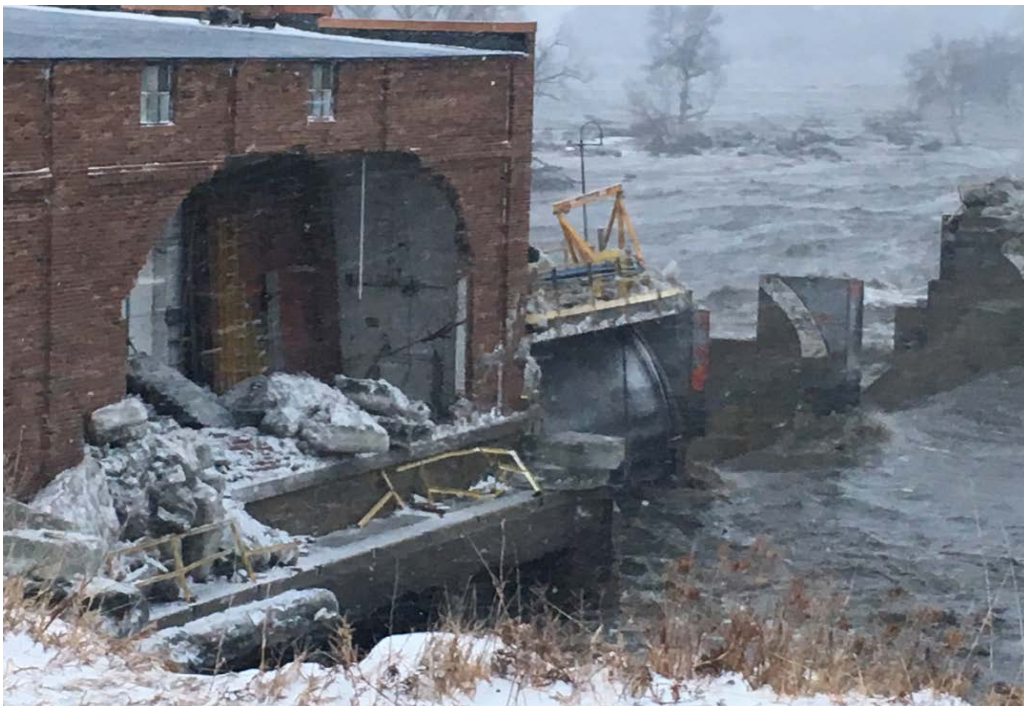
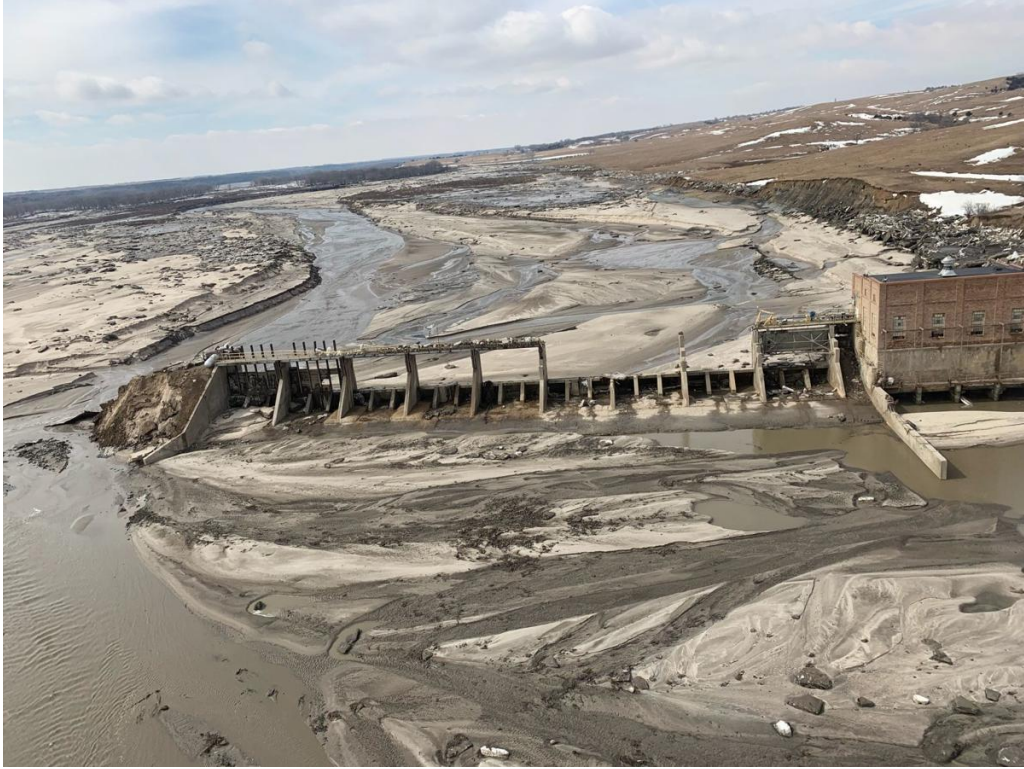
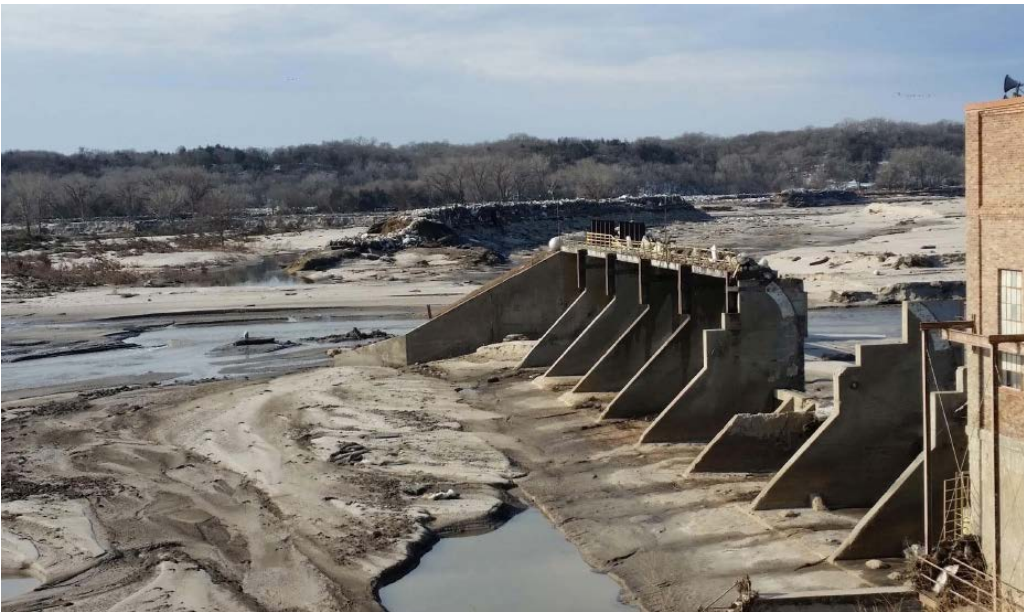
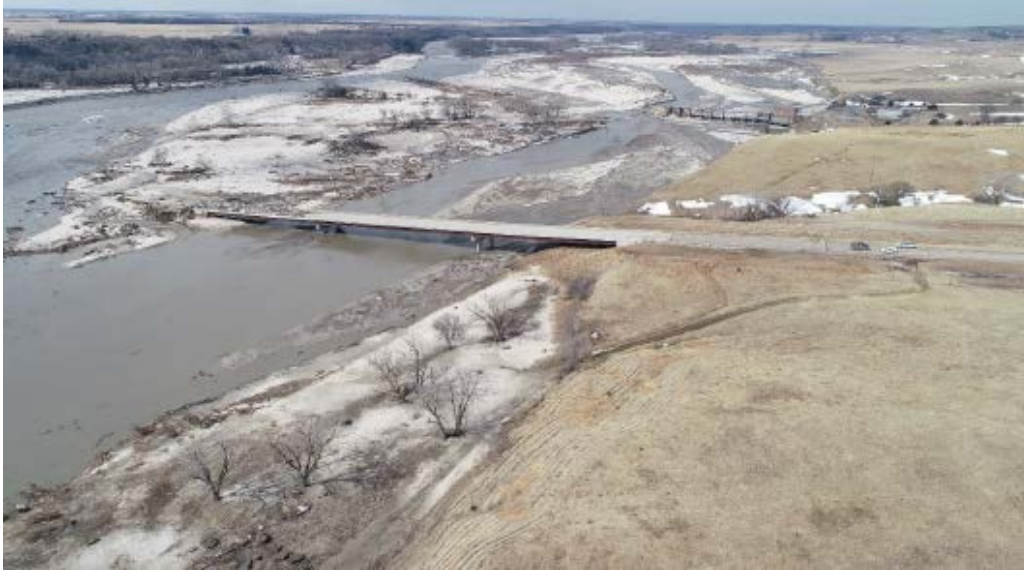
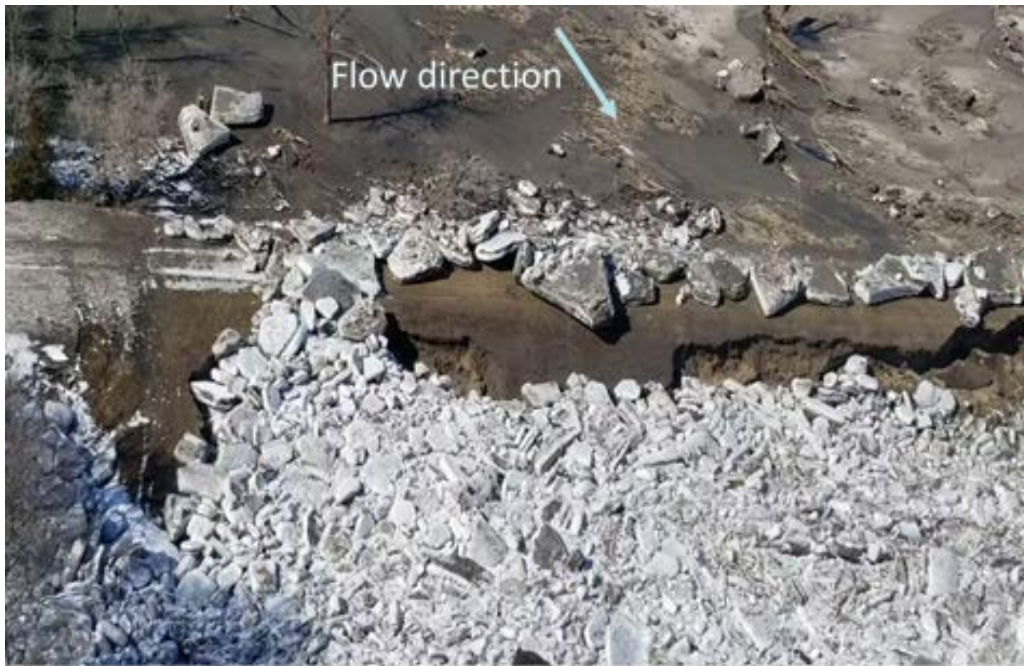
(a) of Figure 10

Figure 10. Views of the dam site and areas adjacent to the site (after the ice run), March 15, 2019 (Sources: NPPD, NEMA, Omaha World Herald): (a) view of the powerhouse at 8:00 AM (ice impact had largely demolished the upstream wall); (b) devastated Spencer Dam; (c) view along the spillway now with its radial gates and a concrete pier missing (note here how the wall containing the embankment is wider (upstream to downstream) than the piers. This configuration caused the two south bays to be shaded, enabling ice build-up over the winter); (d) view looking upstream at the Highway 281 bridge with breached south-approach embankment; and, (e) view, looking upstream, of ice rubble on the remnant embankment (note the headcutting on the embankment's downslope)

flowing out from under the ice likely initiated a headcut erosion on the downstream toe of the embankment that worked its way through the crest at the breach location(s); evidence for such a headcut exists in the remnant embankment. Portions of the embankment that remained standing after the embankment breached show signs of this headcutting (Figure 10e).
