Ice Booms in Rivers; Lessons Learned and the Development of Reliable Solutions

Razek Abdelnour

Fleet Technology Limited,
Ontario, Canada

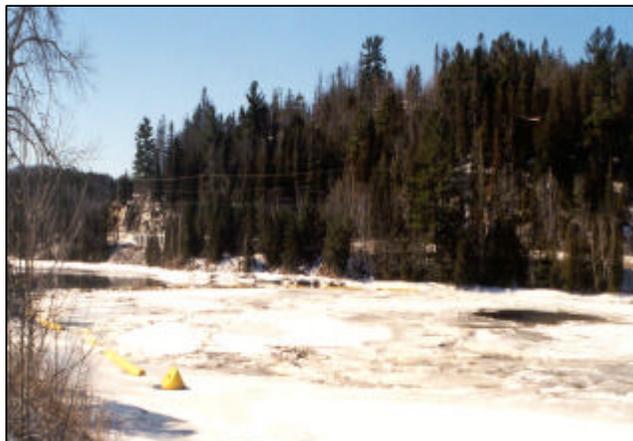
Figure 2: The accumulation of ice floes upstream of the ice boom 24 hours before the opening of the boom. This photo was taken on March 13, 2000.

The Wakefield ice boom was installed on the Gatineau River by Hydro-Quebec in early 1990's and was re-designed then redeployed in its present form in November of 1999 (see Figure 2). The boom is located about 3 km upstream of Lake Wakefield, located about 50 km North of Hull, Quebec. The boom is between two hydroelectric dams, the Paugan Dam located about 35 km upstream, and the Chelsea Dam located about 20 km downstream. A description of this project is given in Abdelnour et al, 2000.

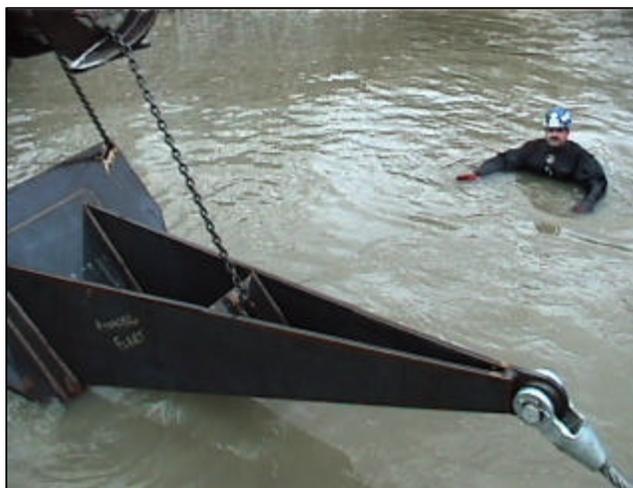
Figure 3: Installation of «Stevin» Anchor.

The ice boom was designed to resist a maximum ice load of 100 tonnes. When this load is exceeded, the boom's East anchor, designed to resist up to 50 tonnes, breaks through the mud and drifts downstream with the ice. The anchor acts as a fuse to ensure no other components are damaged (see Figure 3).

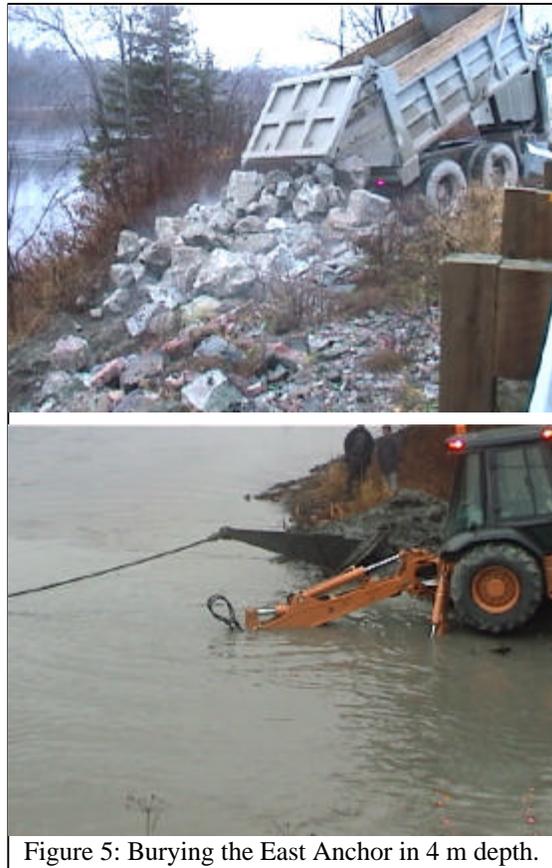
Figure 5: Burying the East Anchor in 4 m depth.

The anchor was also retrieved and re-buried in a 4 m crater and rocks were placed on top to add to its resistance capacity (Figure 5).

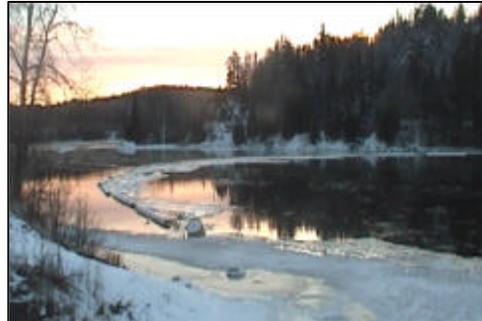
During the ice formation period and 12 hours following the start of one of the heaviest snowstorms during the winter of 2000/01, a second event occurred at noon on December 12, 2000. The snowstorm followed a period of cold air temperature and was -12°C during the storm. Small thin ice flows started to form between the boom and 35 Km upstream, starting at the Paugan Dam. Two days earlier, the ice had already started to form behind the boom as shown in Figure 6.

Figure 6: The ice boom as seen from the East side on December 9, 2000.

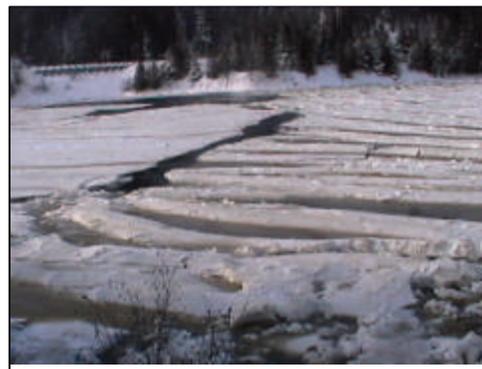
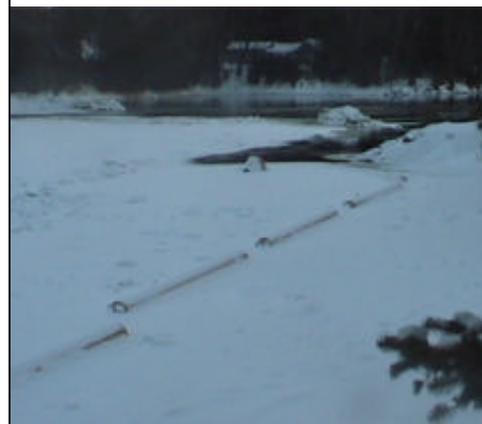
The east anchor retention capacity was exceeded and the ice combined with wet snow that had accumulated in very large quantities behind the boom and drifted about 300 m downstream and formed a barrier preventing any ice from drifting further downstream (see Figure 7). On December 14, a solid ice cover continued its progress at least 10 km upstream.

Figure 7: The snow behind the boom drifted 300 m to form a barrier and blocked the ice drift. Photos on December 12 and 20, 2000.

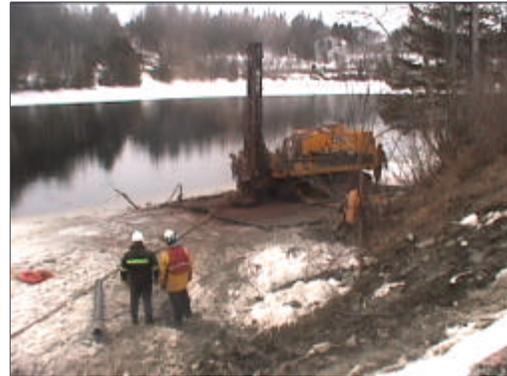
Figure 10: The drilling rig on the shore ice.

Preparations were made for drilling a hole up to 15 metres. Because of the availability of a small window where an ice platform was available for drilling, it was decided to reach the rock regardless of the depth. The rock was found after drilling 40 m (see Figures 10 and 11). Two 15 cm diameter holes were drilled where a 7 m long anchor was placed. The anchor was welded to a 50 m long, 32 mm diameter chain all the way to the river bottom. The hole was grouted using cement. Each anchor resistance capacity is 136 tonnes and both anchors will provide a total resistance of 272

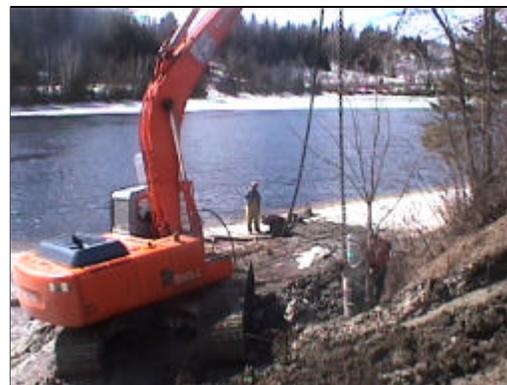
Figure 11: Deployment of the chain inside the concrete filled 15 cm casing.
