CGU HS Committee on River Ice Processes and the Environment
13th Workshop on the Hydraulics of Ice Covered Rivers
Hanover, NH, September 15-16, 2005

**Performance of the Lake Erie Ice Boom,
Eight Years After Major Design Modifications in 1997**

R. Abdelnour, G. Comfort and A. Liddiard,

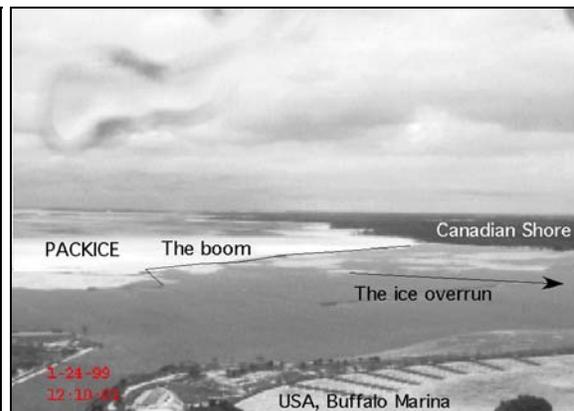
Figure 5: January 24, 1999 Ice Run Event

Another minor event occurred on January 24th, 1999 when large ice floes overtopped the boom (Figure 5) but the volume remained below the amount that would cause any blockage or the water level to rise.

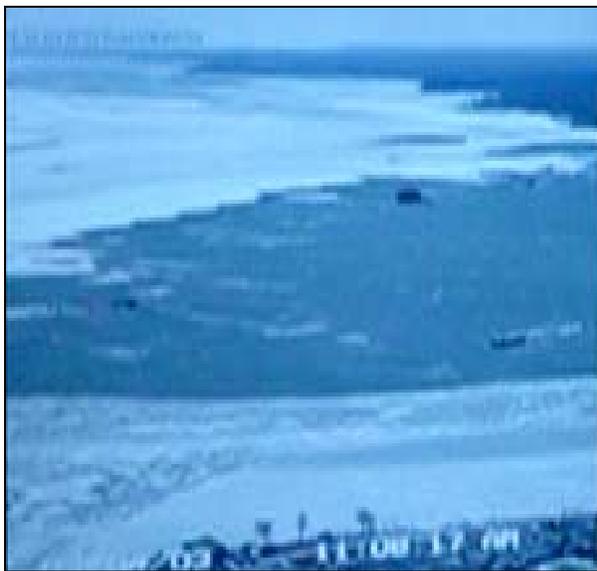
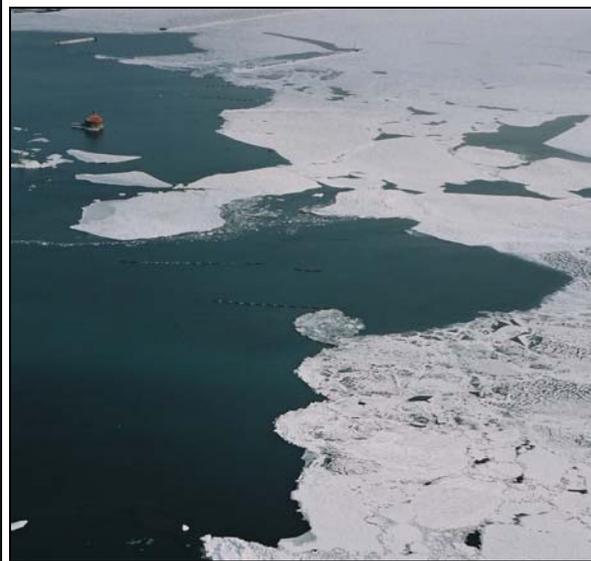
One major event occurred on February 4th, 2003, where the anchor cable No. 18, located on the Canadian side of the boom, broke and precipitated the failure of 13 adjacent span cables. The event occurred when the ice was solidly formed and consolidated to the boom pontoons. The failure of the boom did not result in an ice run because the ice cover was wedged between the north and south shores of the lake. The failure of the boom is shown in Figure 6.

Figure 6: A Video Clip Showing the Failure of the Boom Figure 7: The Failure Started on the Canadian Side

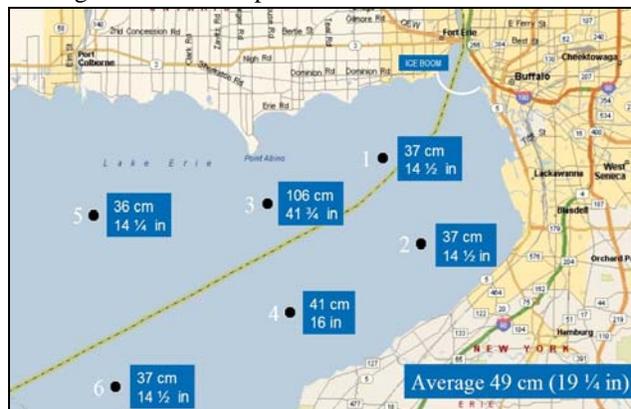
The ice thickness upstream of the boom was measured on February 17 (Harding, 2003), about two weeks after the event occurred. The average ice thickness measured was 49 cm. The data is shown in Figure 18. Figure 19 shows the FDD on February 4th, 2003 and for all the seasons.

Figure 18: Ice thickness taken on February 17, 2003

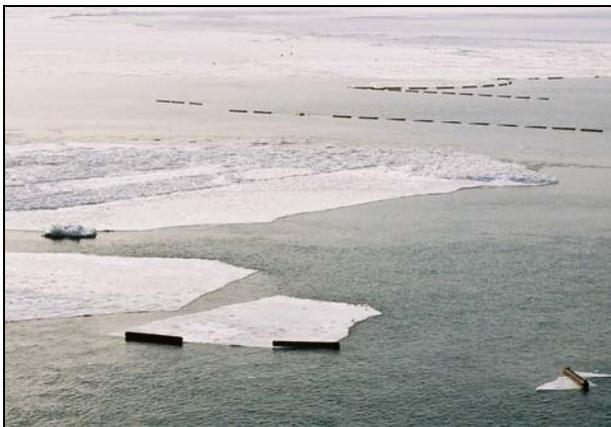
It was therefore likely that on February 4th, 2003, the ice surrounding the pontoons was thicker and the accumulated rubble ice was partly consolidated. This can be observed in Figures 20 and 21, taken on February 7.

Figure 20: Consolidated Ice around One of the Pontoons

The ice consolidation around the boom pontoons will likely hinder the boom from submerging under the ice, which normally allows the ice pressure to be released when the applied load exceeds the capacity of the pontoon thereby releasing the pressure on the boom.

- Monitor the air temperature and the Freezing Degree-Days and as soon as this value reaches 200 FDD, break the ice that surrounds the boom using the icebreaker to ensure that the boom will submerge, even late during the winter, before the ice pressure reaches the anchor or span cable failure loads. This was implemented successfully during the winter season of 2004/05. Icebreaking should be repeated on by-weekly basis, if the air temperature remains cold (below -15°C), a very rare event in Lake Erie.

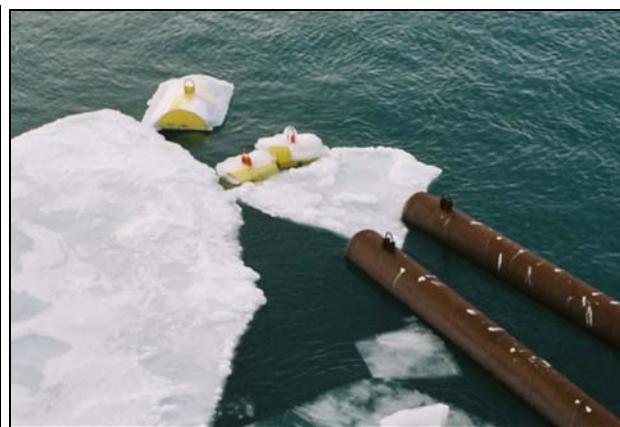
Figure 21: Consolidated Ice around the Buoys
