**CGU HS Committee on River Ice Processes and the Environment**  
13th Workshop on the Hydraulics of Ice Covered Rivers  
*Hanover, NH, September 15-16, 2005*

### **Ice Tree Scar Evidence of Historic Ice Events on the Grasse River**

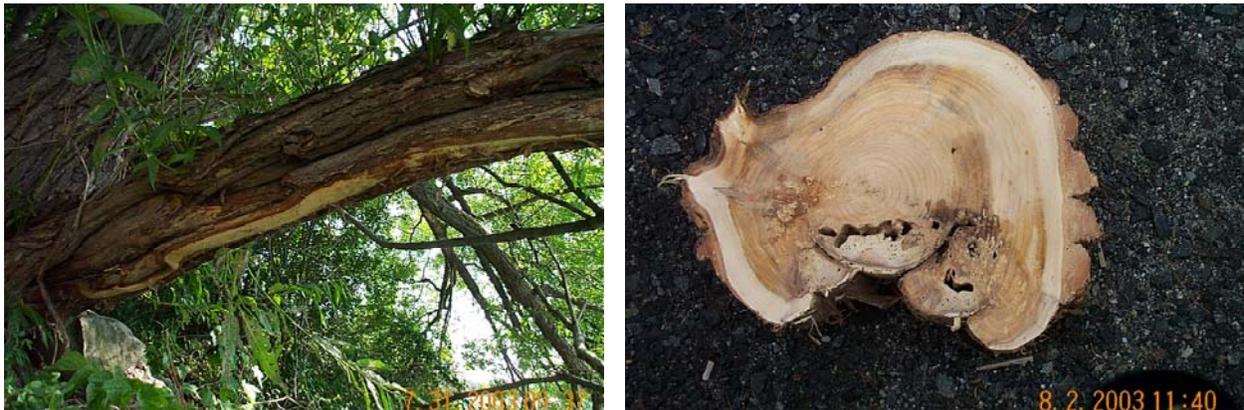
Fig. 4. Ice scarred willow limb overhanging Grasse River near old power canal (left). Sawn section from willow showing 4 distinct ice-scarring events (right).

Inspection of annual growth rings of the 30-cm-diameter, 40-year-old willow near the Power Canal Dam indicates four distinct ice-scarring events in 2003, 1996, 1986 and 1978 (Figure 4). The 2003 and 1996 event dates are quite certain, while the two earlier dates are slightly less certain, probably accurate to plus or minus 1 year. The sections were cut from a portion of tree trunk about 2.4 m above the low water level, indicating that these four ice events caused stage increases of at least this height. Tree ring analysis of the 25-cm-diameter, 34-year-old aspen, 1.3 miles downstream of the Power Canal Dam shows scarring from the 1996 event up to a height of 2.1 m, and scarring from a 2001 event up to 0.9 m above the low water elevation (Figure 5). The absence of scarring from the 2003 event may result from the fact the tree was set back about 3 m from the water's edge. A 2.7-m-high recent scar, located 80 m upstream of the aspen sample, indicates that the 2003 ice levels were high in this area.

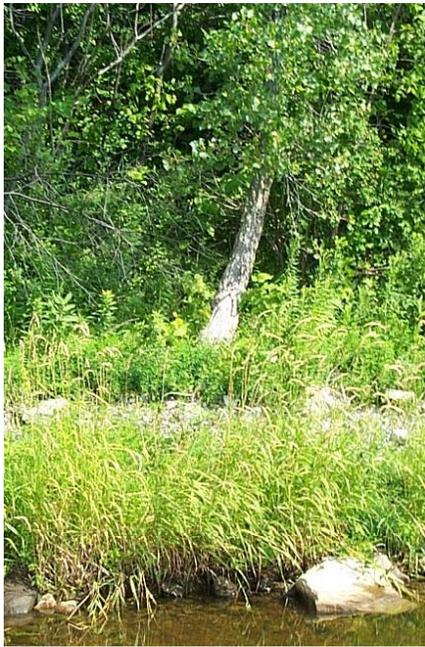
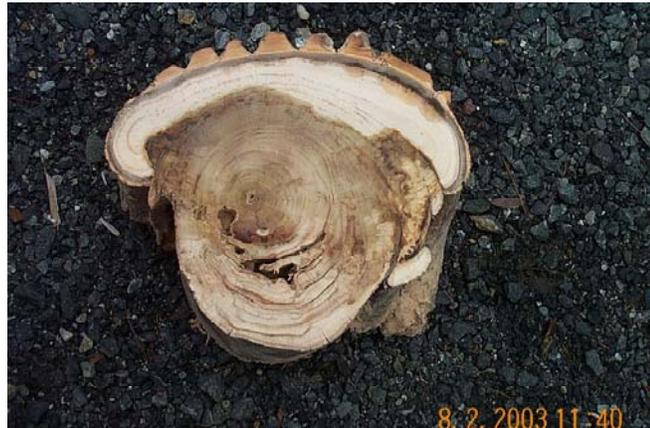
Fig. 5. Aspen 1.3 miles downstream of Old Power Dam, scarred by the 2001 and 1996 events.

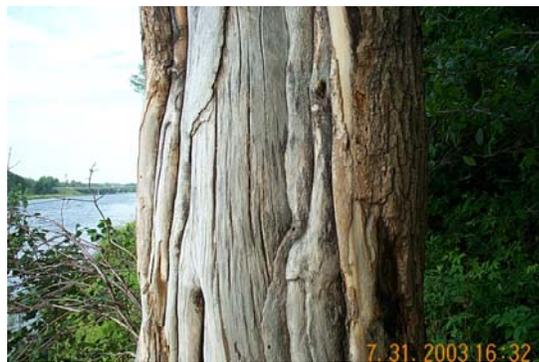
Fig. 6. Ash on upper river with scars from multiple ice events, up to 4 m above low water.

Tree ring data were obtained at two sites on the upper river using an increment borer. Borings from a 60-cm-diameter green ash located 900 m upstream of the Route 37 Bridge (Fig. 6) and a 30-cm-diameter willow 300 m farther upstream (Fig. 7), show evidence of two major ice events about 10 and 20 years ago, in addition to the 2003 event.

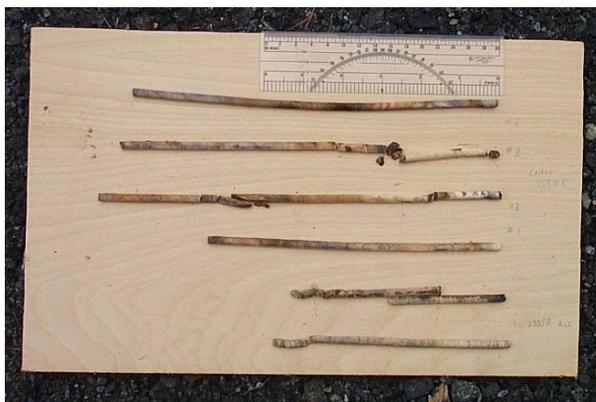
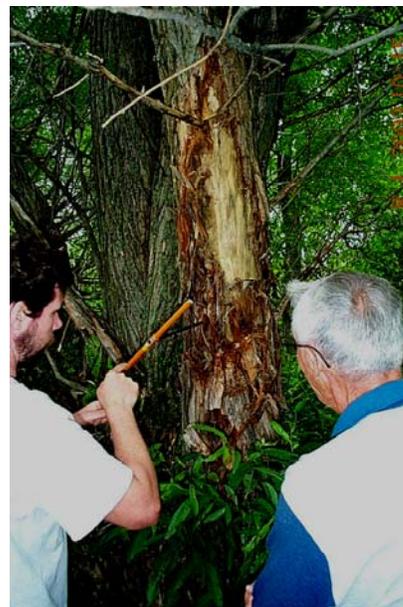
Fig. 7. Cores taken from a willow on the upper river.
