CGU HS Committee on River Ice Processes and the Environment
20th Workshop on the Hydraulics of Ice Covered Rivers
Ottawa, Ontario, Canada, May 14-16, 2019.

**An Emerging Picture of Peace River Break-up Types that Influence Ice Jam
Flooding of the Peace-Athabasca Delta
Part 1:
The 2018 Peace River Break-up**

Martin Jasek

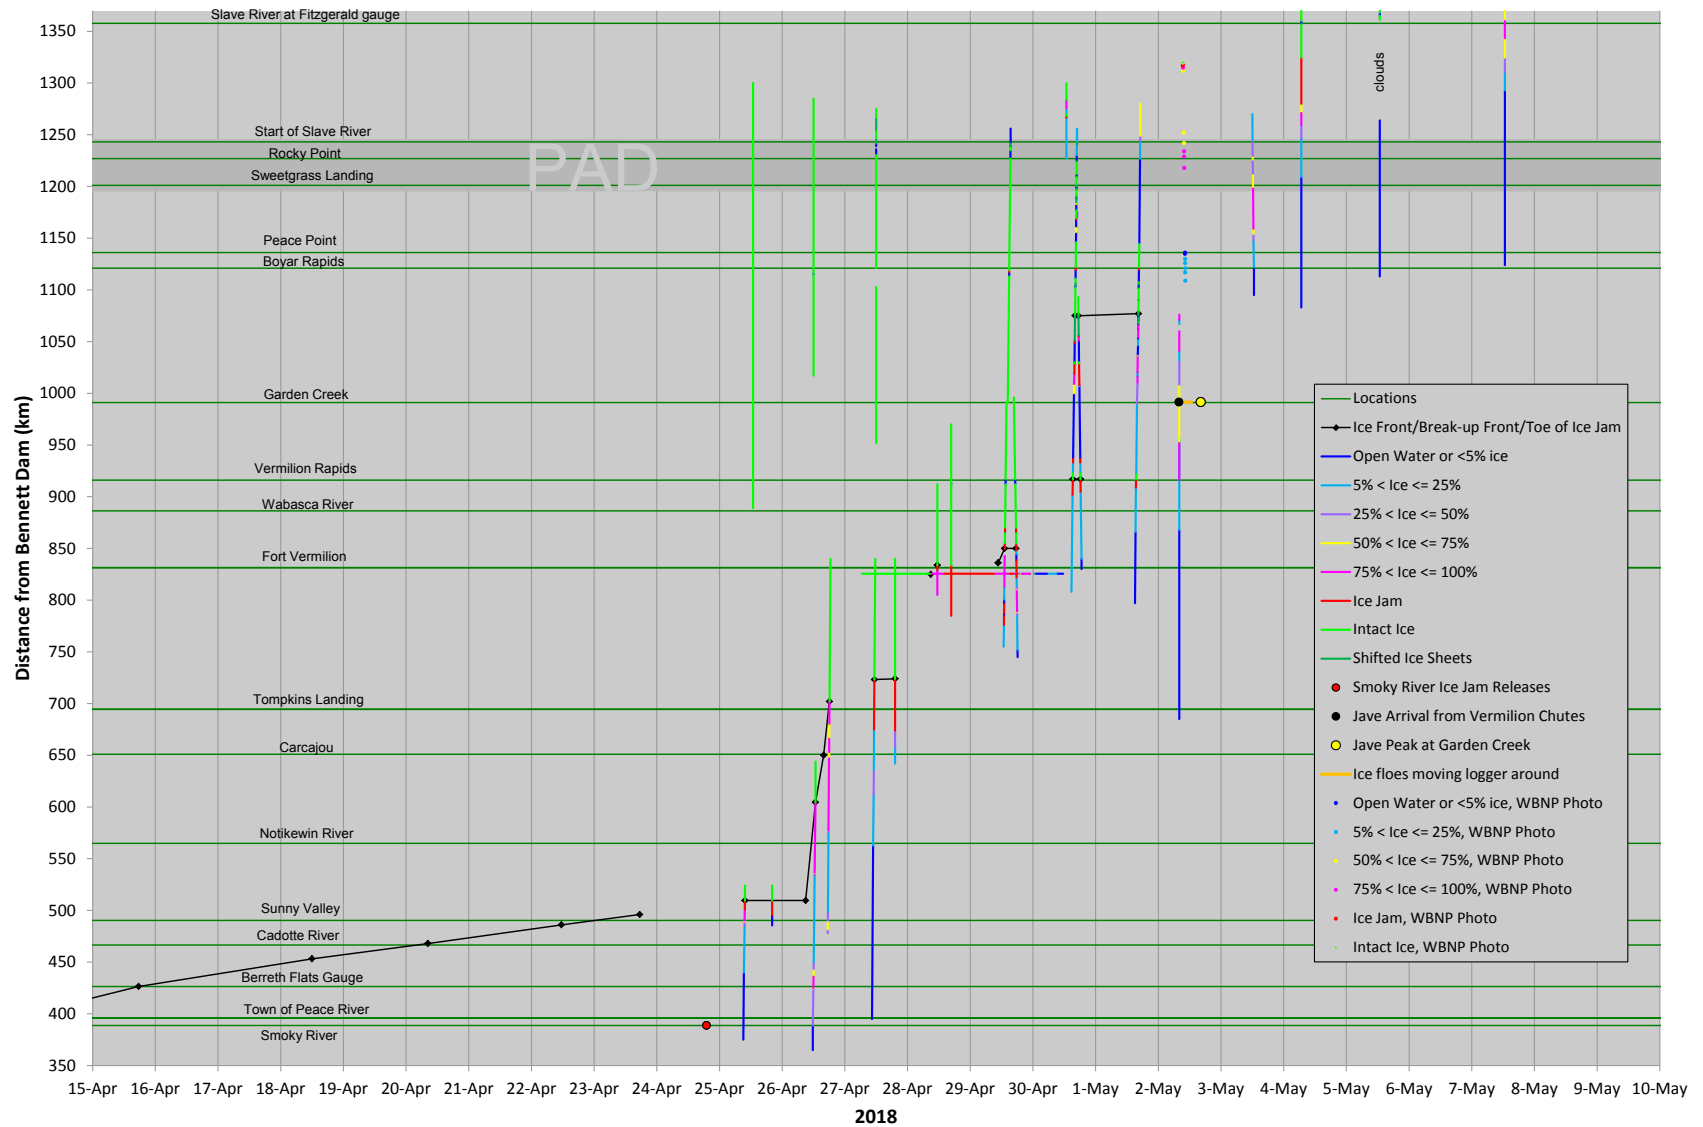
Figure 3. Ice conditions on the Peace River based on aerial, satellite and ground observations.

The progression of break-up based on aerial surveys, satellite imagery, remote camera imagery, and ground based observations is summarized in Figure 3. The ice front in Figure 3 is denoted by the black diamonds connected with black lines. In the case of the thermal break-up on the Peace River, the receding ice front marks the location of the demarcation between solid winter ice downstream and the open water or a small amount of rubble ice upstream. In the case of a dynamic break-up, the ice front is also the break-up front, and if the dynamic break-up front is arrested, it becomes the toe of an ice jam. Each multi-coloured vertical line in Figure 3 depicts the ice conditions based either on aerial observations or satellite imagery. Horizontal lines indicate locations of interest, but some contain ice observation information based on ground observations or web cameras.

These four observation timing points were recorded for a sheet break-up front the initiated in the morning of Apr 26. The points are plotted in Figure 3 and are also summarised in Table 1 where the rate of break-up between each observation location is also listed.

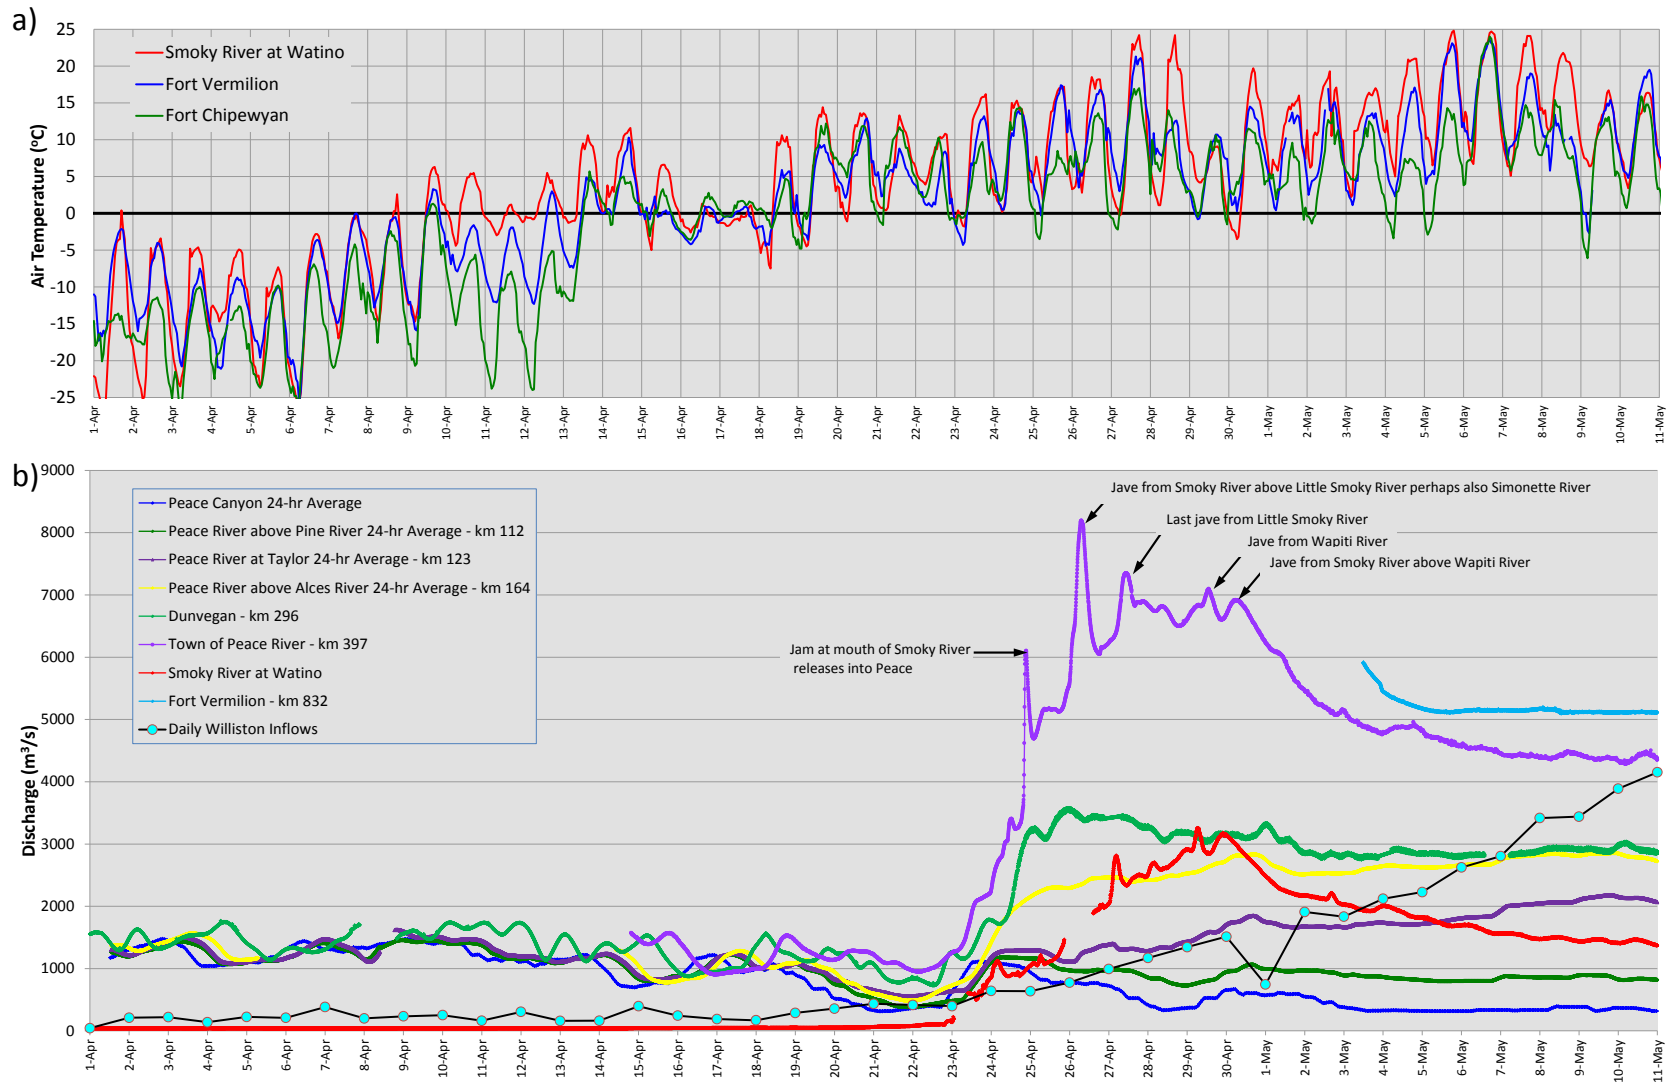
Figure 4. a) Hourly Air Temperatures at Smoky River at Watino, Fort Vermilion and Fort Chipewyan April 1 to May 11, 2018.
 b) Discharges of Peace River, Smoky River and Slave River Apr 1 to May 11, 2014. Ice affected or bad record removed.

Following a below freezing temperatures in early April (Figure 4a), significantly warmer temperatures started on Apr 18 and river level gauges in the Smoky Basin started to respond on Apr 20. There was significant snowmelt run-off by Apr 22 on the lower elevation (plains) of the Smoky River basin (Figure 5). Ice runs and jam formations on various streams in the Smoky Basin began on Apr 22 and by Apr 24 an 18 km long ice jam formed between 20 km and 2 km from the Smoky-Peace confluence, Figures 6 and 7 respectively. By this time, the lower 74 km of the Smoky River and another 159 km of the Little Smoky River had broken up.

Following the largest jave event on Apr 26, several smaller javes entered the Peace River between Apr 27 and Apr 30 whose origins are noted in Figure 4b and described in Jasek (2019b). These additional javes sustained the high discharge between 6500 and 7000 m³/s on the Peace River until Apr 30 (Figure 4b); once the javes stopped, the discharge in the Peace River at the Town of Peace River started to decline significantly.

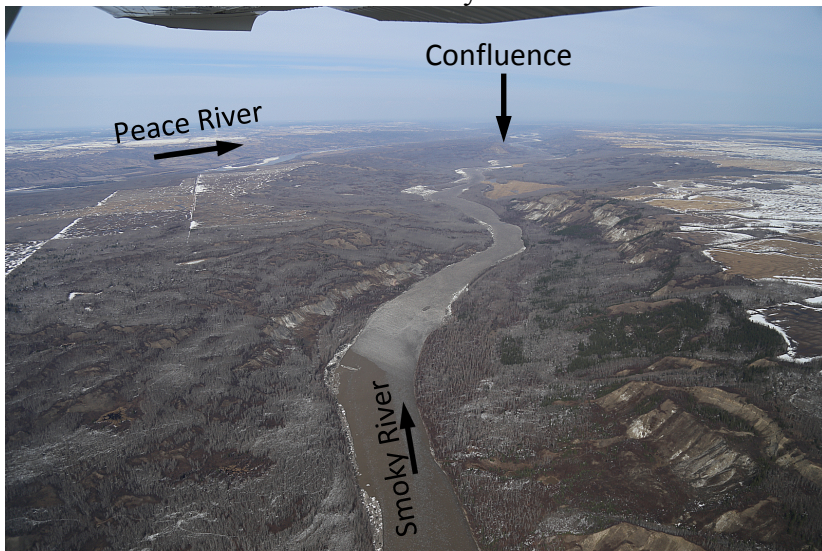
Figure 6. Head of an 18 km long ice jam on the Smoky River above the Peace River on Apr 24, 2018 15:40 MDT.

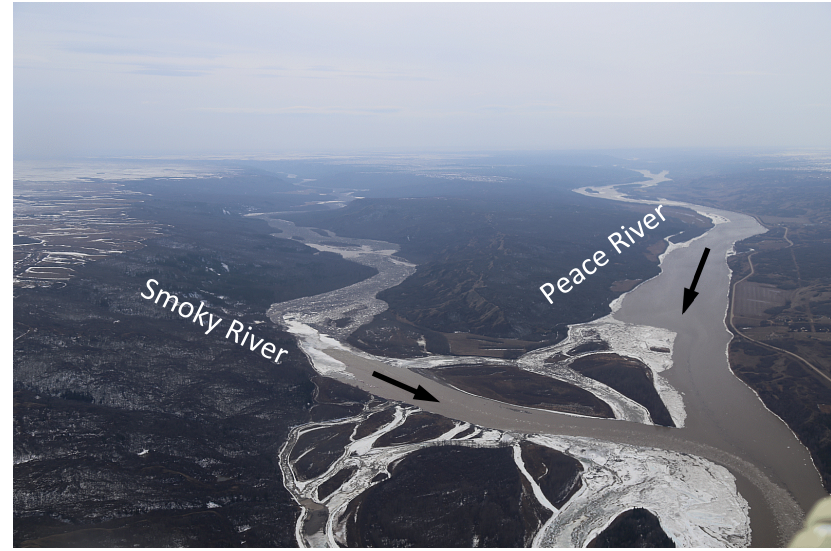
Figure 7. Toe of an 18 km ice jam on the Smoky River (left) on Apr 24, 2018 15:25 MDT, 2 km from the confluence with the Peace River (right) which had broken up thermally on Apr 12.

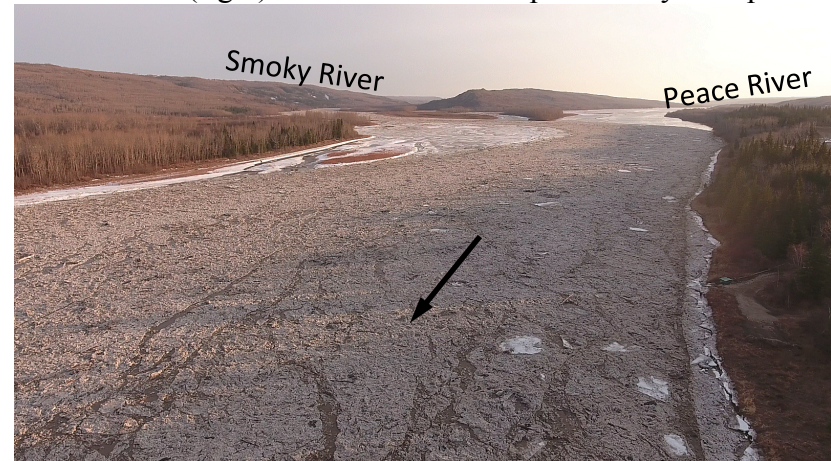
Figure 8. Smoky River 18 km long ice jam releasing into the Peace River on Apr 24, 2018 21:17 MDT (about 2.25 hours after the start of the release).

At approximately 18:00 hrs on Apr 24, the 18 km long ice jam on the Smoky River started to release into the Peace River (Figure 8). This sudden release increased the discharge in the Peace River from about 3200 m³/s to about 6100 m³/s (Figure 4b). However, part of this increase was due to increasing inflows on the main stem of the Peace River as noted by the gauge at Dunvegan, about 100 km upstream of the town. This large discharge increase is significant because had there been an ice cover in the Peace River at the town at the time, the dykes would have likely been overtopped as the calculated capacity of the town dykes under ice jam conditions is 3500 m³/s (Andres, 1996). Even after the main jave had passed, the total flow at the town receded to only 5000 m³/s.

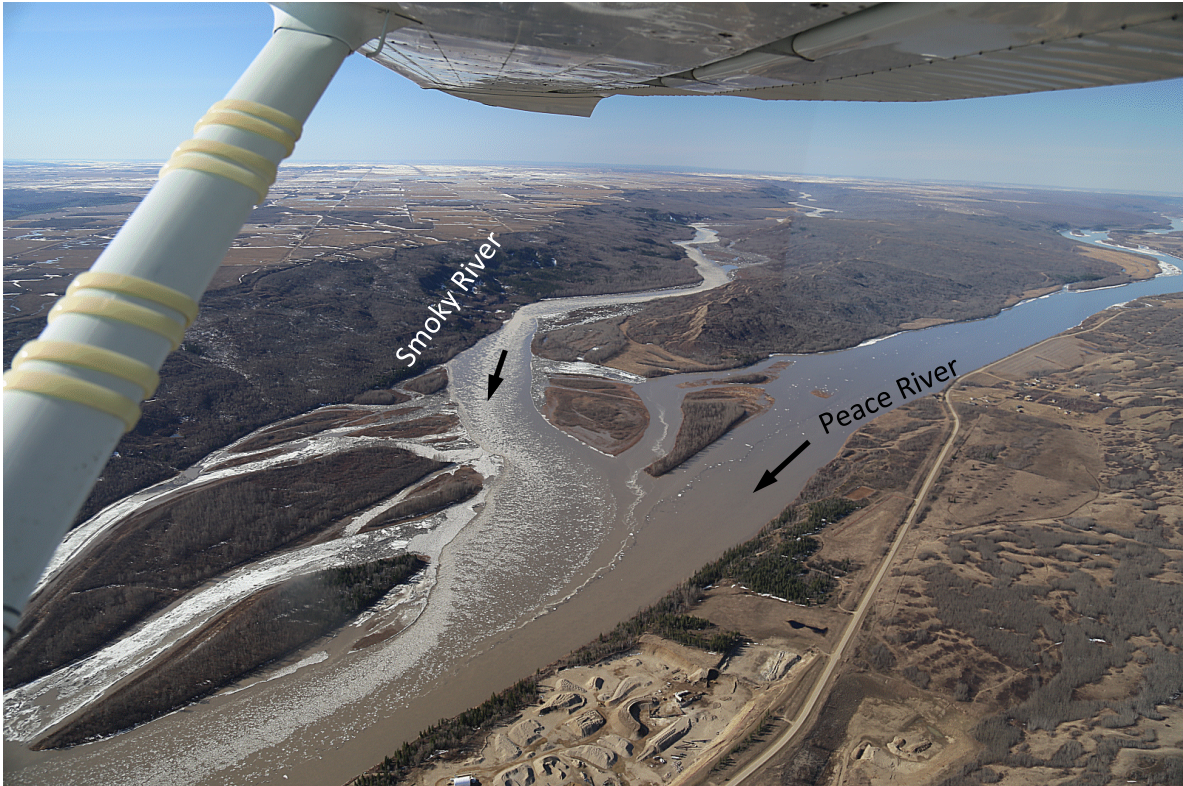
Figure 9. An ice run (jave) from the Smoky River on Apr 26, 2018 10:57 MDT that produced the highest water level and discharge on the Peace River in spring 2018.

The next big event was a large jave from the Smoky River above the Little Smoky River that increased the discharge in the Peace River from about 5000 m³/s to 8200 m³/s on Apr 26 (Figure 4b). This produced the peak water level and flow for the entire 2018 break-up at the Town of Peace River. The WSC gauge in TPR was malfunction during this peak water level and the flow was determined from the gauge at the south end of town. The ice run that was documented by aerial recognisance extended from 44 km upstream on the Smoky from the Peace to 60 km downstream of the Peace-Smoky Confluence (Figure 9 and 10), a total length of more than 100 km. The peak water level for the entire break-up was confirmed by the Berreth Flats gauge 30 km further downstream from the Town of Peace River which was also under open water conditions (Figure 18).

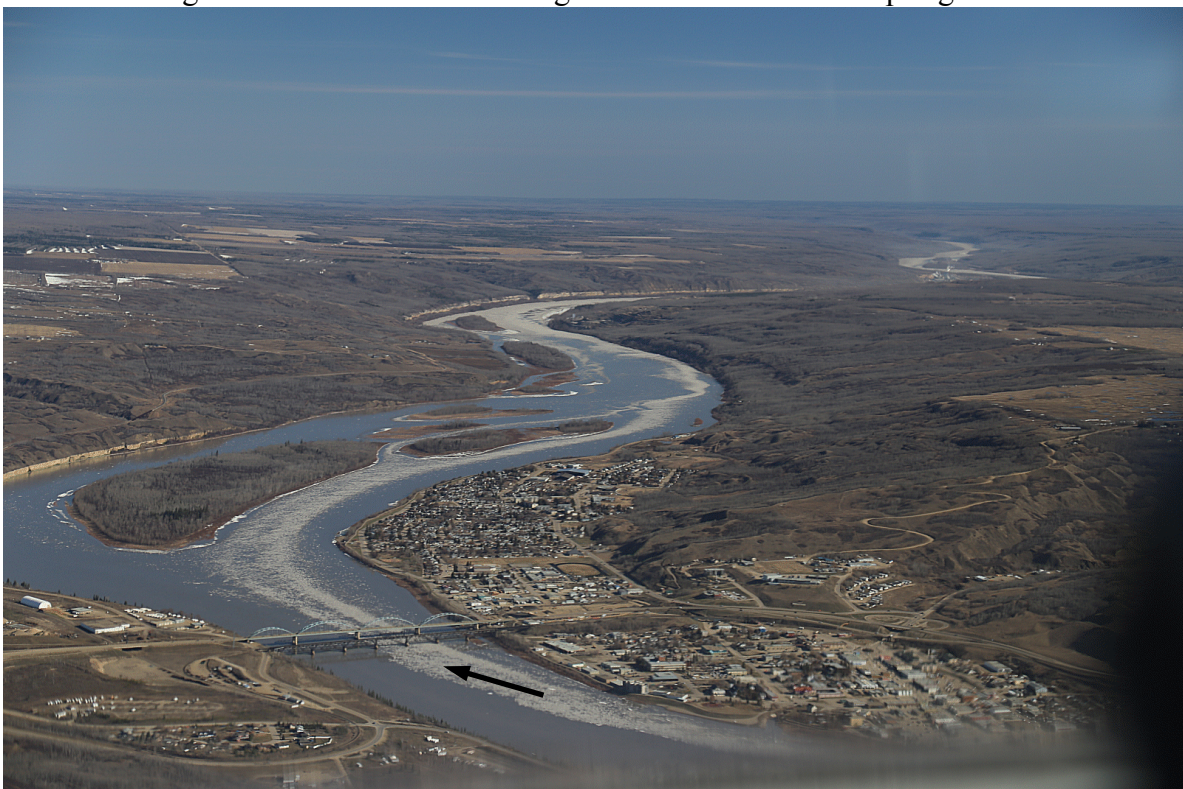
Figure 10. Looking downstream from the Town of Peace River at an ice run on Apr 26, 2018 10:57 MDT that originated from the Smoky River and produced the peak flow in spring 2018.

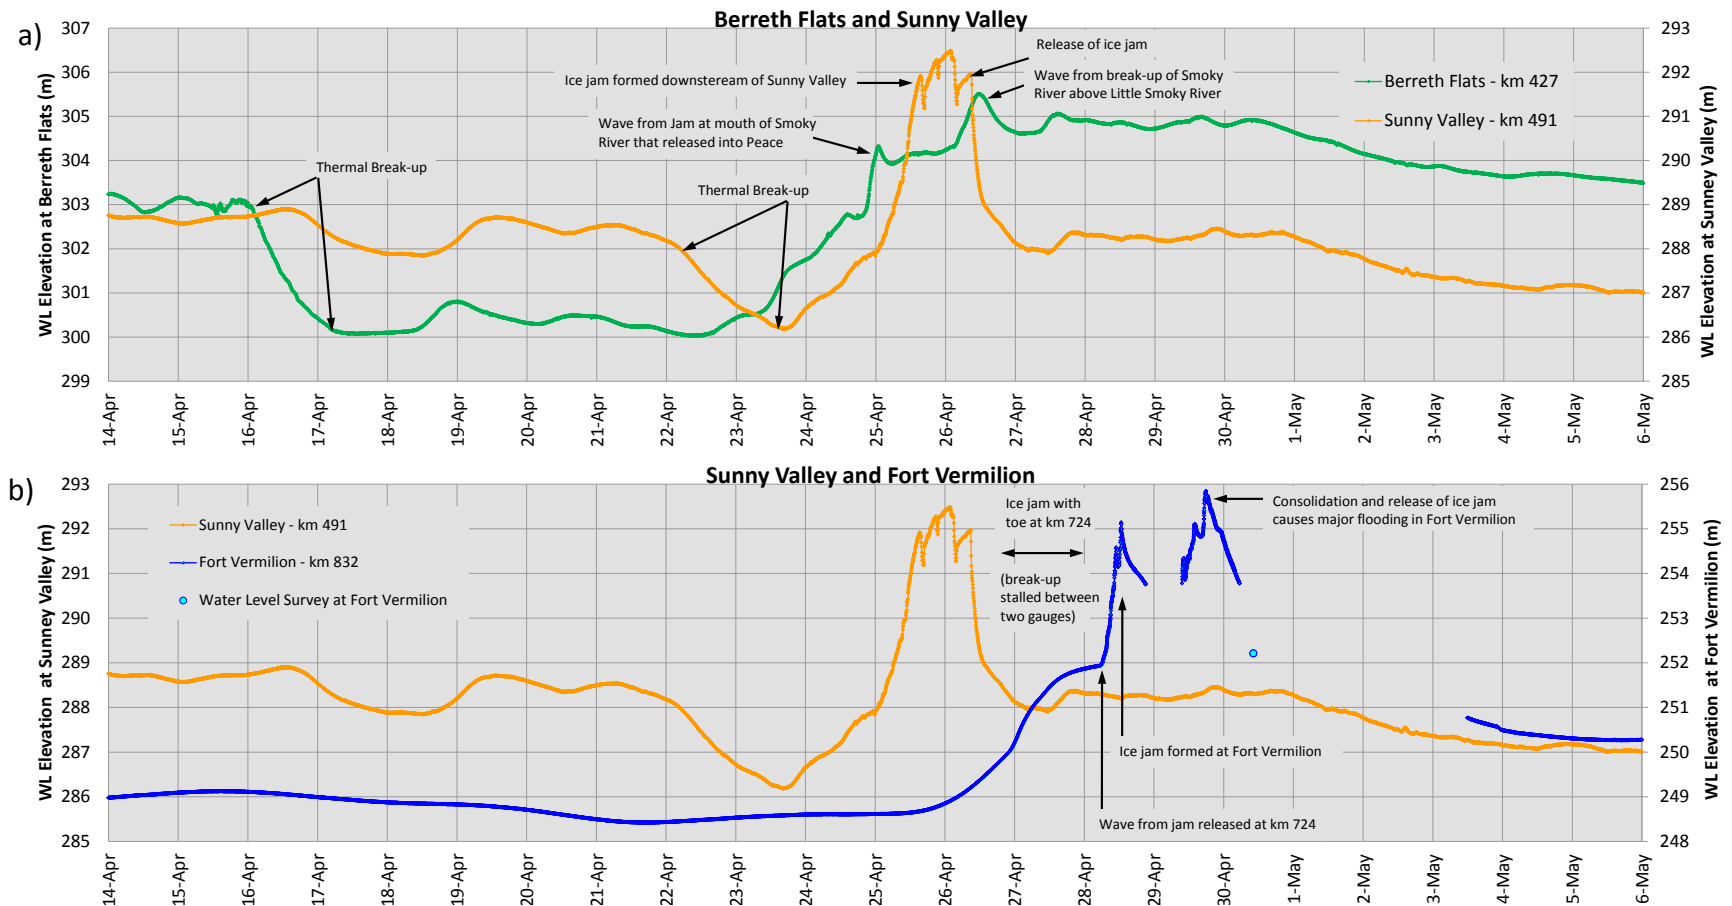
Figure 11. a) Water level elevation at Berreth Flats and Sunny Valley and b) Sunny Valley and Fort Vermilion April 14 to May 6, 2018.

The ice broke up, mostly thermally, in the 100 km reach downstream of the Town of Peace River and Sunny Valley. Figure 11a shows the 2 to 3 metre gradual drop at the Berreth Flats and Sunny Valley gauges on Apr 16 and Apr 23 associated with the benign thermal break-up at these two gauges respectively. The break-up front was traveling between 8 to 10 km/day around these dates (Figure 3), also indicative of a thermal break-up.

The 14 km ice jam downstream of Sunny Valley which was causing a flood at Kalyna Flats released on Apr 26, 2018 09:00 as indicated by the sudden drop in the gauge at Sunny Valley in Figure 11. The release was coincident with the arrival of the largest jave from the Smoky River above the Little Smoky River. The ice jam downstream of Sunny Valley was resting against a solid ice cover and once it mobilized it proceeded to break-up the Peace River as a “sheet break-up front” (defined in Jasek, 2003).

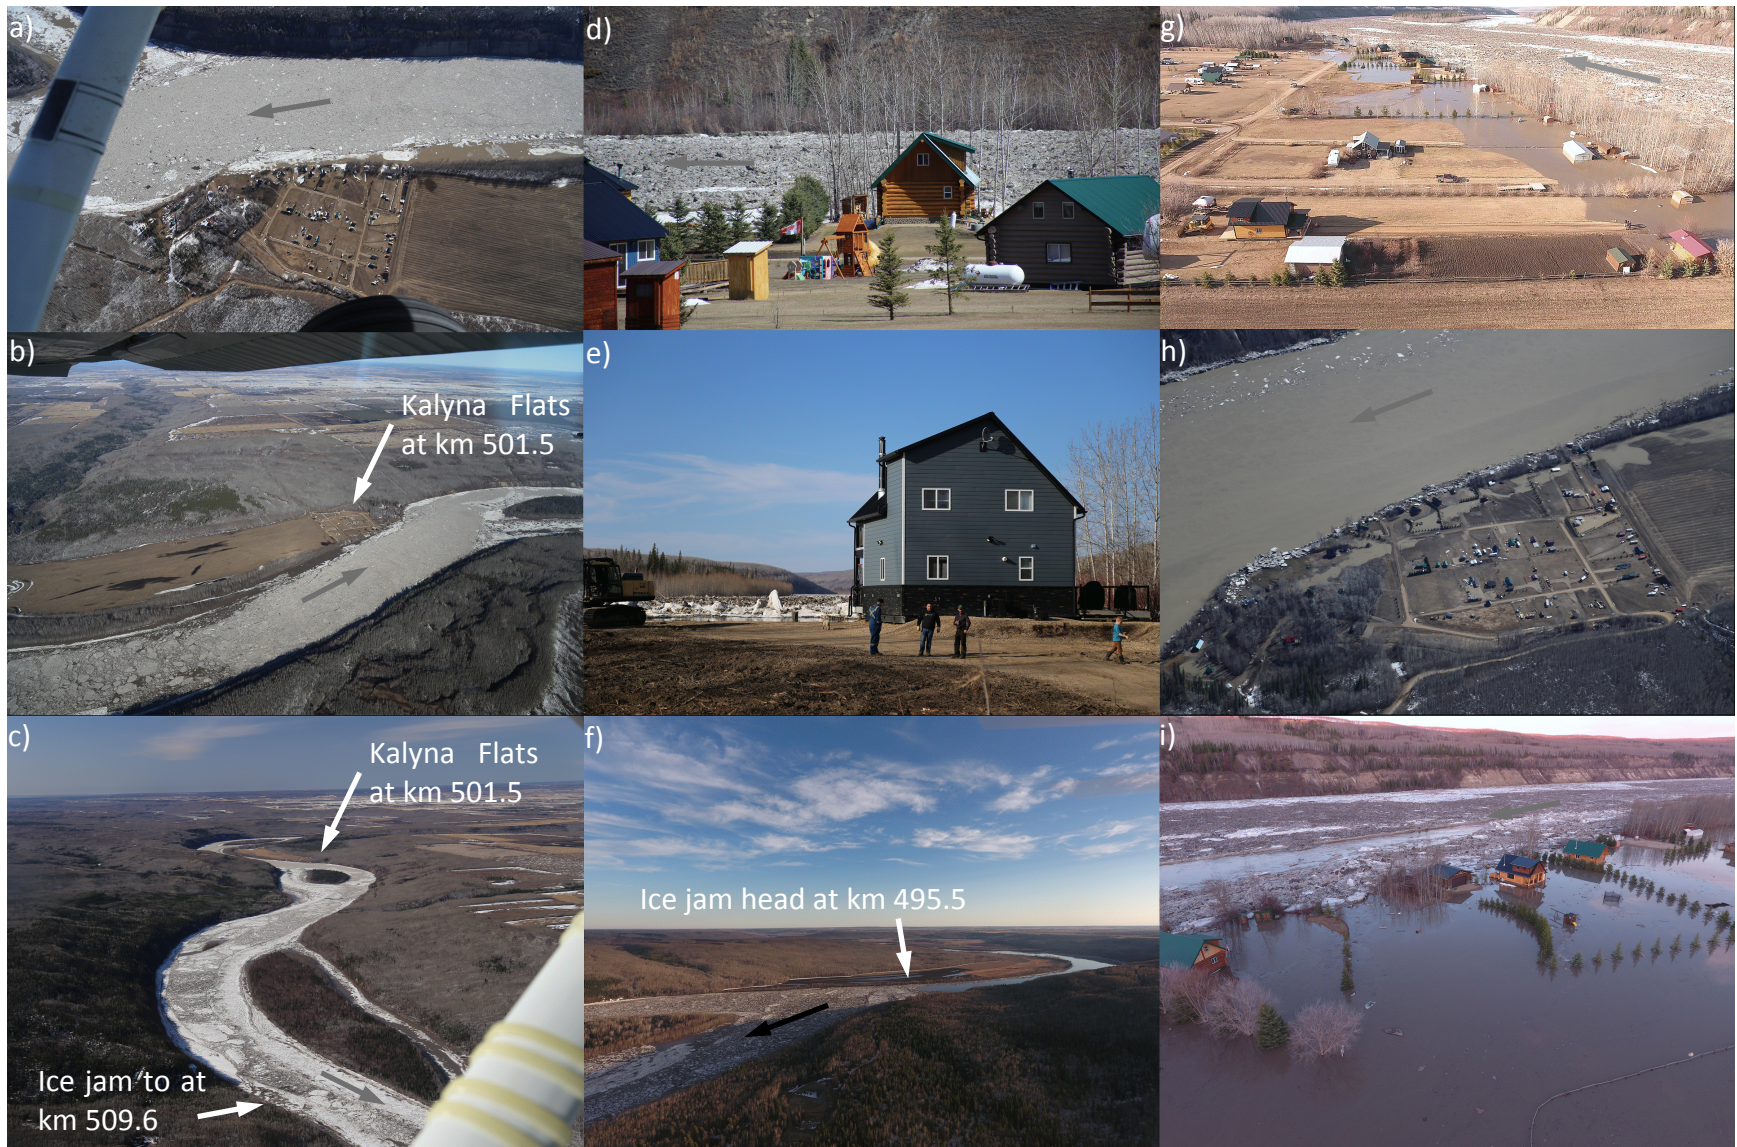
Figure 12 a,b) Ice jam formation c) toe at km 509 on Apr 25, 2018 09:47 MDT. d,e) increasing water levels at Kalyna Flats. f) Head of ice jam at km 495.5 on Apr 25, 2018 20:09 MDT. g,h,i) flooding at Kalyna Flats.

A change in break-up progression was noted on Apr 24-25, when the jave from the release of the 18 km ice jam just above the mouth of the Little Smoky River described in Section 4.1 travelled down the Peace River and encountered the solid Peace River ice cover and formed a 14 km long ice jam just downstream of Sunny Valley (See April 25, Figure 3). This produced significant flooding as the ice jam consolidated into the evening of Apr 25 and overnight to Apr 26 (See 6.5 m stage increase in Sunny Valley gauge, Figure 11a) and resulting flooding at Kalyna Flats, about 10 km further downstream in Figure 12). The missing data in the Fort Vermilion hydrograph was caused by declining water levels after the ice moved the sensor into a shallower area.

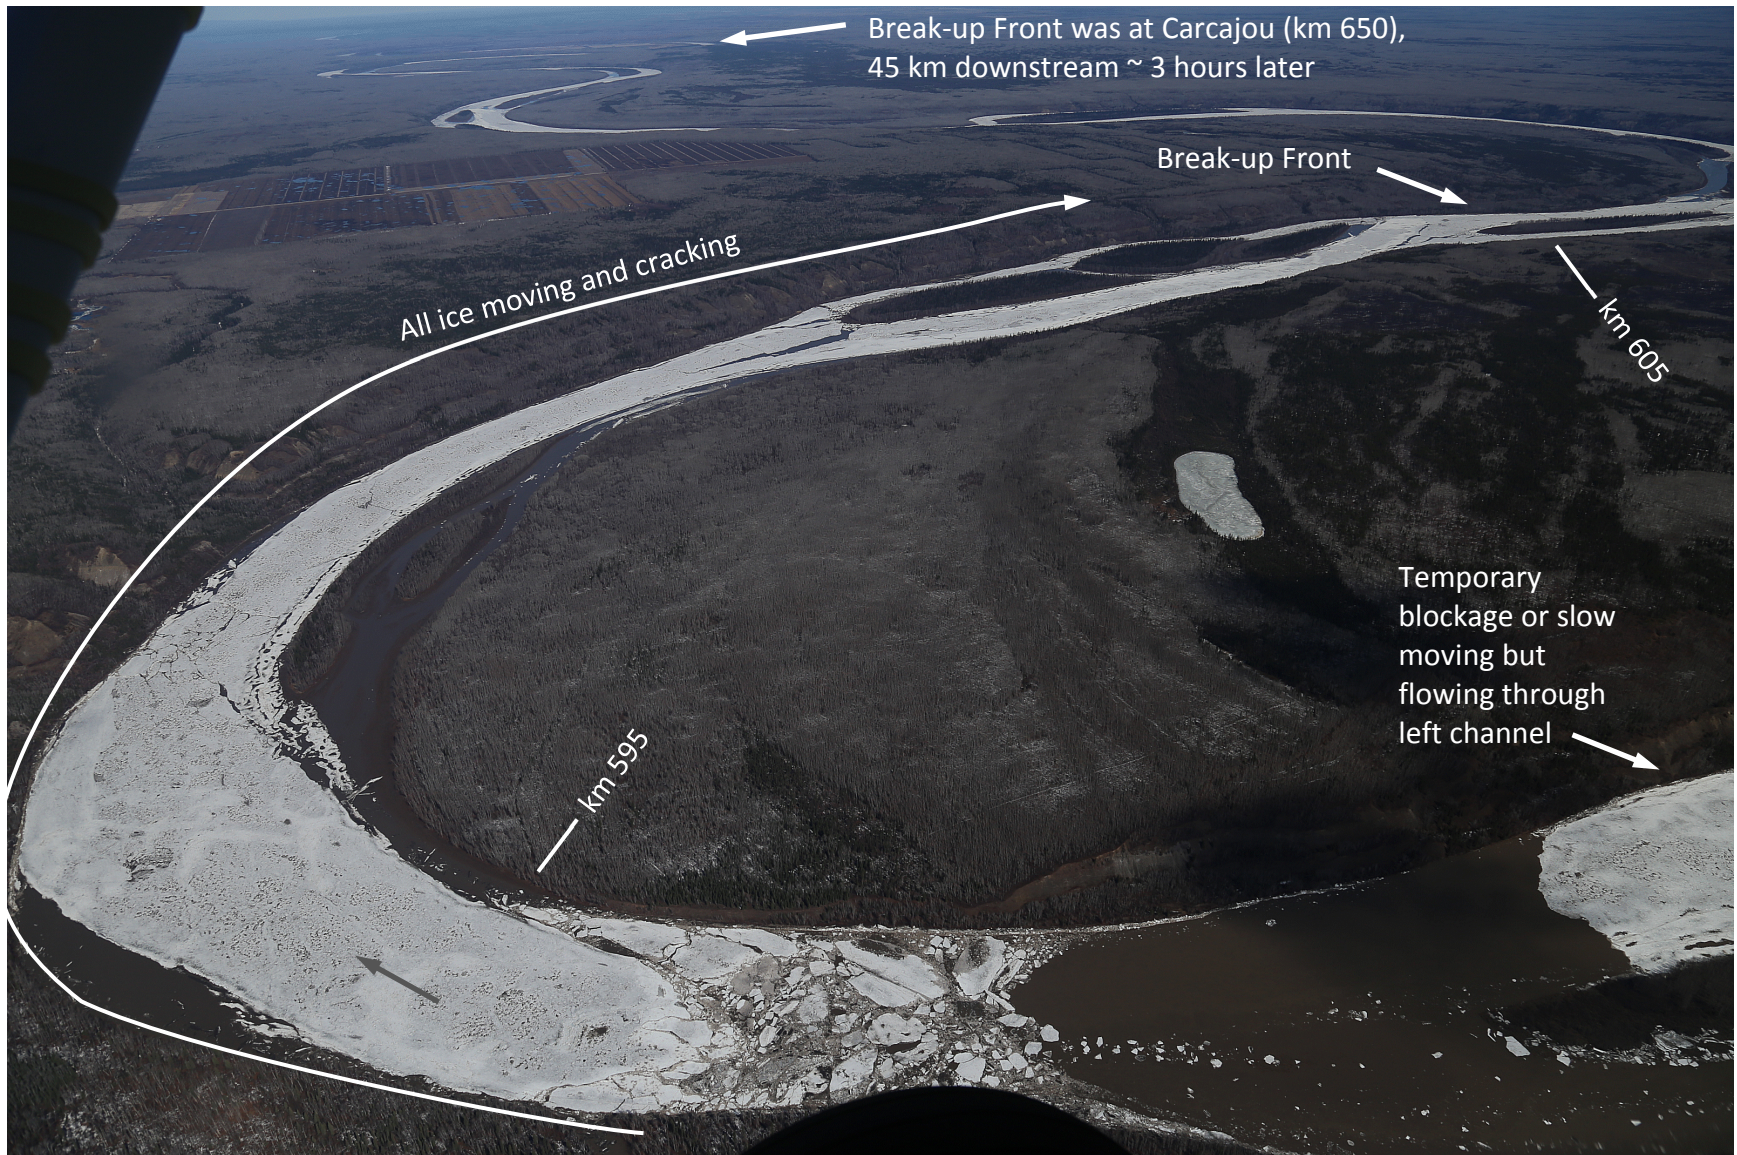
Figure 13. Sheet break-up front at km 605 on Apr 26, 2018 12:44 MDT.

About 3.75 hours after the ice jams release and about 95 km further downstream the break-up front was documented via a flight by BC Hydro. Figure 13 shows a sheet break-up front at km 605 on Apr 26, 2018 12:44 hrs with 10 km of moving ice sheet upstream of the break-up front. Numerous cracks in this ice sheet can be seen, these were progressive cracks getting more numerous as the ice sheets were moving.

Sheet break-up fronts were successfully recorded with aerial photography indicating how many km of river ice sheet is able to mobilize instantaneously despite there being a solid ice cover downstream. This is particularly illustrated in Figure 13 where the extensive cracking ice sheet is able to move in a bend in the river and through islands by shoving into open water areas along the banks and side channels, eventually crack into smaller pieces and keep moving.

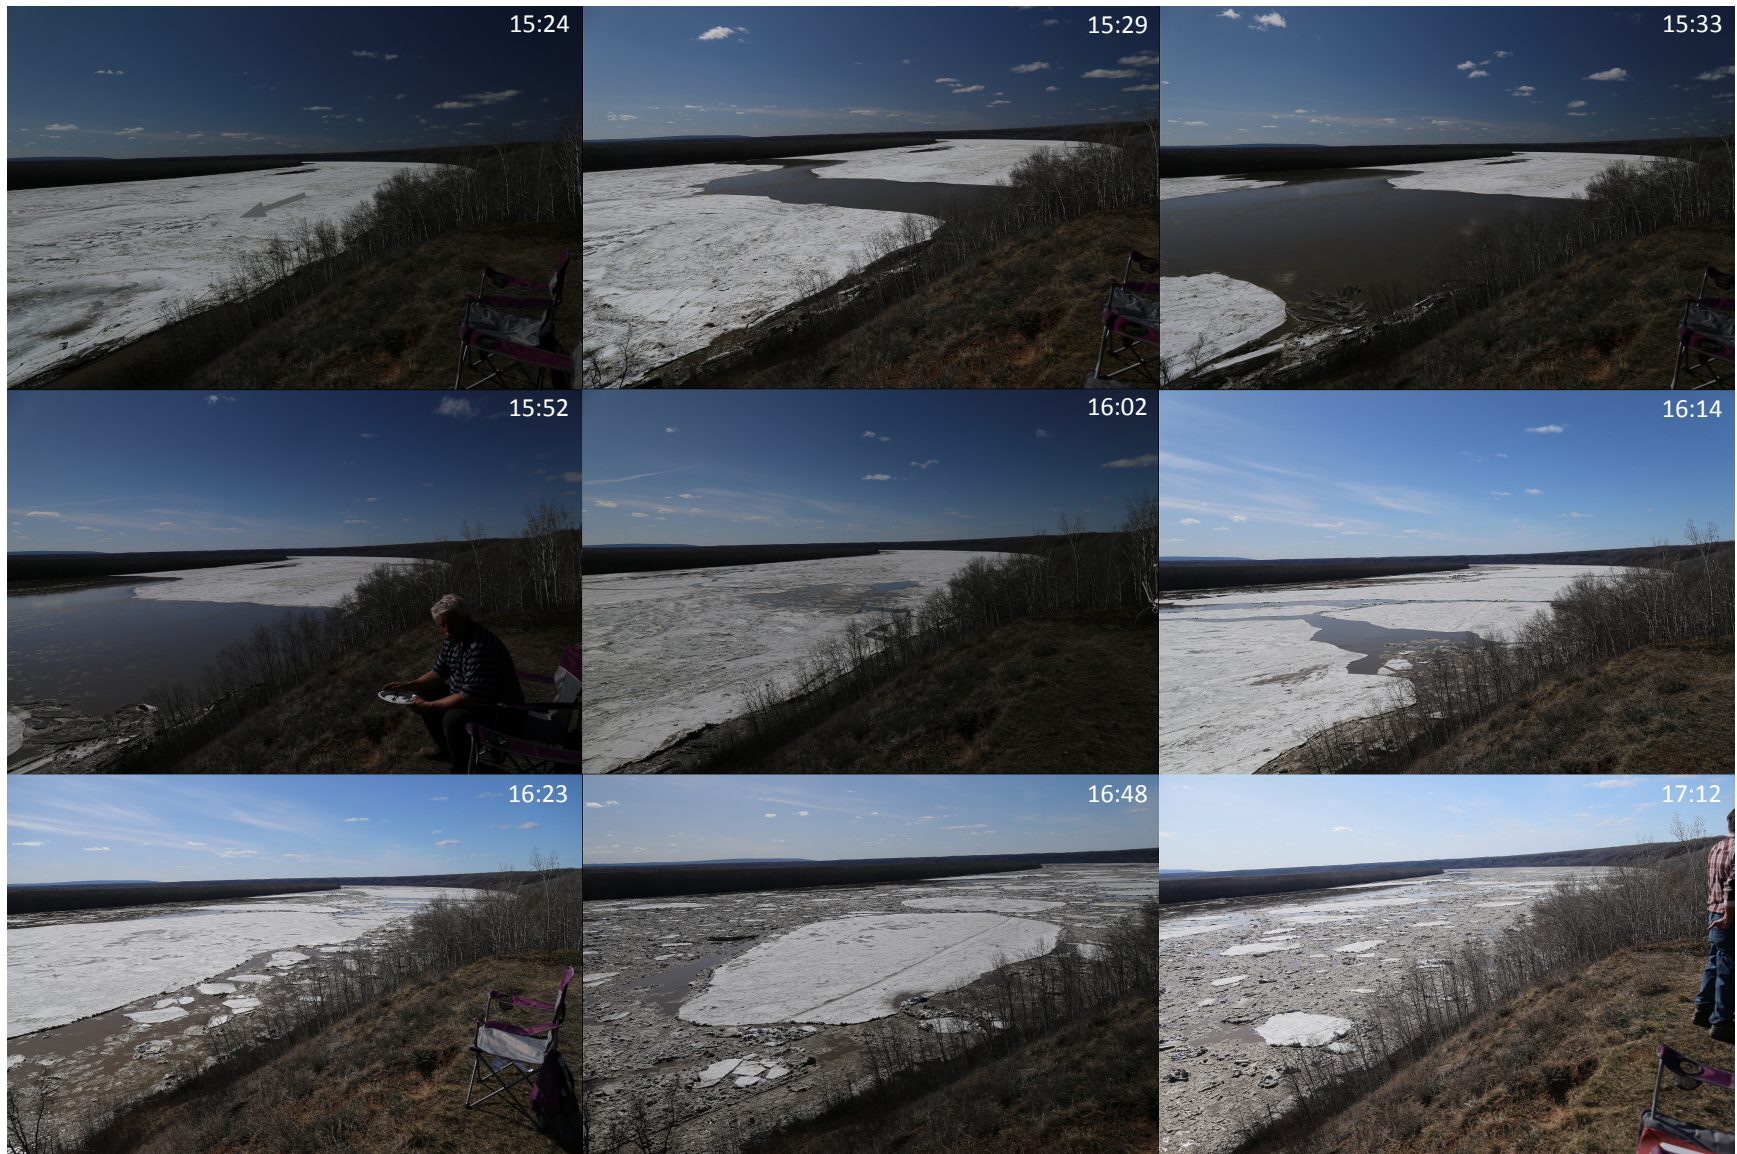
Figure 14. Sheet break-up front captured at Carcajou (km 650) on Apr 26, 2018. Local ice movement started at 15:25 MDT and lasted a few minutes. Sustained break-up arrived at 15:52 MDT. Ice sheets in ice-run getting more broken and smaller 15:52 to 17:12 MDT.

About 3 hours later and 45 km further downstream at Carcajou, the sheet break-up front was captured by in a series photographs shown in Figure 14. Some local ice movement started at 15:25 MDT and the entire river mobilized 27 minutes later at 15:52 MDT. Large sheets of ice ran for about an hour transitioning to smaller and smaller pieces until there was mostly flowing ice rubble.

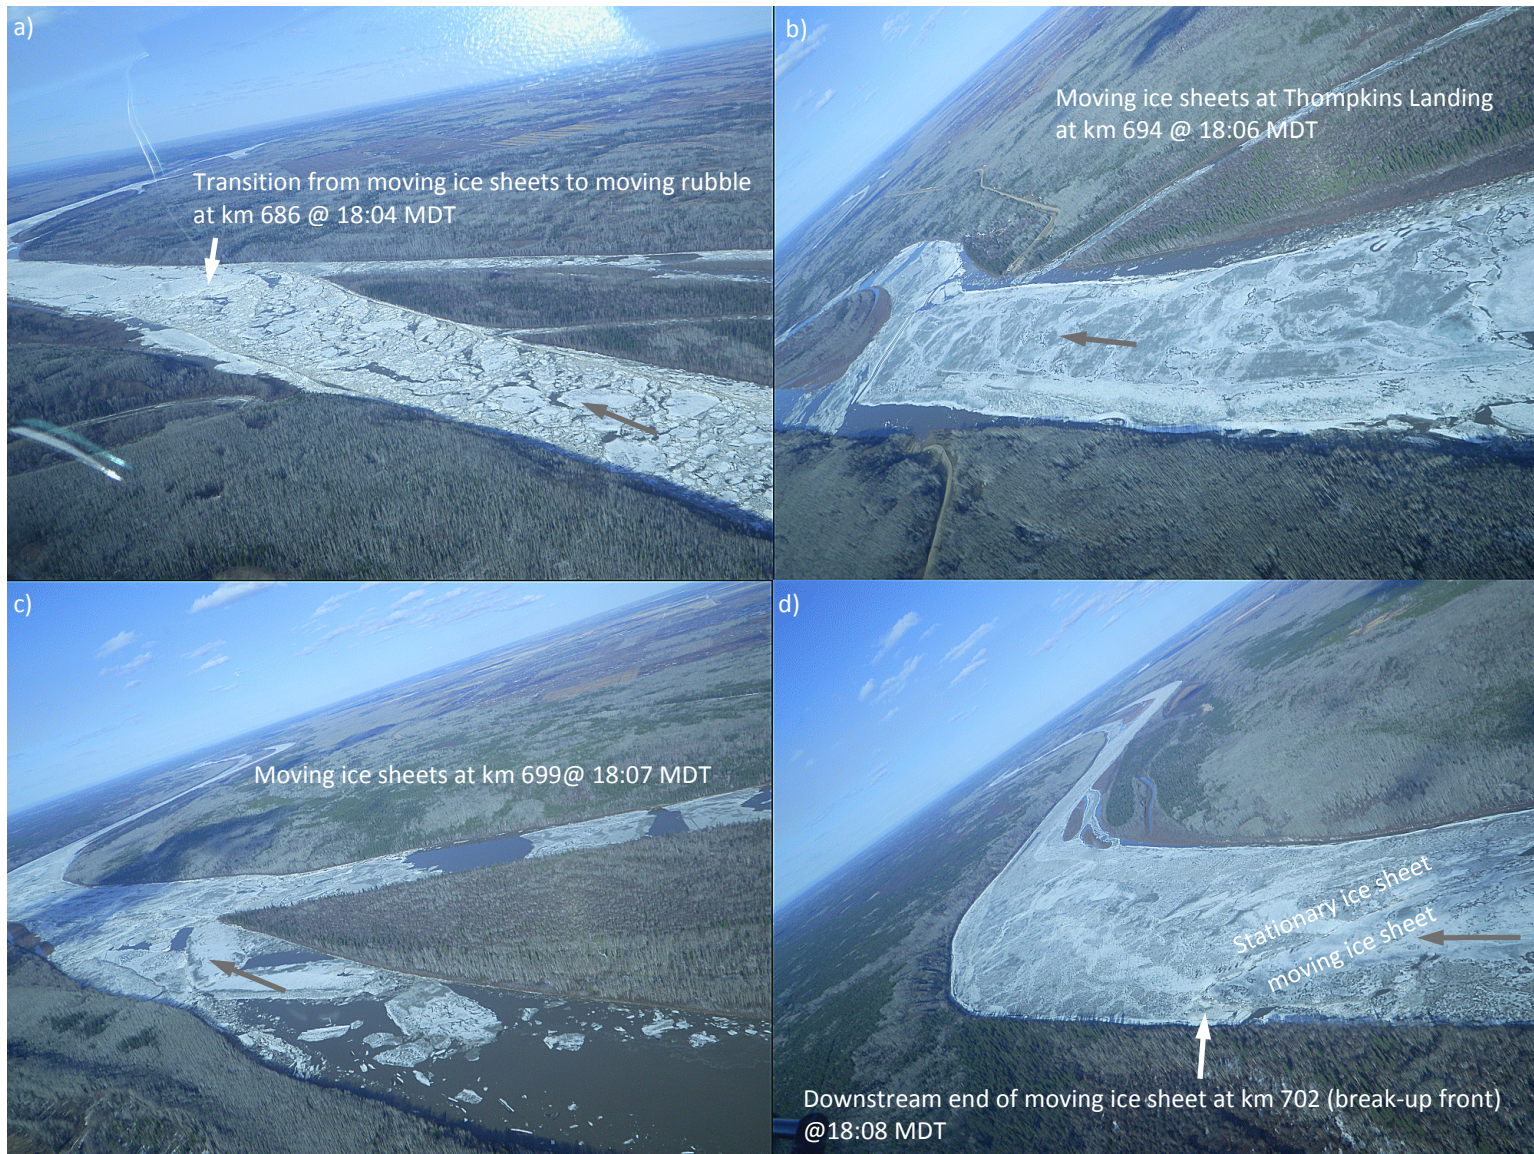
Figure 15. Sheet break-up front documented on Apr 26, 2018 18:08 MDT at km 702. Photographs courtesy of Stefan Emmer, Alberta Environment and Parks.

About 2 hours after the break-up front passed Carcajou it was observed by an Alberta Environment and Parks flight about 52 km further downstream, several km passed Thompkins Landing. The transition from sheet break-up at km 702 to flowing ice run of rubble at km 686 is documented in Figure 15. The following day this break-up was observed that it had stalled at km 723.

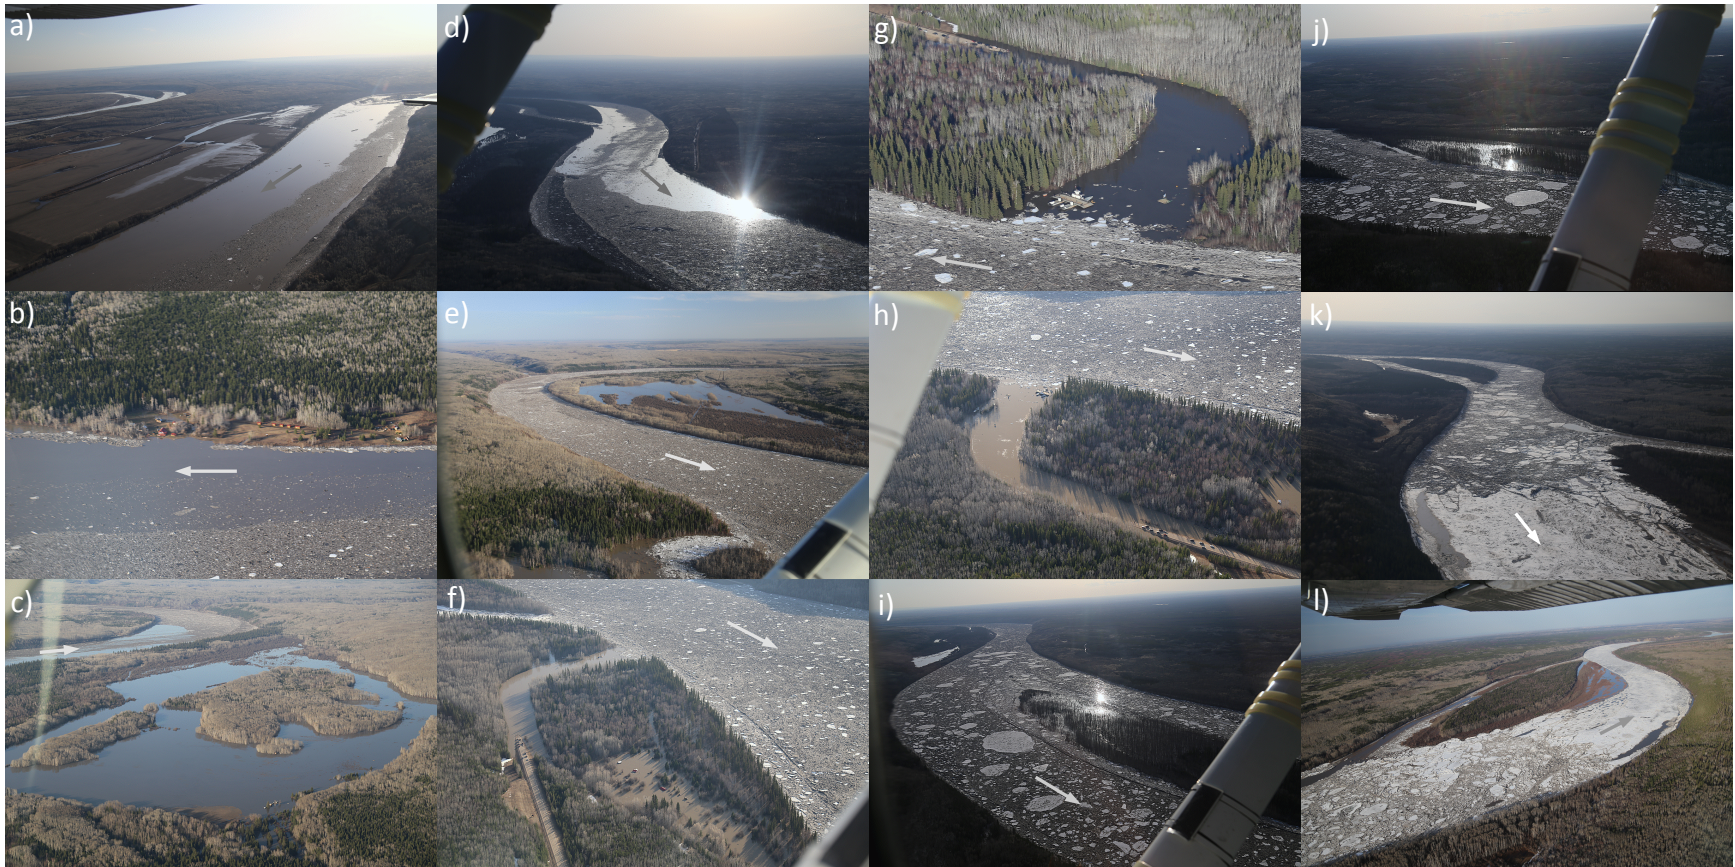
Figure 16. Ice jam flooding on Apr 27, 2018 at a) km 660 at Carcajou, b) km 663 at Carcajou, c) inside meander bend km 664 – 673 at Carcajou, d) head of ice jam at km 674, e) ice jam flooding at km 677, f,g,e) ice jam flooding at La Crete Ferry at Thompkins Landing at km 694, i) ice jam flooding at km 710, j) ice jam flooding at km 713, k,l) toe of ice jam at km 724.

Photos taken between 19:15 to 19:45 MDT downstream to upstream.

This ice run stopped and formed a large ice jam about 108 km upstream of Fort Vermilion on Apr 26-27 causing significant flooding at the Thompkins Ferry crossing, and the farmlands and buildings around Carcajou (Figure 16).

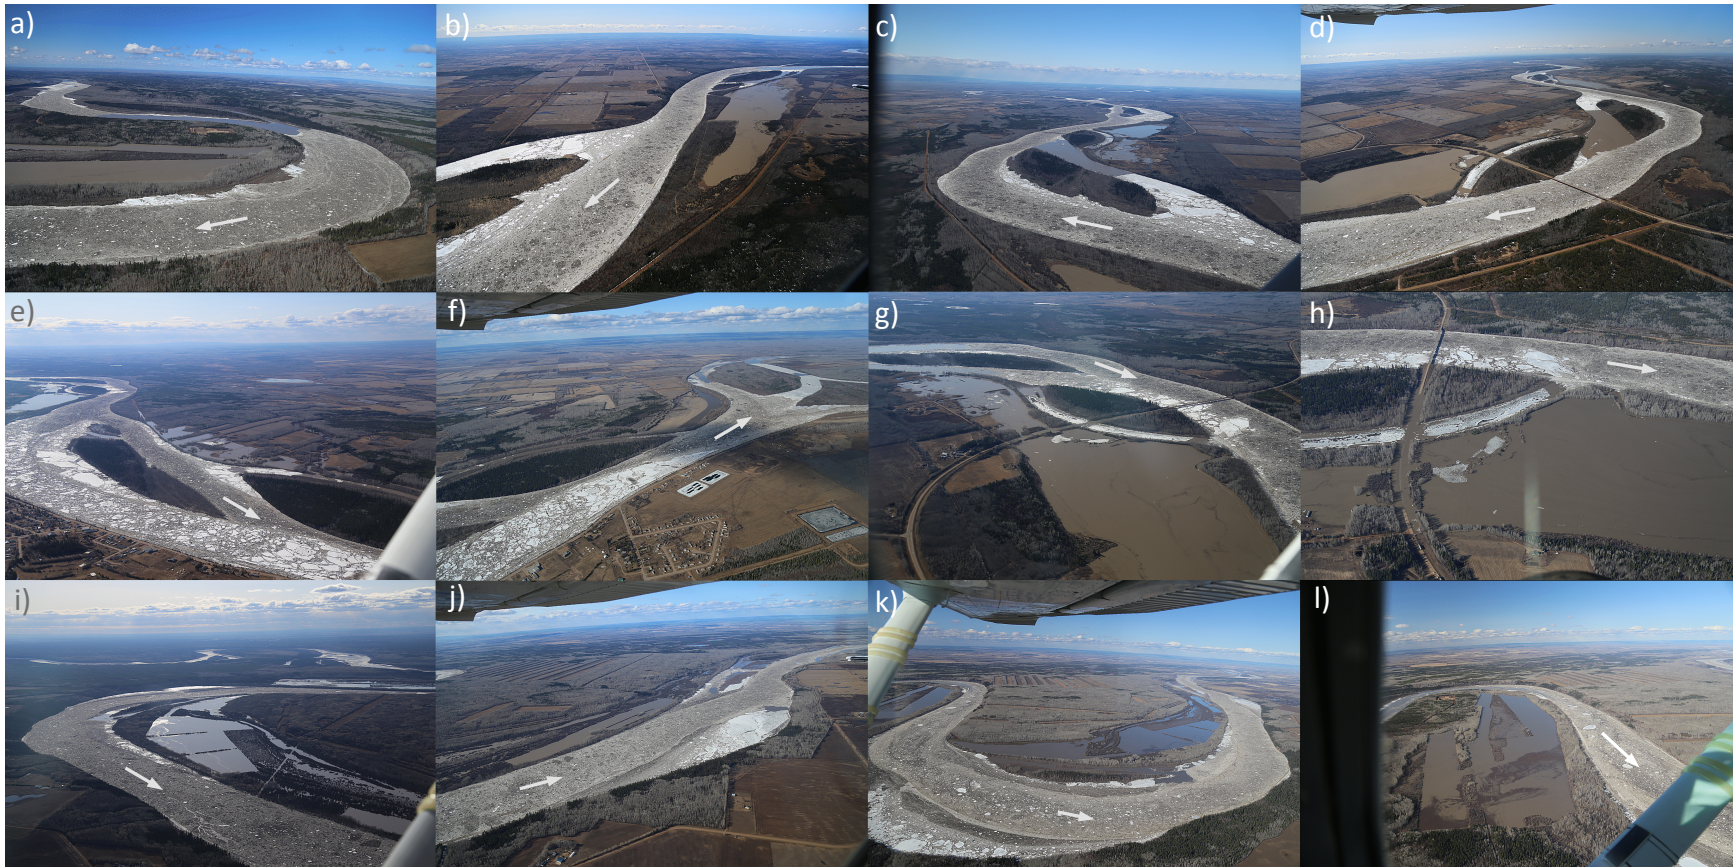
Figure 17. Ice jams and flooding at Fort Vermilion and upstream in early afternoon on Apr 29, 2018 at, a) km 790 @ 12:50 MDT, b) km 820 @ 13:00 MDT, c) km 821 @ 12:58 MDT, d) km 826 @ 13:02 MDT. The same reach was flown again in late afternoon showing ice jam at Fort Vermilion at e) km 833 @ 17:37 MDT, toe of ice jam at f) km 834 @ 17:38 MDT, g) km 826, @ 17:40 MDT h) km 826 @ 17:41 MDT, and an ice run from a released ice jam at i) km 819 @ 17:49 MDT, j) km 799 @ 17:50 MDT, k) km 796 @ 17:52 MDT, l) km 793 @ 17:53 MDT.

The ice jam upstream of Fort Vermilion remained in place for about a day and released on Apr 28 and re-jammed just downstream of Fort Vermilion causing extensive flooding from km 728 to 838 including the town of Fort Vermilion on Apr 28-29 (Figure 17). The increasing water levels on Apr 28 are shown in Figure 11b as the ice jam initially formed. The water levels started fall after initial formation but started to rise again the next day on Apr 29. In the evening of that day the ice jam consolidated increasing the water levels further causing even more extensive flooding in Fort Vermilion; water levels exceeded the previous high water mark by almost 1 m in Figure 11b. Photographs showing the flood in Fort Vermilion are shown in Figure 17.

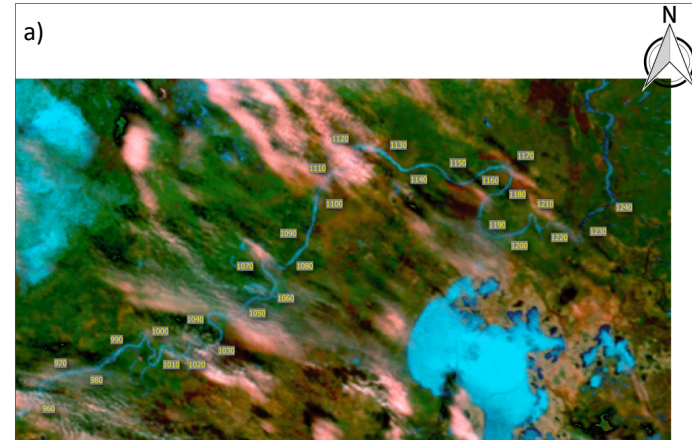
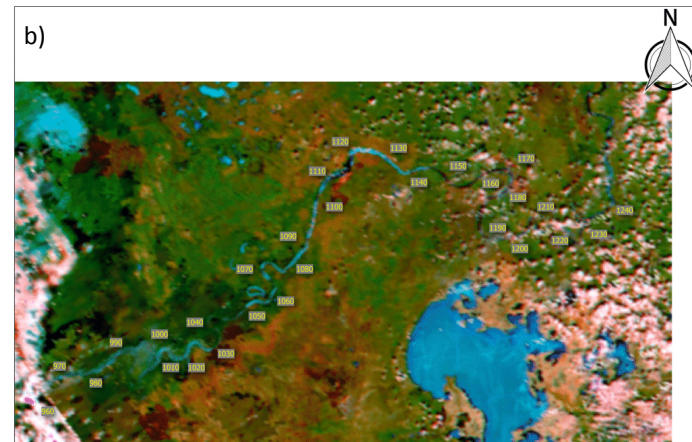
Figure 19a) Apr 27 and b) May 1 satellite images.
