CGU HS Committee on River Ice Processes and the Environment
20th Workshop on the Hydraulics of Ice Covered Rivers
Ottawa, Ontario, Canada, May 14-16, 2019.

**An Emerging Picture of Peace River Break-up Types that Influence Ice Jam
Flooding of the Peace-Athabasca Delta
Part 1:
The 2018 Peace River Break-up**

Martin Jasek

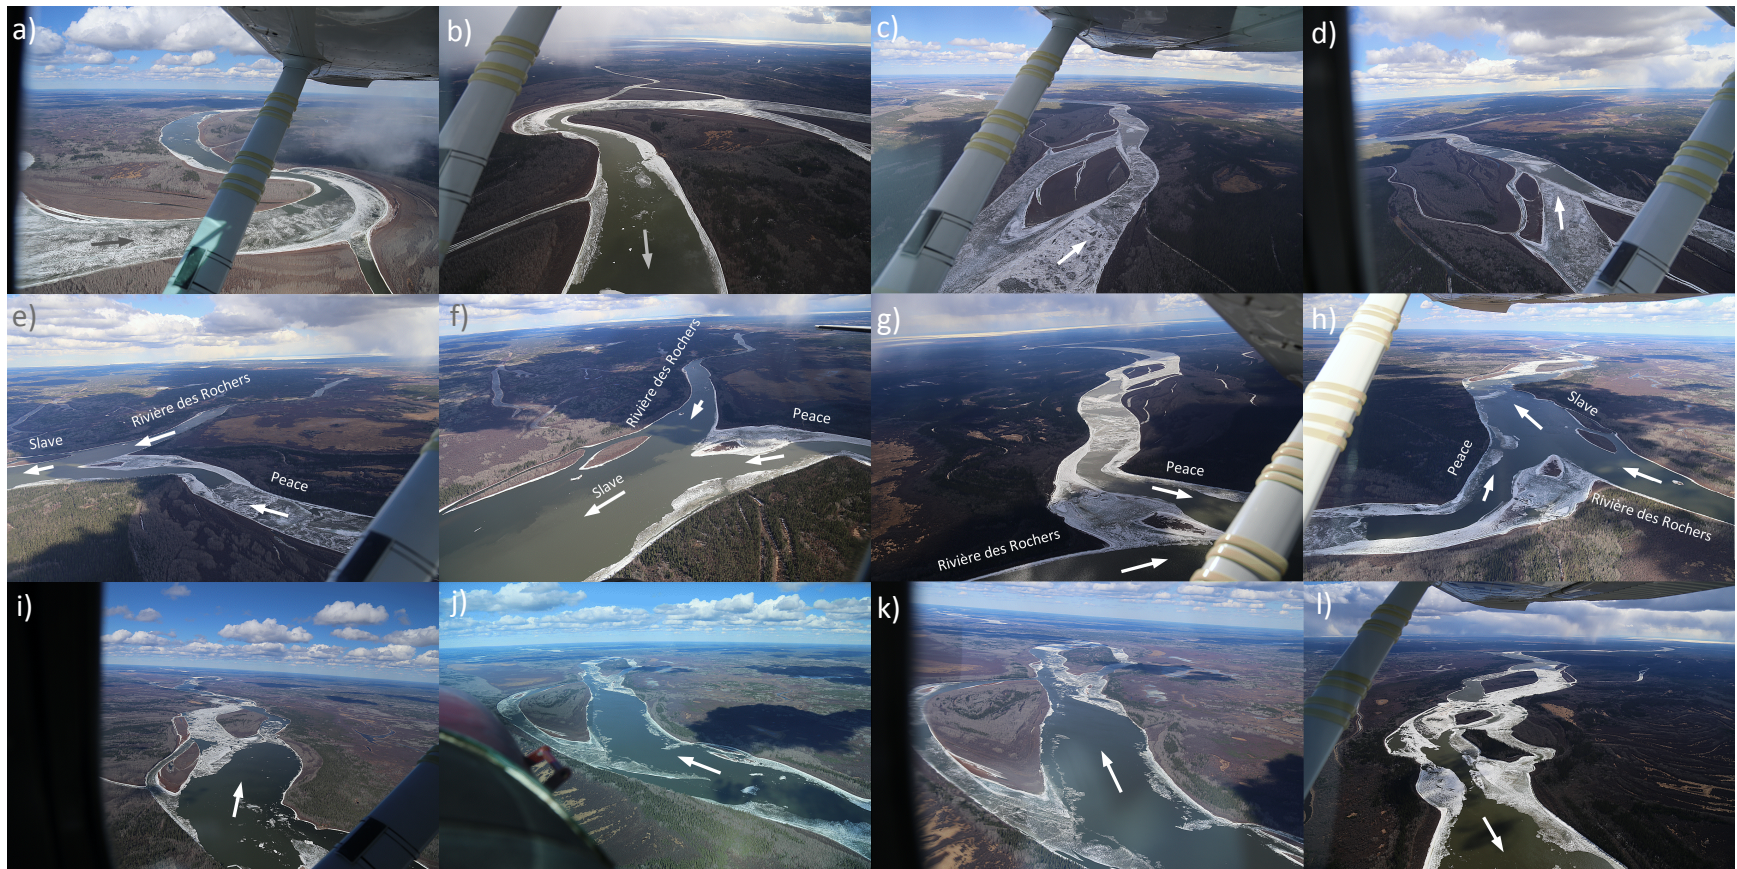
Figure 20. Photographs taken on Apr 29, 2018 showing that most of the ice cover had melted in the Peace River PAD reach from Rocky Point and Slave Rivers where ice jams that typically flood the PAD form. a, b) Rocky Point at km 1228 , c) km 1236 , d) km 1238, e, f, g, h) Peace-Slave-Rivière des Rochers confluence at km 1243, i) Slave River 3 km downstream of confluence , j) Slave River 12 km downstream of confluence, k) Slave River 13 to 25 km downstream of confluence, l) Slave River 11 km downstream of confluence.

While the Peace River was breaking up dynamically, causing a series of sequential and severe ice jam floods approximately 500 km upstream of the PAD, indicating that the ice there was strong and discharge high, by contrast, the ice in the PAD reach was starting to thermally deteriorate significantly more than the upstream reaches. This is evident in Figure 3 where solid ice cover denoted in bright green starts disappearing on Apr 27 in the PAD reach while there is an ice jam downstream of Thompkins Landing. Figure 18a is a high resolution Sentinel 2 satellite image showing the ice cover on Apr 25. Much of the ice cover is dark indicating water on the ice and likely a weakened ice cover with the exception of a reach from Boyer Rapids (km 1115) to km 1144. Note that this reach contains the Peace Point gauge at km 1130. Open water sections (black) are few and far between. Readers are encouraged to zoom into this high resolution image to see the details. Figure 18b shows a MODIS satellite image which is lower resolution than the Sentinel 2 and it does not discriminate as well between weaker and stronger looking ice, but it indicates that the ice is still intact in the Peace and Slave Rivers on Apr 26. Figure 19a shows another MODIS image from Apr 27 indicating big changes in the Peace River ice cover in the PAD reach and also in the Slave River. Lengthy open reaches (dark) downstream of Rocky Point (km 1227) and in the Slave River are visible. A flight on Apr 29 of the PAD reach and Slave River showed that there was barely any ice cover left (Figure 20), where typically ice jams form that flood the PAD.

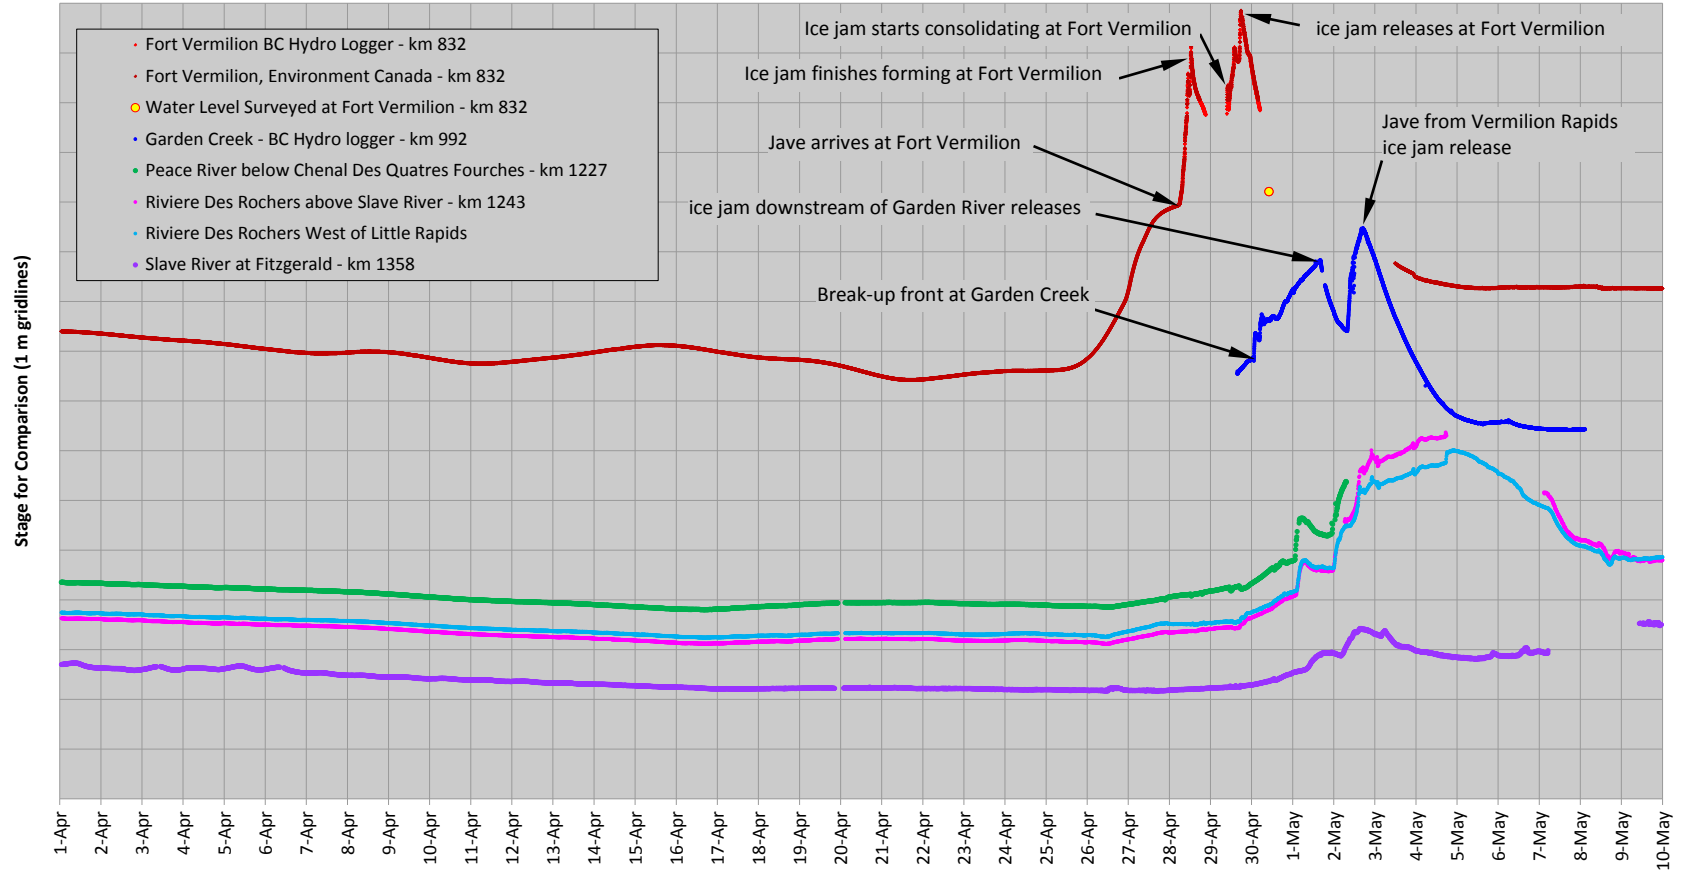
Figure 21. Relative water levels at Fort Vermilion, Garden Creek, gauges in the PAD reach and Slave River at Fitzgerald. Gauges in the PAD reach have a common offset.

Gauge records in the PAD reach did not show any indication of a dynamic break-up of the ice when the ice started disappearing from the PAD reach between the Apr 25 and Apr 29 (Figure 21); there are only gradual increases in water levels by less than half a metre during this time period. This indicates that much of the ice cover likely melted in place.

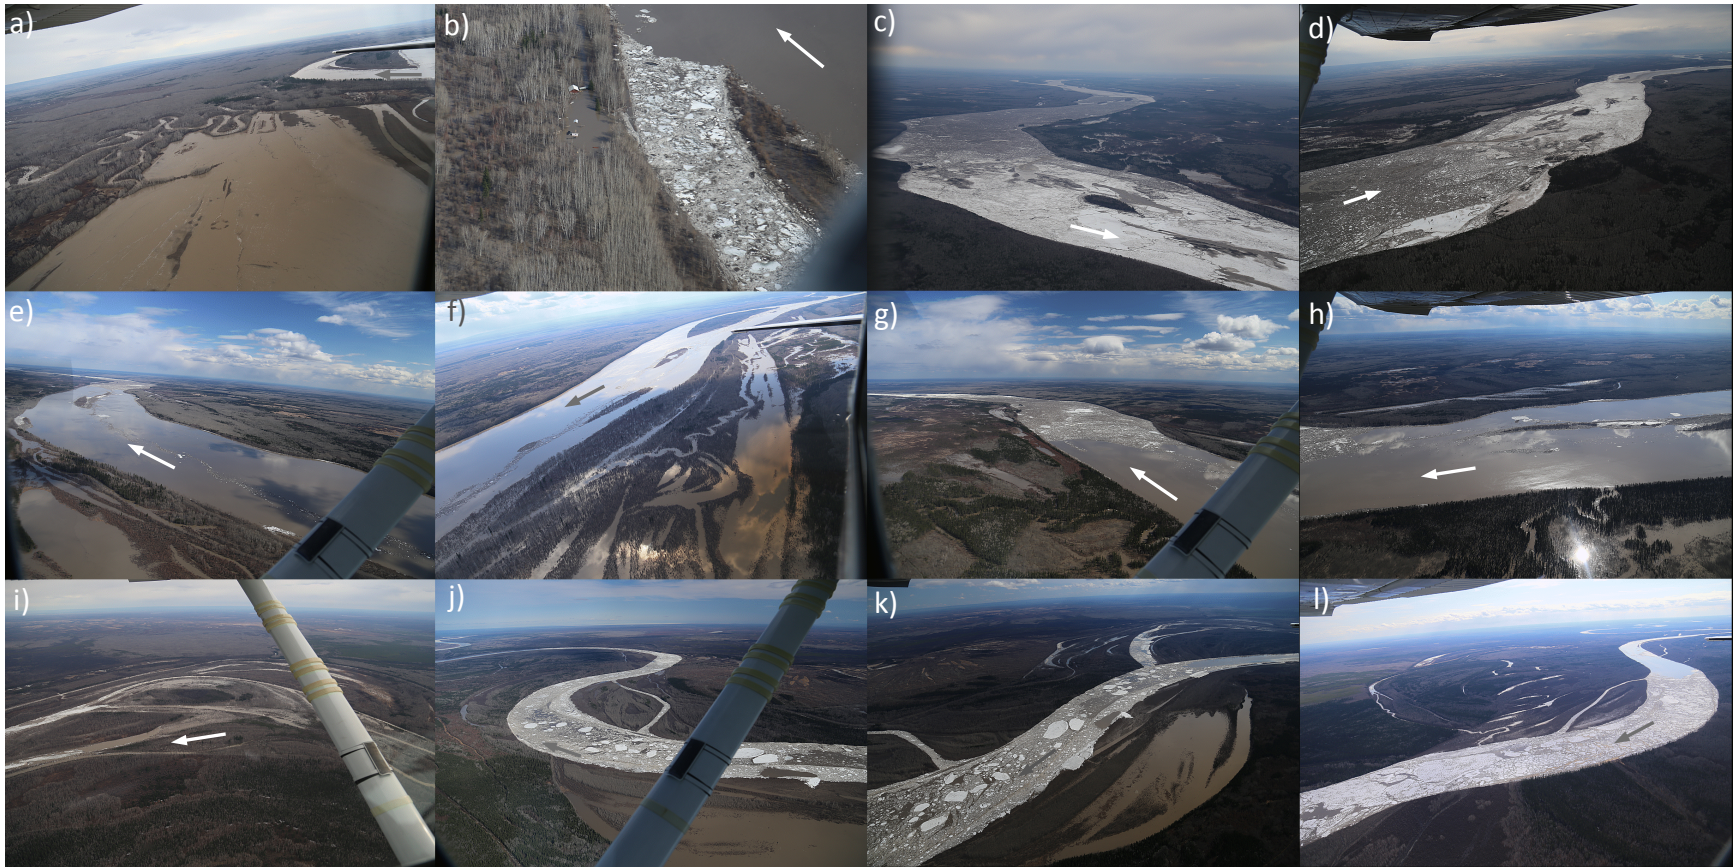
Figure 22. Photos of break-up and ice jams, and flooding on the Peace River between Fort Vermilion and the PAD at a) km 868 on Apr 30, 2018 18:28 MDT, b) Adam's Landing at km 903 on May 1, 2018 15:25 MDT, c) toe of ice jam at Vermilion Rapids at km 914 on Apr 30, 2018 18:10 MDT, d) toe of ice jam at km 914 at Vermilion Rapids and head at km 905 on Apr 30, 2018 18:10 MDT, e) ice jam backwater at km 901 on May 1, 2018 15:24 MDT, f) ice jam backwater at km 899 on May 1, 2018 15:24 MDT, g) head of ice jam at km 909 on May 1, 2018 15:27 MDT, h) ice jam backwater at km 907 on May 1, 2018 15:27 MDT, i) overbank ice jam flooding at km 1018 over 6 km away from the Peace River main channel on Apr 30, 2018 17:39 MDT, j,k) running ice and overbank flooding at km 1022 on May 1, 2018 16:04 MDT, l) running ice and overbank flooding at km 1056 on May 1, 2018 16:17 MDT.

The jam which flooded Fort Vermilion released late on Apr 29 and by Apr 30 the ice from that ice jam had moved to the Vermilion Rapids and jammed there (Figure 3), causing extensive flooding upstream of the Rapids and the historical site of Adams Landing (Figure 22). However, a second dynamic break-up front likely triggered by the jave of the former continued on below Vermilion Rapids on Apr 30 that broke up more than 100 km of additional ice (Figure 3). This second break-up front stalled for about a day and caused flooding in the km 980 – 1108 reach (Figure 22). However, the jave continued underneath the ice cover and it travelled through the

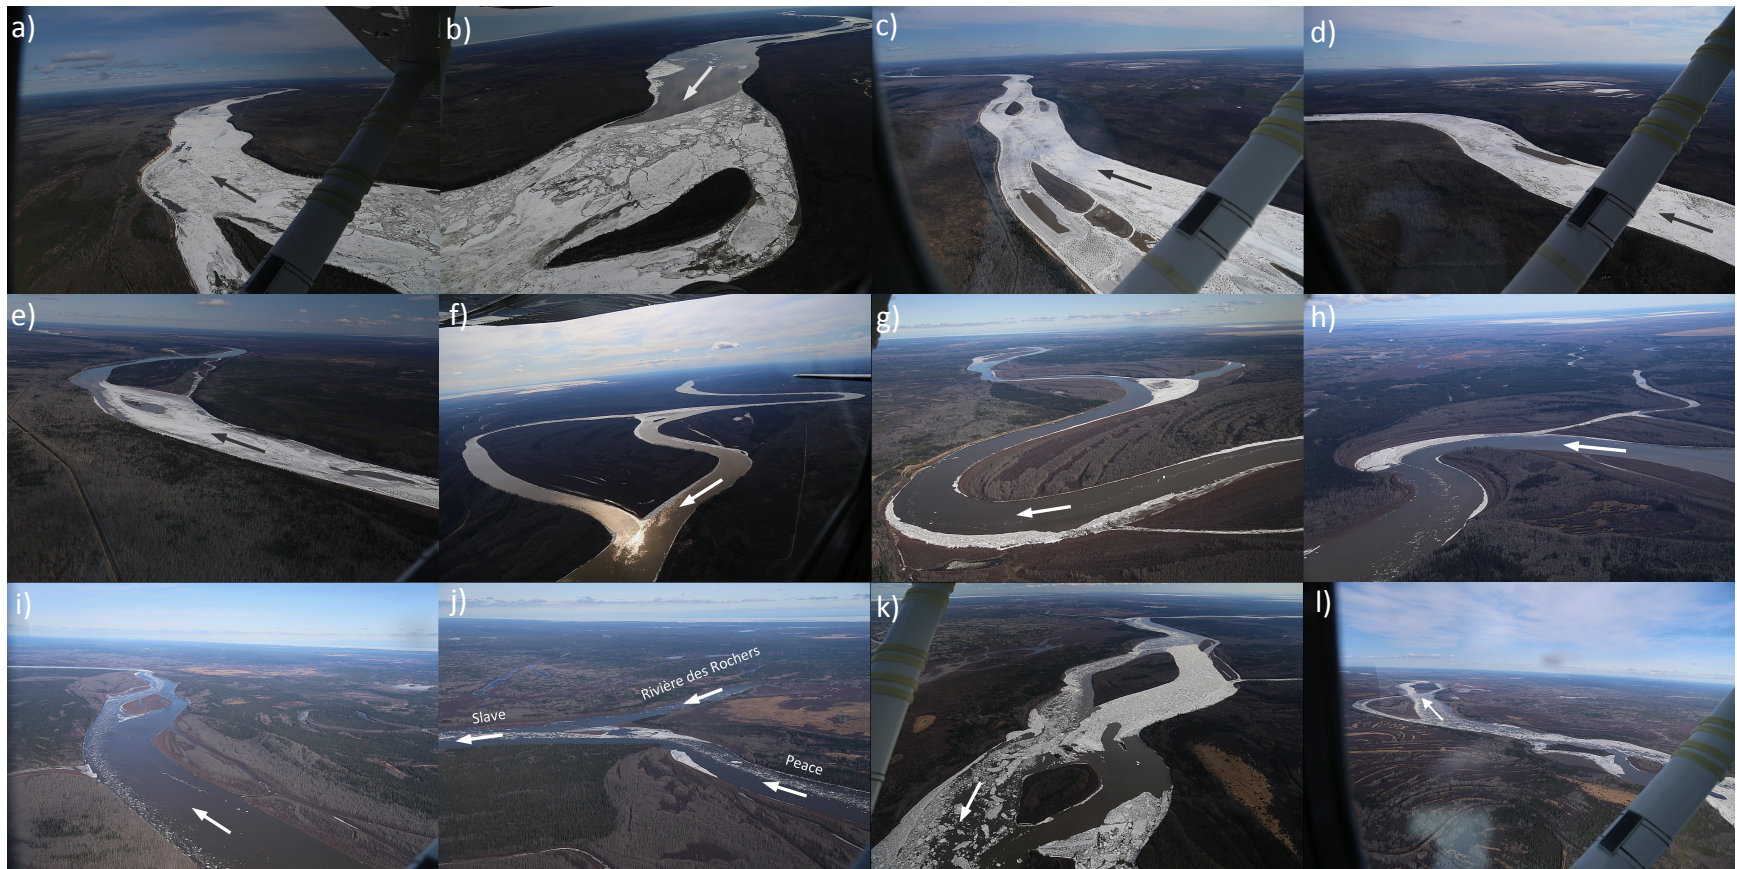
Figure 23. a,b) Ice jam at Boyer rapids at km 1122 on May 1, 2018 16:37 MDT, c-e) extent of solid and more competent ice from Boyer Rapids to past Peace Point (km 1122 – 1144) on May 1, 2018 16:41 MDT. Peace point shown in (d). e,f,g) Open water from km 1144 past Peace Point to Rocky Point km 1228 on May 1, 2018 17:03 MDT. i,j) remnants of ice run between Rocky Point and start of Slave River (km 1243) on May 1, 2018 17:05 MDT, k) running ice 0 to 10 km downstream on the Slave River on May 1 2018 15:10 MDT, l) running ice 10 to 25 km downstream on the Slave River on May 1 2018 15:08 MDT.

PAD reach breaking and flushing what little ice was left downstream of Rocky Point and the Slave River and away from the PAD on May 1 (Figure 23). An ice jam at Boyer rapids and a solid ice cover in the Peace Point reach remained intact as the ice cover flushed out of the PAD reach (Figure 23). On May 2, a jave from the jam that eventually released from Vermilion Rapids flushed through the PAD reach on May 3, although it increased the water levels further in the PAD, the ice did not stop or jam in the PAD reach due to the lack of ice cover there (Figure 24). Reverse flow (from the Peace River into the PAD) was observed in the main PAD channels on May 3 (Figure 24). Ice was observed to run past the PAD from May 2 to May 4 (Figure 3). However, the break-up front apparently encountered more competent ice on the Slave River further downstream; a toe of an ice jam was documented by WBNP staff on May 2, 76 km downstream of the PAD on the Slave River and by May 4, a satellite imaged indicated a toe of an ice jam 82 km downstream of the PAD. However, this was too far downstream to flood the PAD as there was not enough volume to create an ice jam long enough to back up to the PAD reach even though some ice obviously ran into some of the PAD channels and jammed there due to reverse flow (Figure 24).

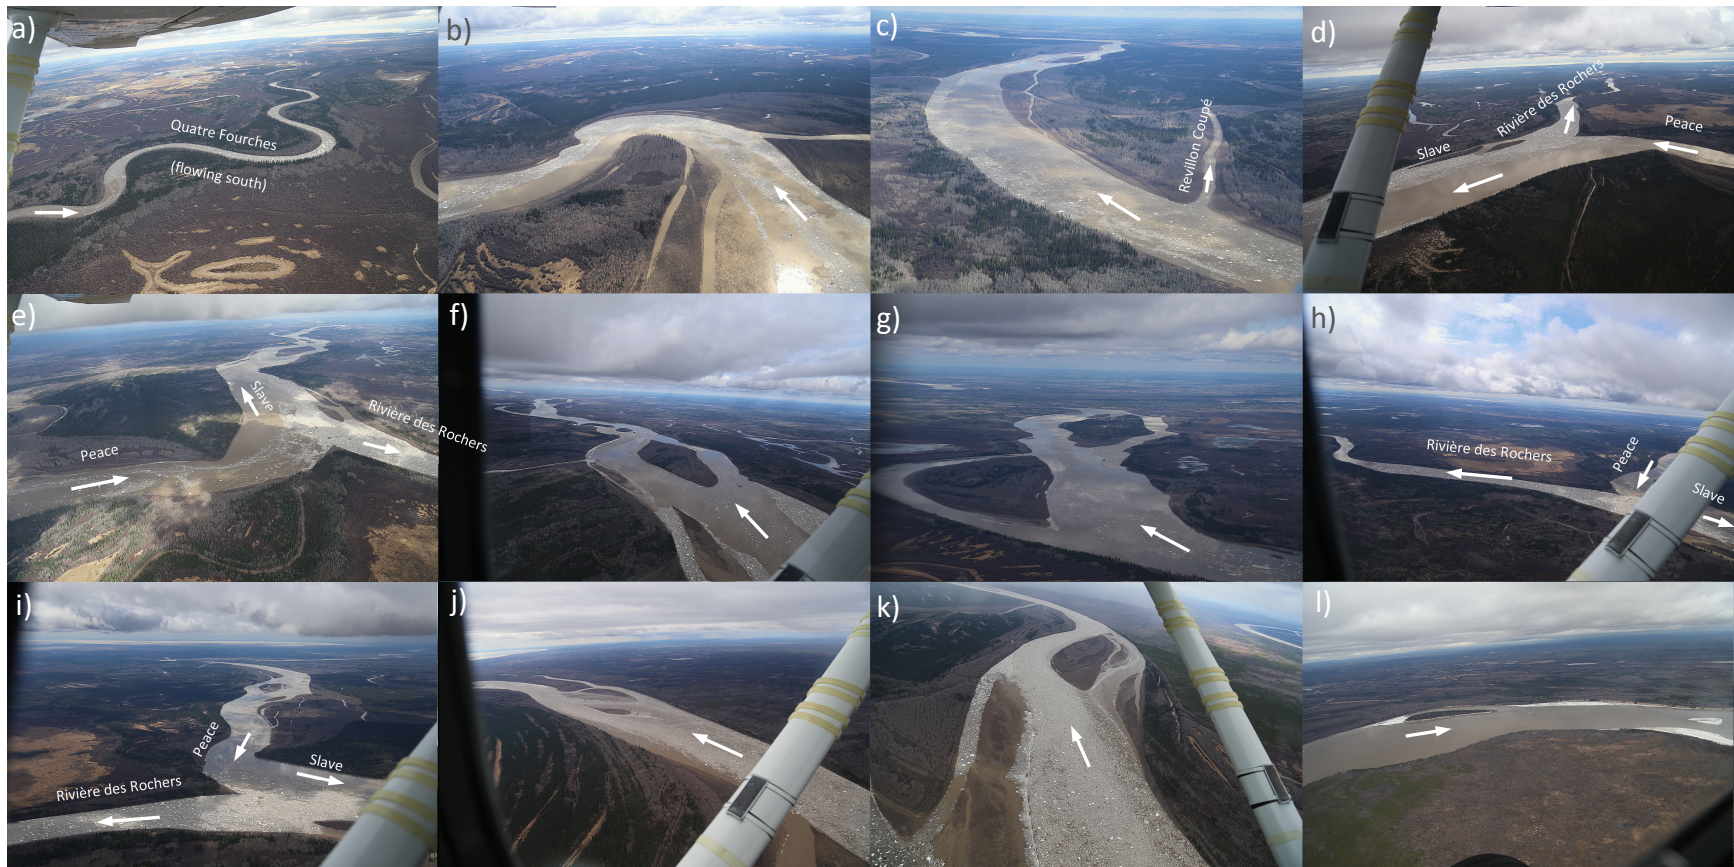
Figure 24. a) High water on the Peace causing break-up and ice jam on the Quatre Fourches flowing south on May 3, 2018 11:44 MDT, b) ice run by Rocky Point at km 1228 on May 3, 2018 11:44 MDT c) ice run between Rocky Point and start of Slave River causing reverse flow on the Revillon Coupé on May 3, 2018 11:49 MDT d,e) ice flowing by the PAD reach down the Slave River and reverse flow in Rivière des Rochers causing a short ice jam on May 3, 2018 11:54 MDT, f,g) running ice up to 25 km downstream on the Slave River on May 3, 2018 11:56 MDT, h,i) ice flowing by the PAD reach down the Slave River and reverse flow in Rivière des Rochers causing a short ice jam on May 3, 2018 12:02 MDT, j,k) ice run from Vermilion rapids ice jam on May 3, 2018 at km 1185 on May 3, 2018 12:52 MDT and km 1177 on May 3, 2018 12:19 MDT, l) open water at Boyer Rapids at km 1120 on May 3, 2018 12:37 MDT.
