CGU HS Committee on River Ice Processes and the Environment
22nd Workshop on the Hydraulics of Ice-Covered Rivers
Canmore, Alberta, Canada, July 9-12, 2023.

Insights from the 2022 mechanical breakup of the lower Peace River and contribution to flooding of the Peace-Athabasca Delta

Martin Jasek

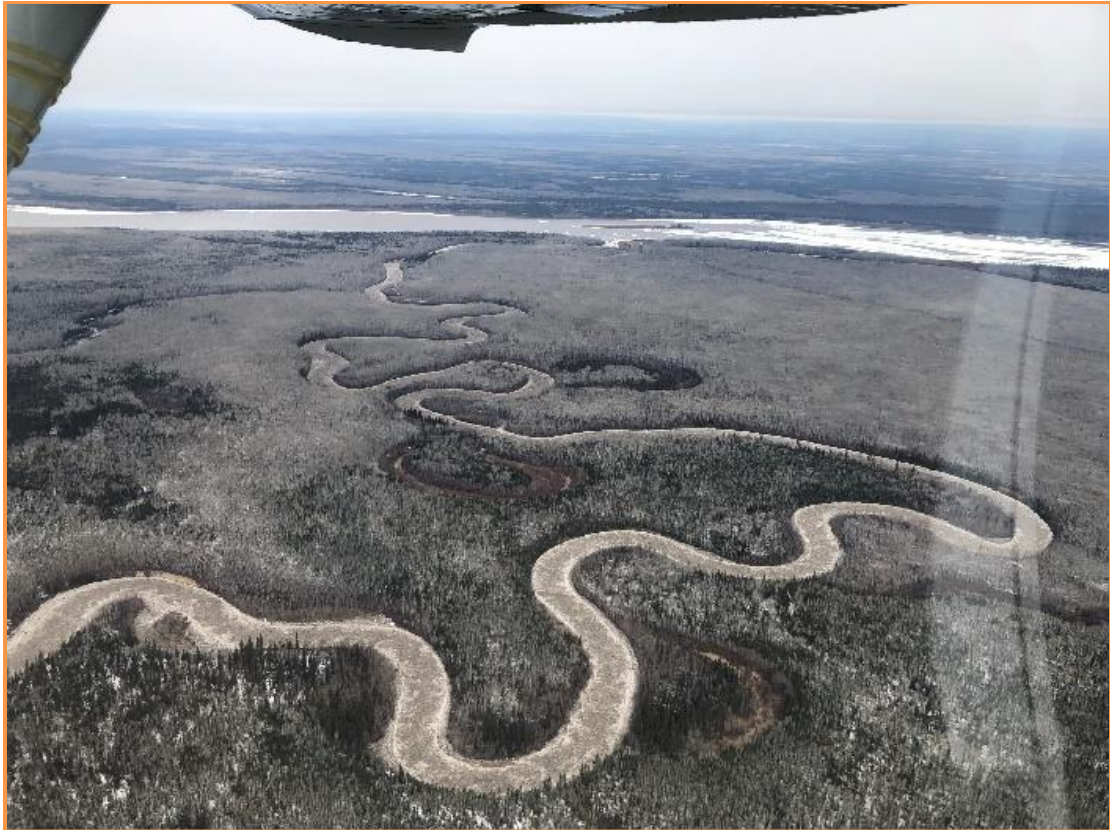
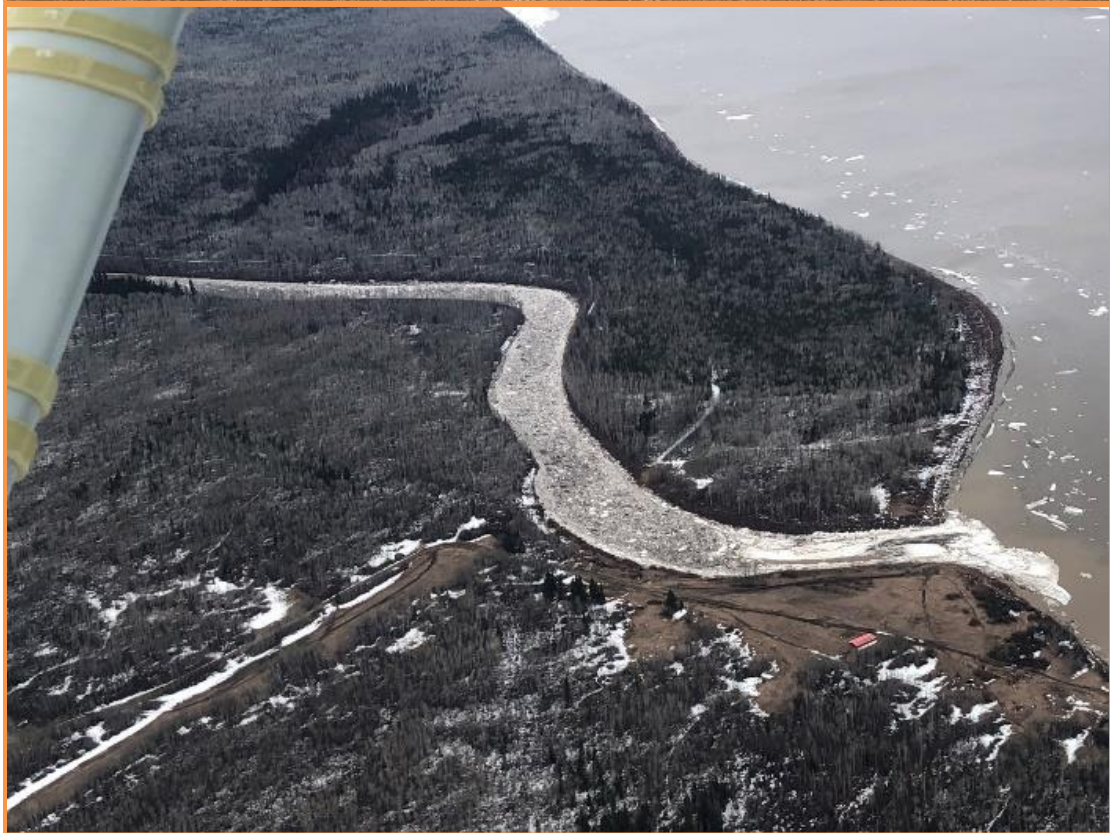
Figure 9. Photos of ice jam on the Mikkwa River on May 3, 2022.

Noted on the BC Hydro flight on May 3 was a 21 km long ice jam on the Mikkwa River, (Figure 9) from its confluence with the Peace River and was still in place on a May 4 Sentinel 2 satellite image and was 16.2 km long. The Mikkwa River enters the Peace River at about km 924 from the south. It too likely released and contributed to Peace River flows during the breakup further downstream. Note the presence of snow in the bush in Figure 9, probably melting quickly with high temperatures reaching about +17 °C in Fort Vermilion that day.

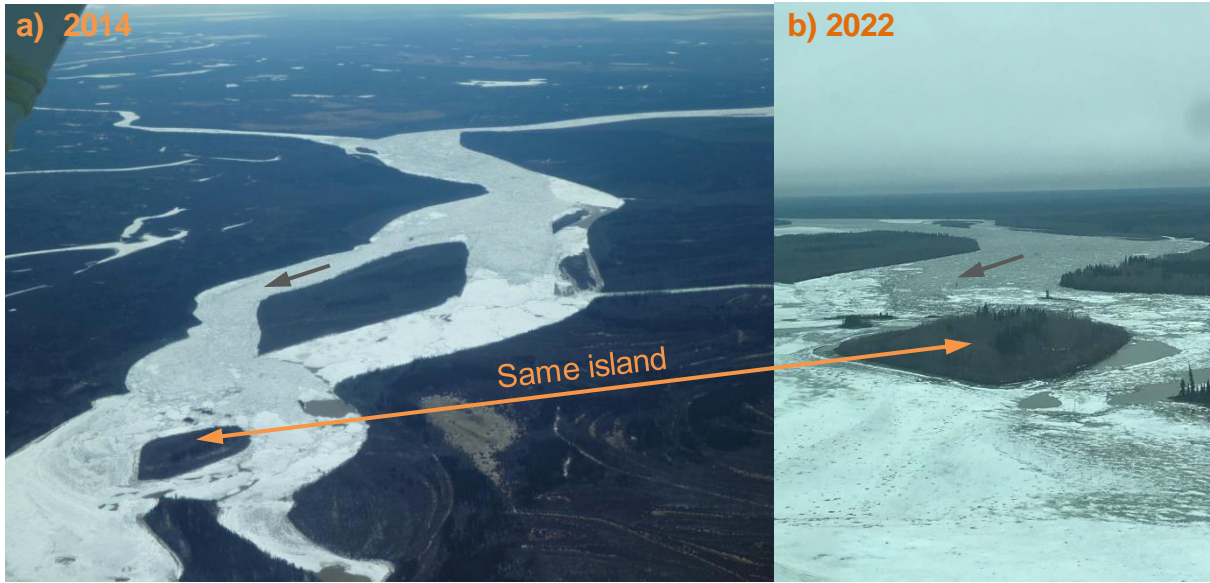
Figure 11. Photographs looking upstream at ice jam toes on Slave River a) May 3, 2014, and b) May 6, 2022, taken by BC Hydro and Parks Canada respectively.
