Fluvial geomorphological responses to river ice dynamics downstream of a hydroelectric facility, southwest Yukon

Dan McParland¹, Robin McKillop², and Forest Pearson³

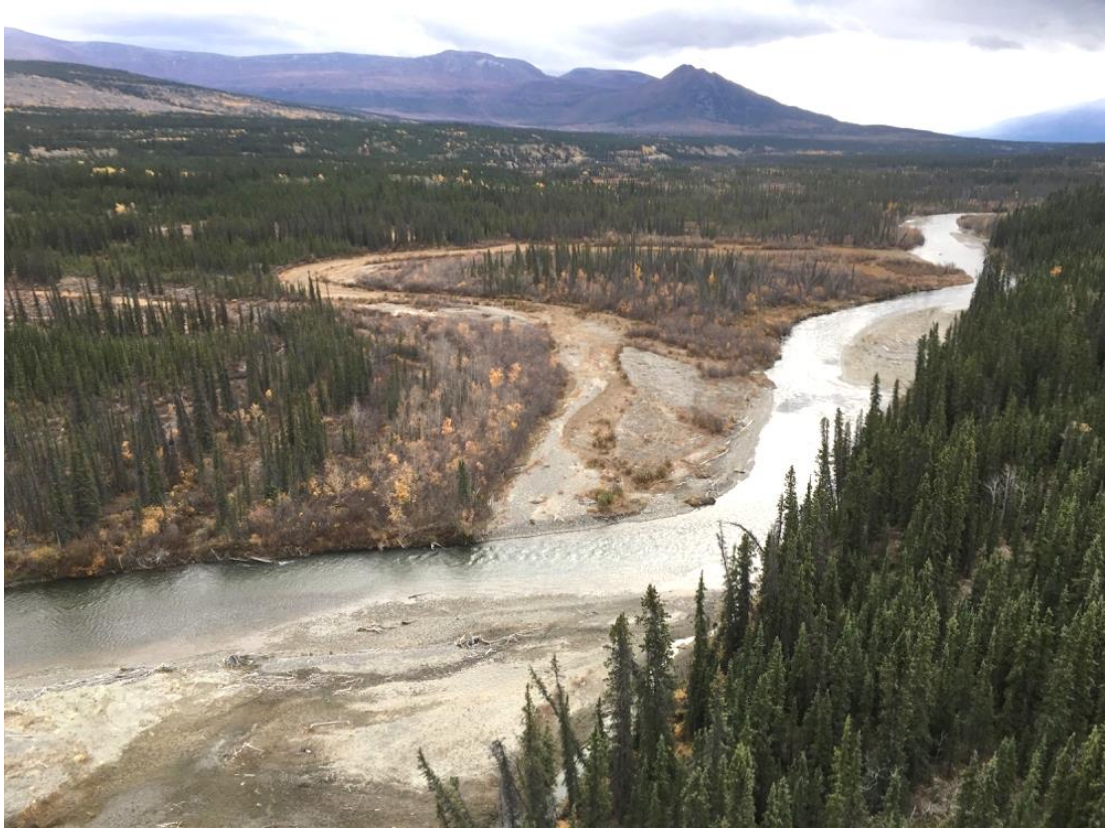
Figure 2. Looking downstream along the Aishihik River valley near a large meander cut-off in Reach 2 (September 22, 2016).

Along Aishihik River, there has been a general downstream trend in channel destabilization since flows became regulated. Large channel cut-offs in Reaches 1 and 2 (Figure 2) in the decades following regulation led to notable reduction in sinuosity (Figure 4). Reach-scale channel restructuring occurred along Reaches 3 and 5 (Figure 7) and, to a lesser extent, along Reaches 4 and 6 between 1987 and 2013 (although there is a 26-year gap in the photographic record) mainly as the result of channel cut-offs. Instability and a large cut-off were observed along Reach 6 between 2013 and 2017.

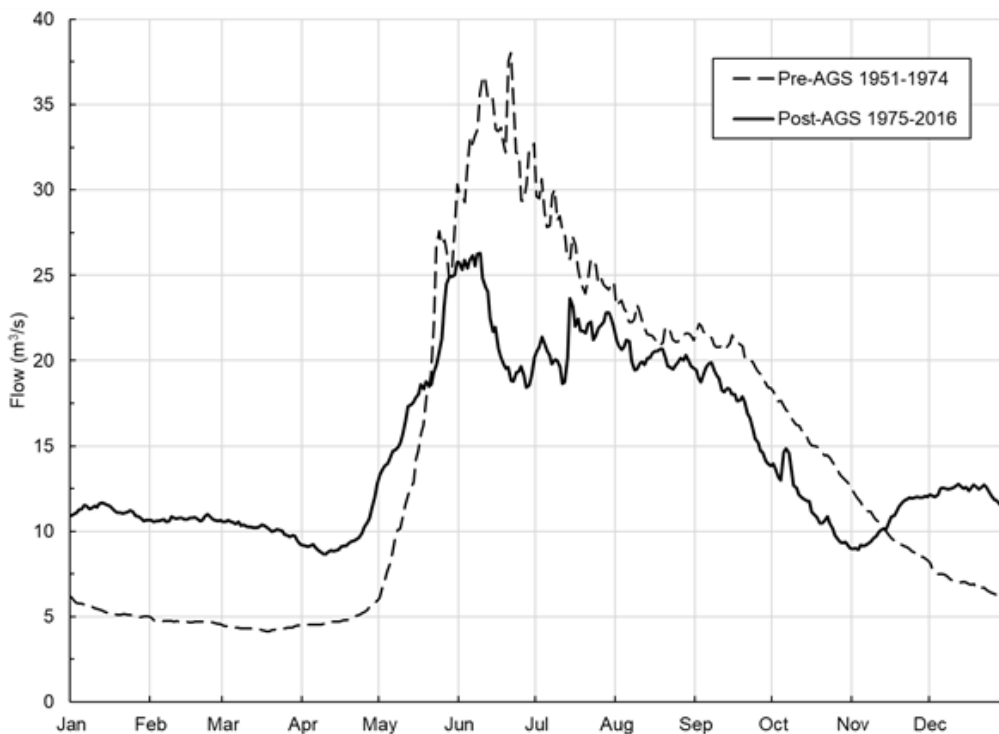
Figure 3. Average hydrographs for Aishihik River at Canyon before and after flow regulation.

The construction of the AGS in the mid-1970s resulted in alteration to the pre-development flow regime of East Aishihik River and Aishihik River, as well as Dezadeash River downstream of the Aishihik River confluence. Flows from the AGS depend on energy demands. During the winter months when energy demand is high, outflow from the AGS greatly increases winter flows in Aishihik River (Figure 3) and, to a lesser extent, Dezadeash River in comparison to pre-AGS conditions. Since the construction of a third turbine in 2011, maximum winter flows in Aishihik River can reach 24 m³/s and winter diurnal flow variability can be high. Yukon's electrical demand decreases in the spring, which allows water storage in Aishihik and Canyon Lakes and has reduced the spring freshet and summer flows of Aishihik River and, to a lesser extent, Dezadeash River.

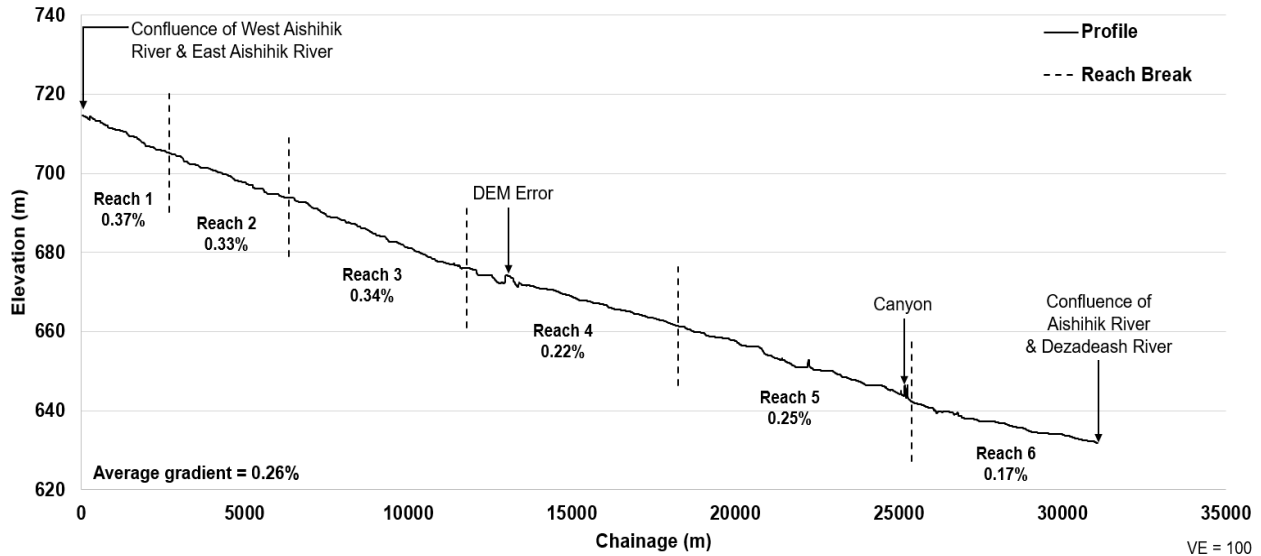
Figure 5. Aishihik River longitudinal profile extracted from a 10 m DEM (2013)

Prior to flow regulation, Aishihik River had a sinuous planform with sinuosity values similar to West Aishihik River (Figure 4). In the decades following regulation, the sinuosity of Reaches 1 to 3 decreased substantially. The combined sinuosity of Reaches 1 to 3 decreased from 1.68 in 1972 to 1.26 by 2017. Changes and trends in the sinuosity of Reaches 4 to 6 are less pronounced and occurred more gradually following regulation. In contrast, the sinuosity of West Aishihik River and East Aishihik River have remained largely unchanged over the period of record. The total length of Aishihik River (AGS tailrace to Dezadeash River) decreased by 4.7 km (13%) from 1972 to 2017. This large reduction in channel length has steepened the channel (the gradient is now 0.0026 m/m) and has led to more homogenous bed morphology (Figure 5).

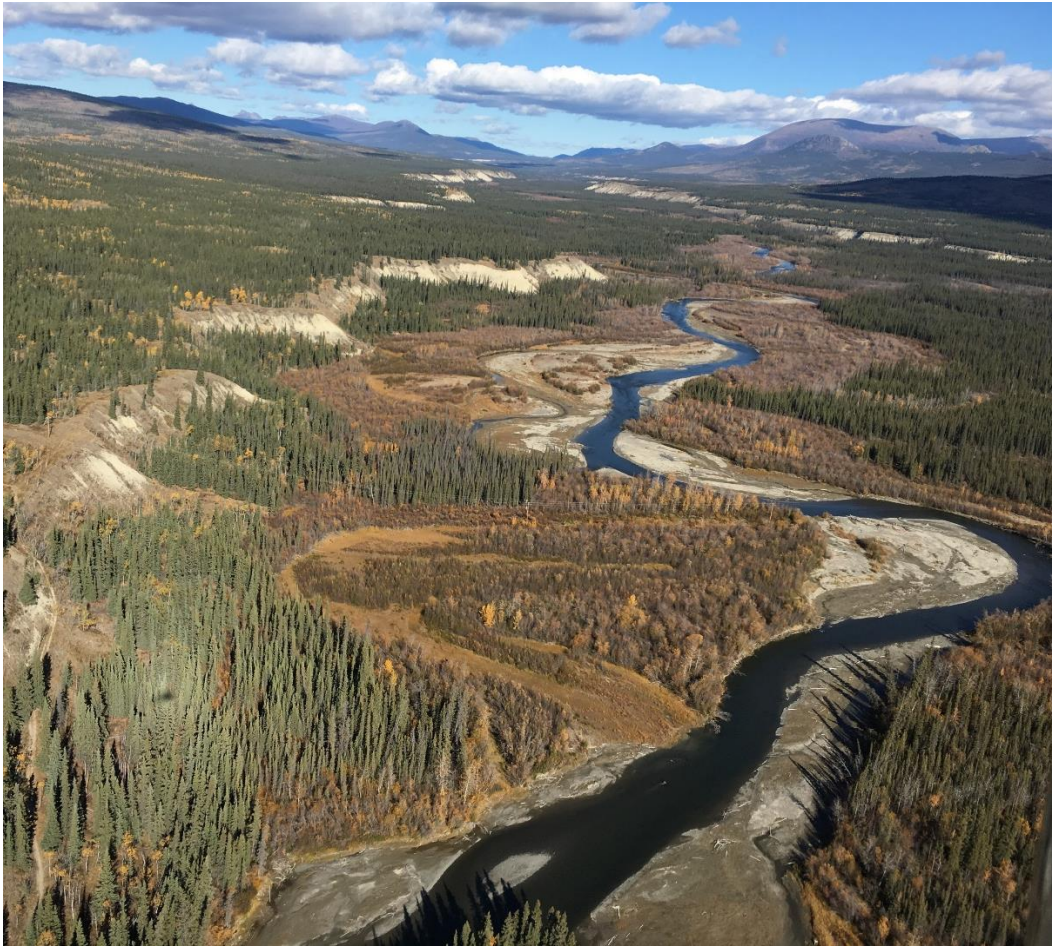
Figure 7. Looking upstream along the Aishihik River valley at successive channel cut-offs in Reach 5 (September 22, 2016).

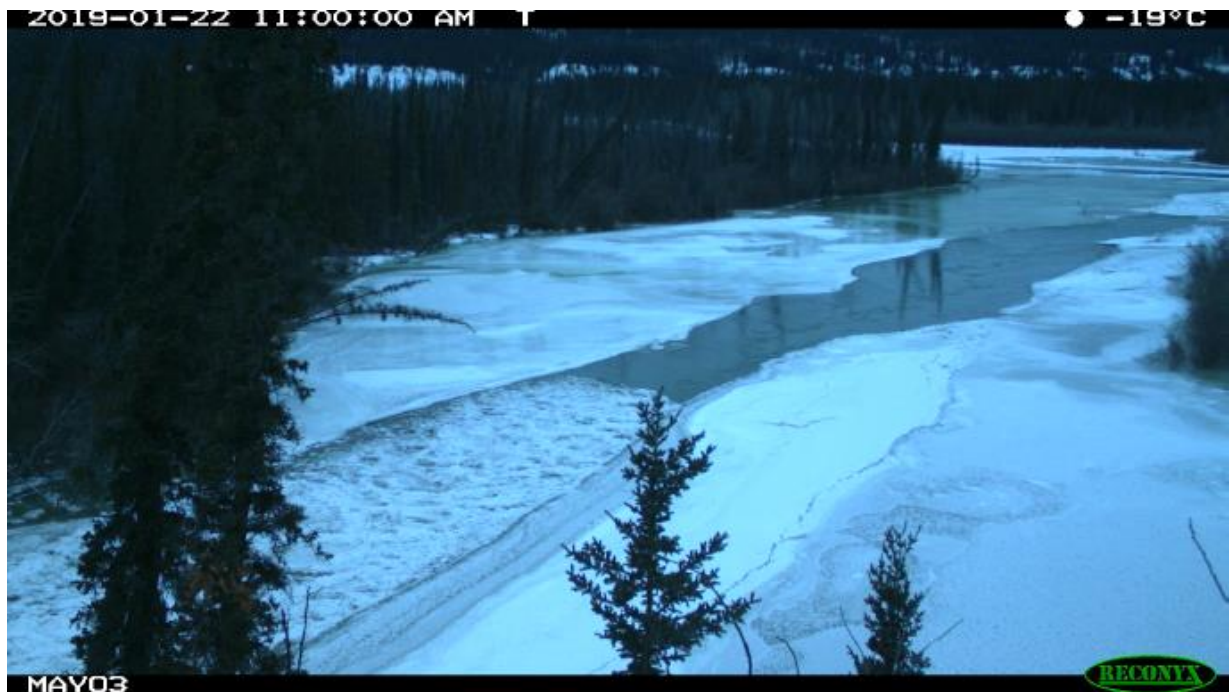
Figure 8. Looking upstream in Reach 3 at overbank ice accumulation atop both banks and frazil ice accumulation (foreground) in the active channel (January 22, 2019). A complete ice cover was formed on January 27, 2019 but periodical overflows occurred throughout the remainder of the winter.

The magnitude and variability of winter flows have increased in Aishihik River since construction of the AGS. The extensive growth of thick shore ice, combined with the accumulation of frazil ice and anchor ice, reduces the cross-sectional area of the channel, most notably in Reaches 2 and 3 (Figure 8). Reduction in the cross-sectional area (hydraulic capacity) of the channel results in overbank flow, typically in early winter, leading to incremental accretion of overbank ice. Overbank ice thickness in the active floodplain ranged from 1.5 m to 2.1 m immediately adjacent the river along three transects at the end of winter 2016/17. The accumulation of ice within the active channel and in the overbank areas is believed to be accelerating channel cut-offs by redirecting high winter flows out of the active channel and across topographic lows within the floodplain (Figure 9).

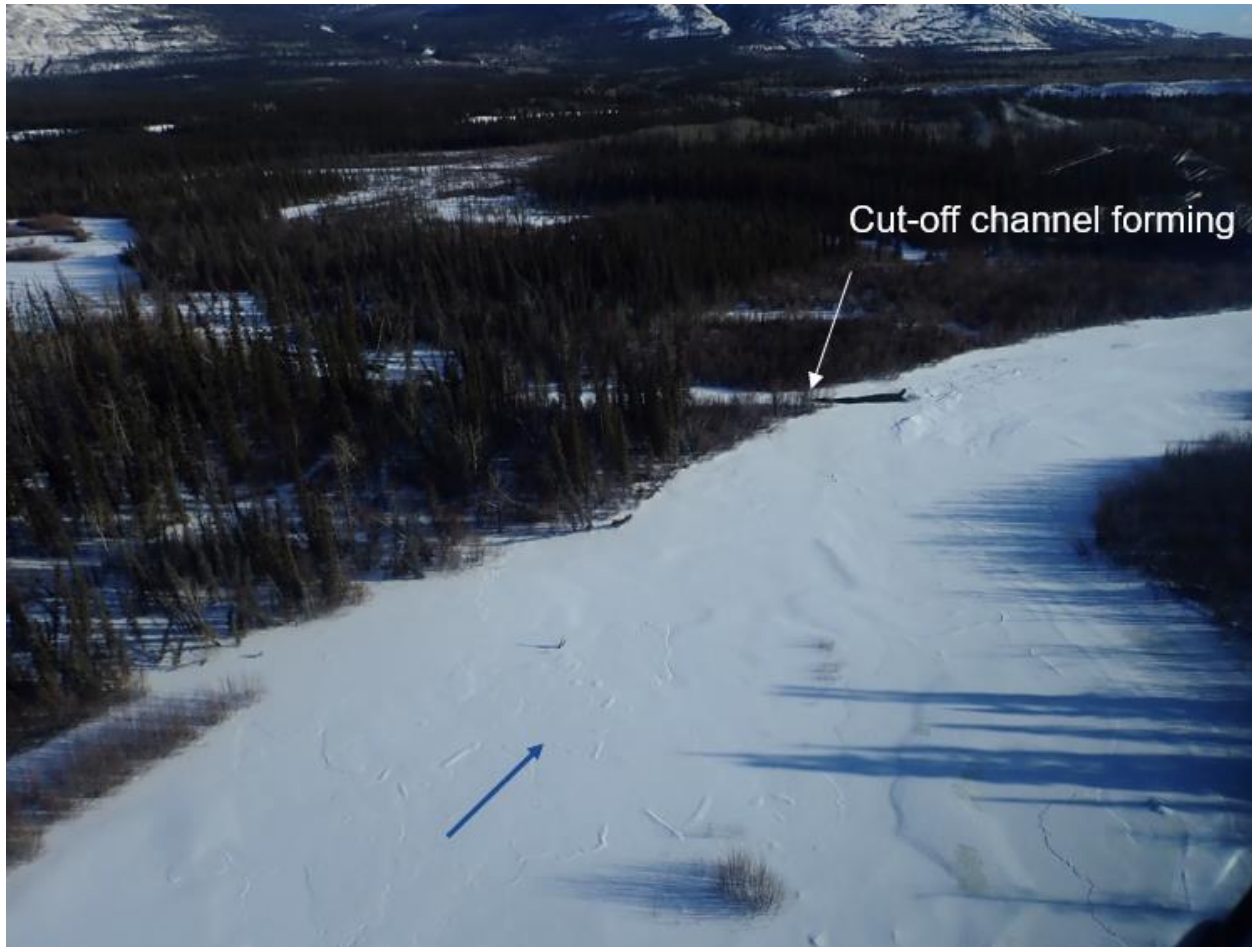
Figure 9. A newly formed cut-off channel was observed in Reach 5 in February 2019 (looking downstream). The cut-off channel enlarged throughout the 2019 and 2020 winters. In spring 2021, the majority of water passed through the cut-off channel.

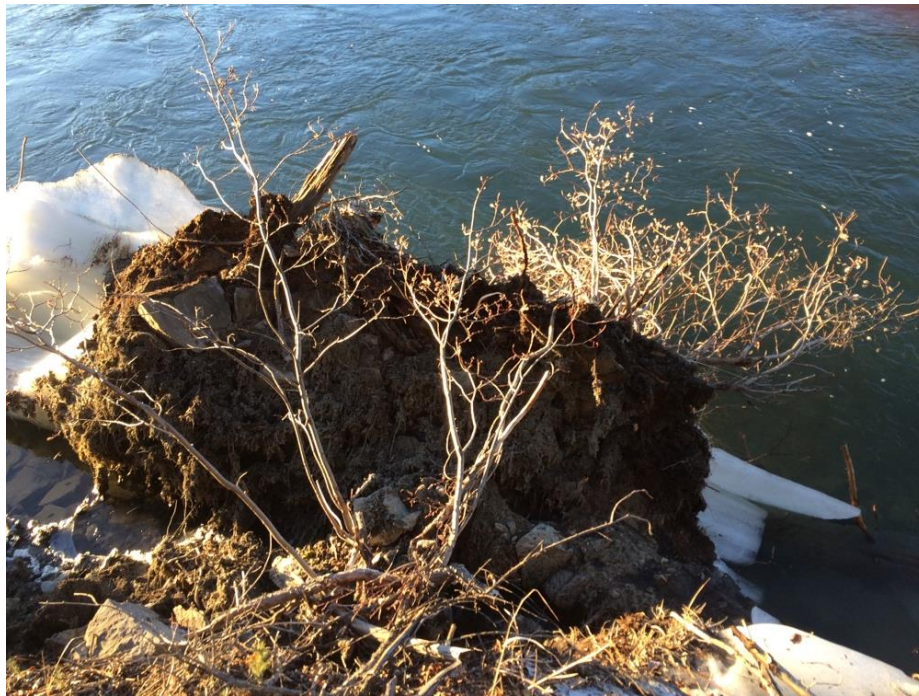
Figure 10. Collapsed shore ice in Reach 3 during an anomalous winter melt in December 2016.

During spring melt, anomalous mid-winter thaws, or sudden reductions in flow, shore ice attached to the channel banks, particularly where steep, collapses into the channel. Sediments and vegetation commonly calve into the channel with the collapsing ice, which reduces the shear resistance of the bank, increases unvegetated width, increases the input of sediment and woody debris to the channel, and exposes new layers of sediment that can be easily eroded (Ettema 2002, Turcotte et al. 2011). Recent shore ice collapse was observed along Aishihik River during an anomalously warm period in December 2016 (Figure 10). As well, anchor ice released from the channel bed was ‘rafting’ gravels and cobble downstream along Aishihik River during 2017 winter field reconnaissance. Kalke et al. (2015) observed a similar process on Peace River and North Saskatchewan River in Alberta. The rafted sediment will randomly settle to the bed in downstream reaches as the ice melts or overturns (Turcotte et al. 2011).
