The 2019 Freeze-up Ice Jam on the Severn River and Flooding of Bearskin Lake First Nation

Lucas Wazney^{1a}, Rick Carson^{1b}

¹KGS Group, 865 Waverley St, Winnipeg, Manitoba R3T 5P4

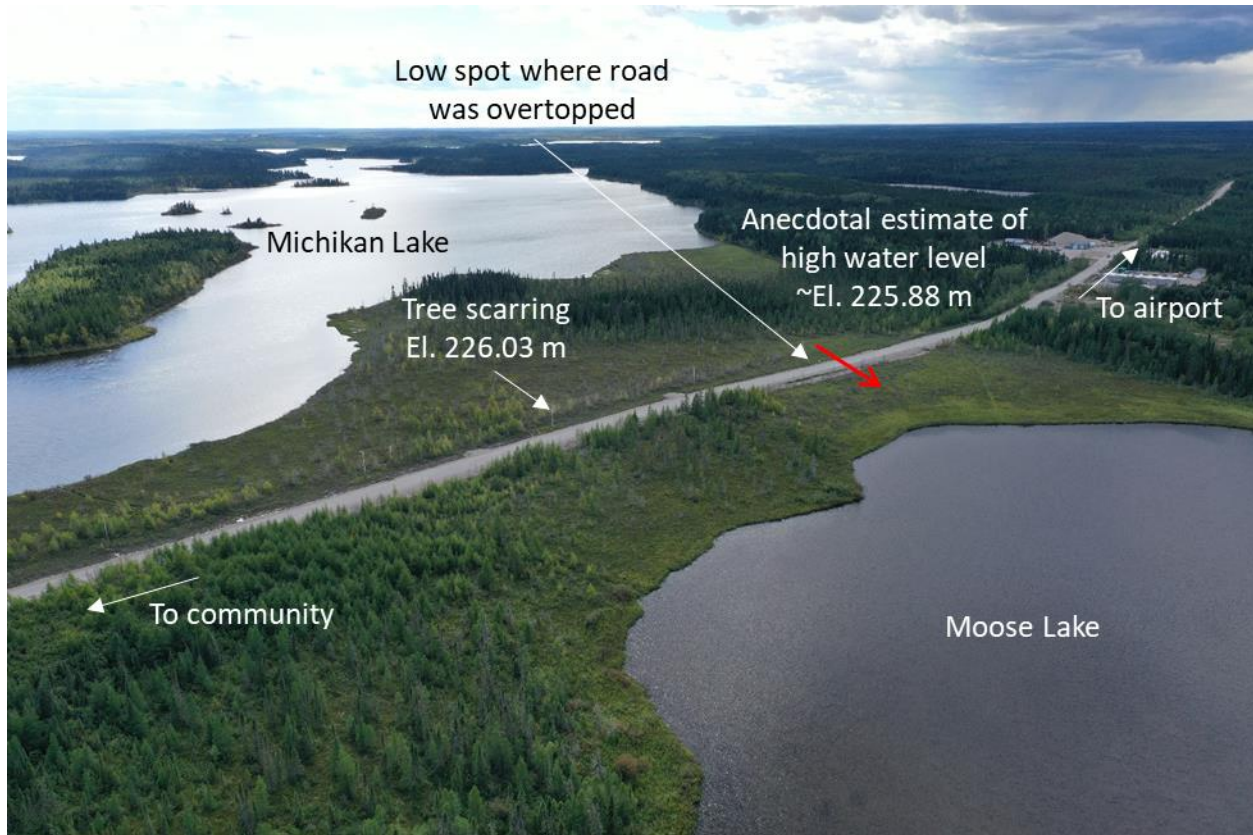
Figure 4. Overtopping of Airport Road

The high water levels in Michikan Lake resulted in flooding to an extent never before experienced in the 80+ year record of the BLFN community. The airport road reportedly overtopped from the Michikan Lake side, causing water to flow over the road into Moose Lake, as annotated in Figure 4. Based on anecdotal accounts from the joint venture on site during the flood, and corroborated by surveyed elevations of tree scars observed after the flood, the peak water level was approximately El. 226 m.

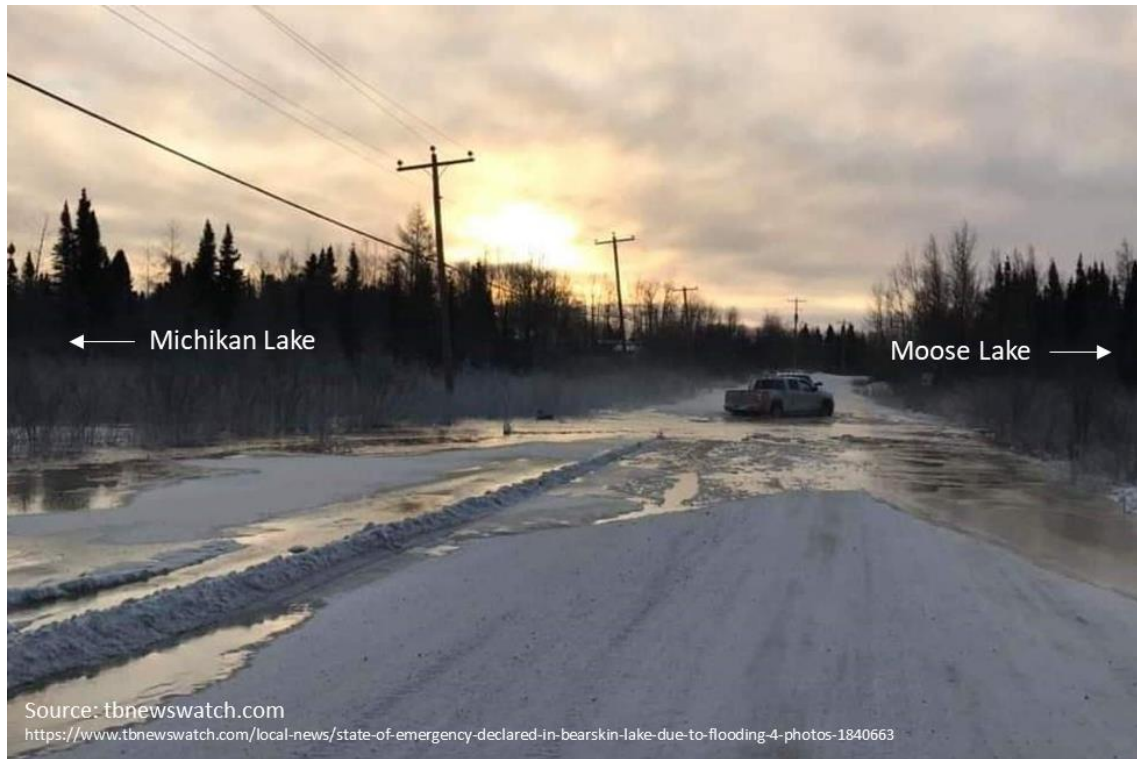
Figure 5. Photograph of overtopped road at Moose River Crossing

At Moose River Crossing, water was reportedly flowing in the reverse direction through the culverts (i.e. from Michikan Lake to Moose Lake) during the flood peak. The roadway was overtopped to the south of the culverts, as shown in a photograph taken during the flood in Figure 5 and annotated in Figure 6. The velocity of the flow over the road was sufficient to wash out a portion of the road, as indicated by a large pile of deposited material on the Moose Lake side. Small dikes were constructed to protect properties in the vicinity of the crossing.

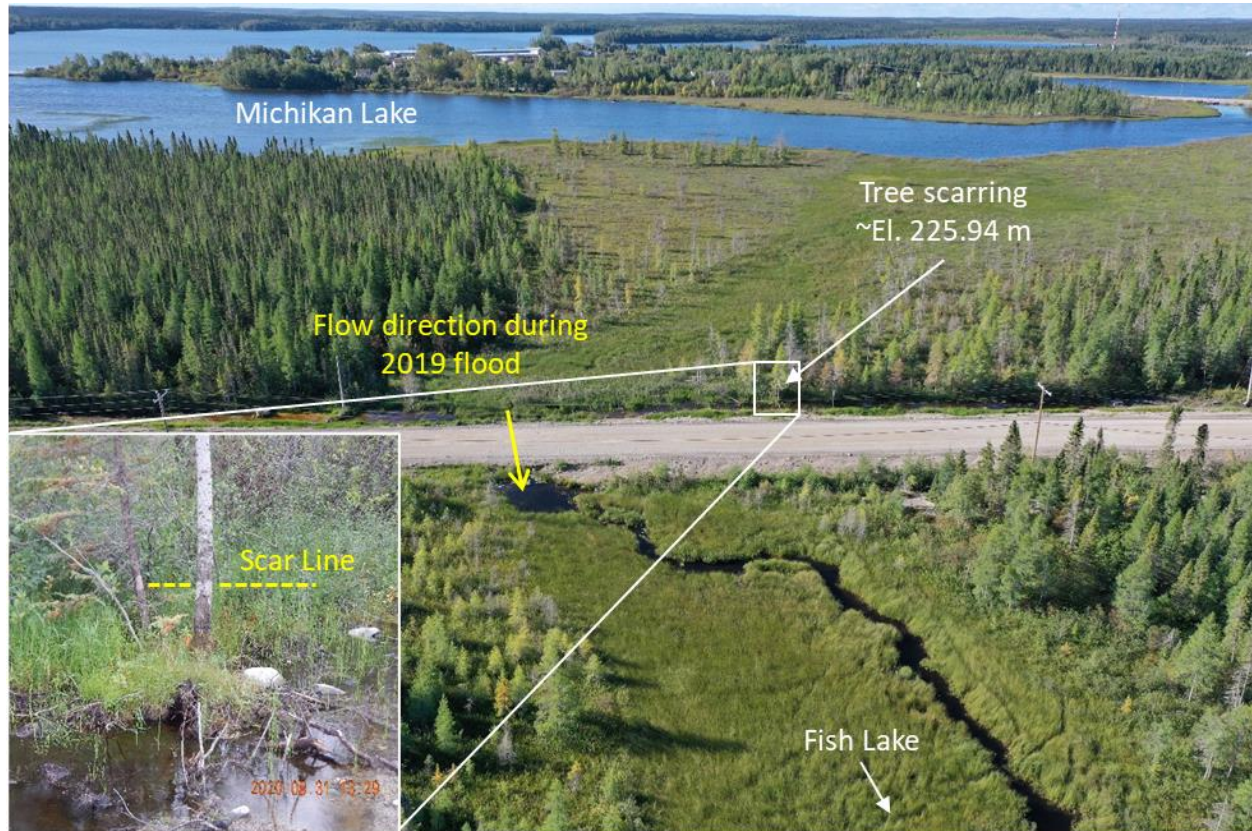
Figure 7. Flood impacts at Riverside Creek Crossing

The culverts at Riverside Creek Crossing were also reported to have been flowing in the reverse direction during the flood peak, as annotated in Figure 7. However, the road did not overtop at this location. Ice scars were observed on trees on the Michikan Lake side of the crossing. The scars were surveyed as El. 225.94 m.

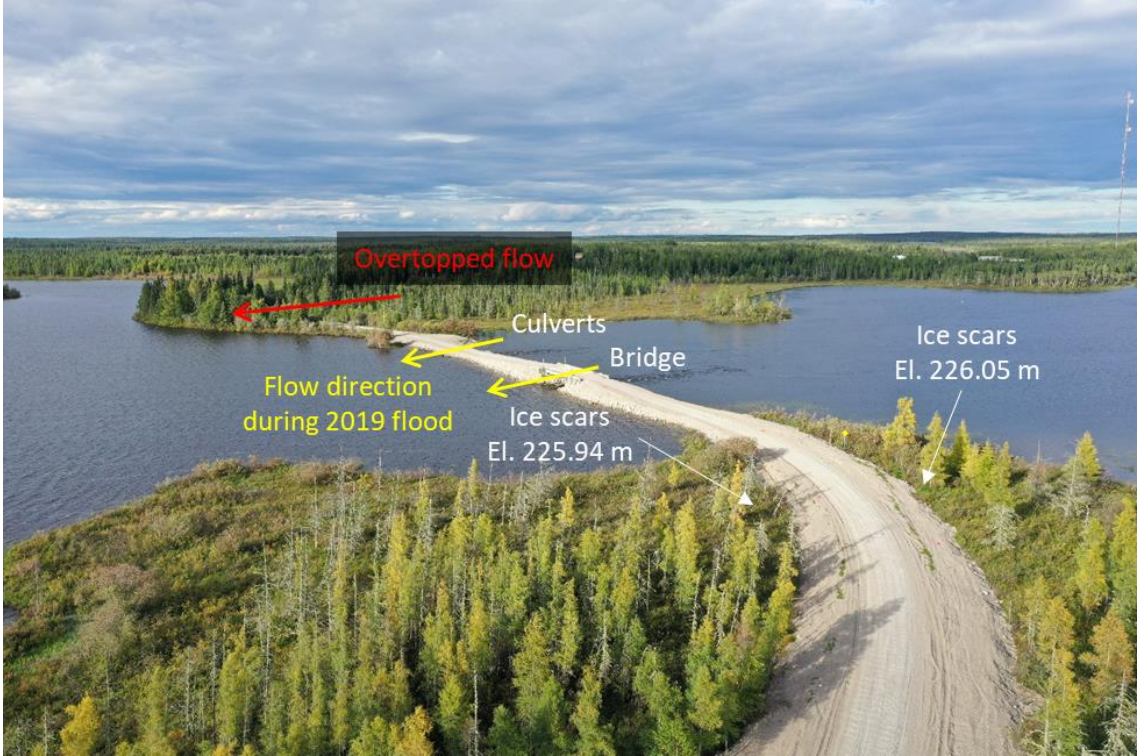
Figure 8. Flood impacts at Mahan Bridge – Photo A

Flow reversal was also reported at Mahan Bridge, both through the bridge opening and through two adjacent 1800 mm CMP culverts (see Figure 8 and Figure 9). Ice scars were observed on both sides of the crossing, with surveyed elevations ranging from El. 225.94 m to El. 226.05 m. Water overtopped the roadway to the north of the culverts, flowing from “downstream” to “upstream”. The post-flood site inspection identified signs of displaced riprap at the abutments of the bridge, indicating high water velocities through the bridge opening during the flood.

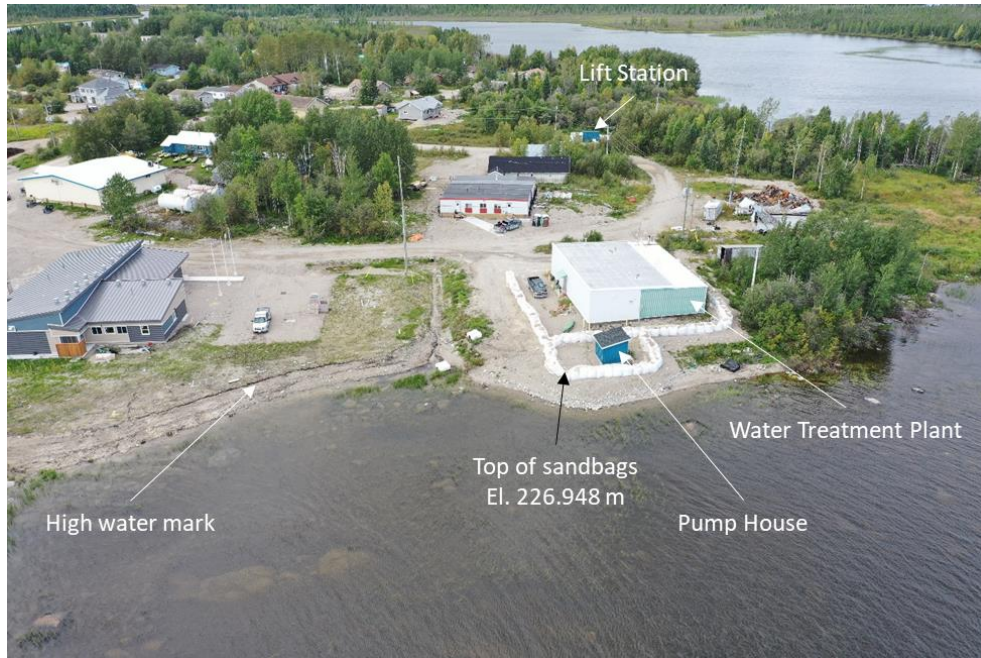
Emergency work conducted by the joint venture on-site during the flood included sandbagging to protect the community's water treatment facility and lift station, which are located on the north shore of Michikan Lake (see Figure 10). The peak water level reportedly came within approximately one foot of the bottom of the sandbag dike around the pump house. An earthen dike was also constructed along the lakeshore just downstream of the Moose River Crossing to protect homes from rising flood waters (see Figure 11).

Figure 10. Sandbag dikes constructed to protect water treatment facility and pump station

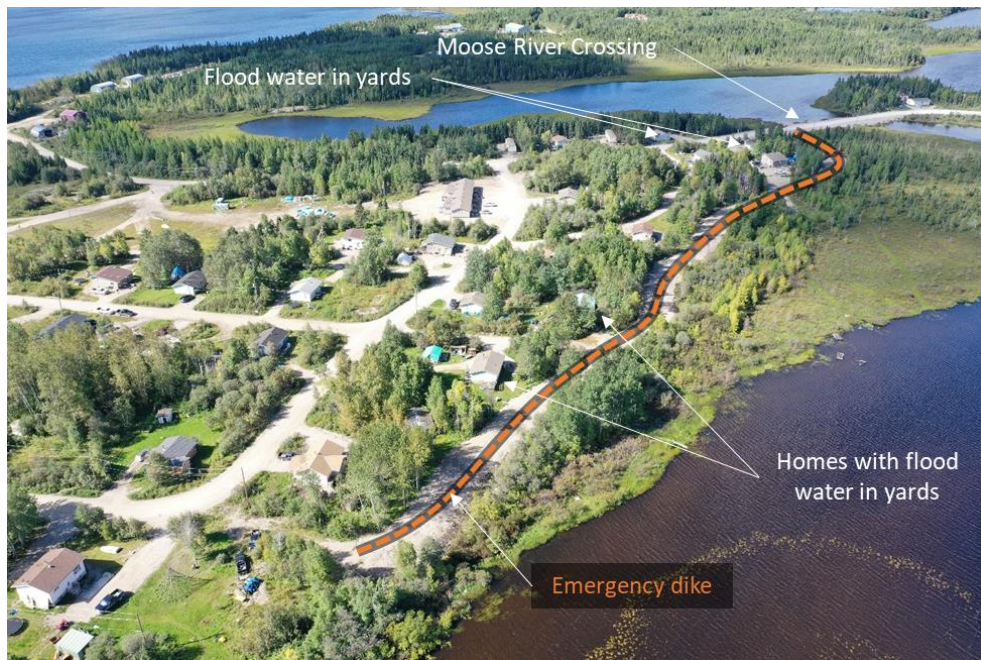
Figure 11. Emergency dike constructed to protect homes on Michikan Lake

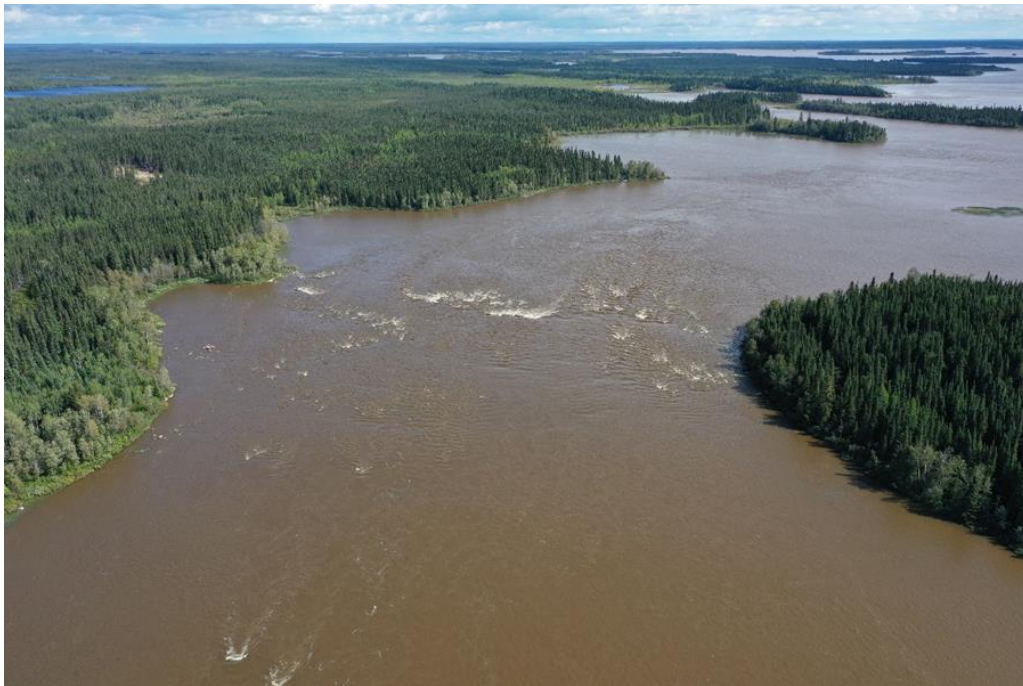
The root cause of the flood was reported to be an ice jam at White Sand Rapids, which is approximately 4.5 km downstream of BLFN (note that in this context, “ice jam” refers to the general obstruction of river flow caused by ice formations; the exact mechanisms are differentiated later in this paper). At this location, the water level drops several feet in elevation over a short distance near the entrance to Severn Lake. A photograph of White Sand Rapids is shown in Figure 12.

Figure 12. White Sand Rapids – view is looking downstream to Severn Lake

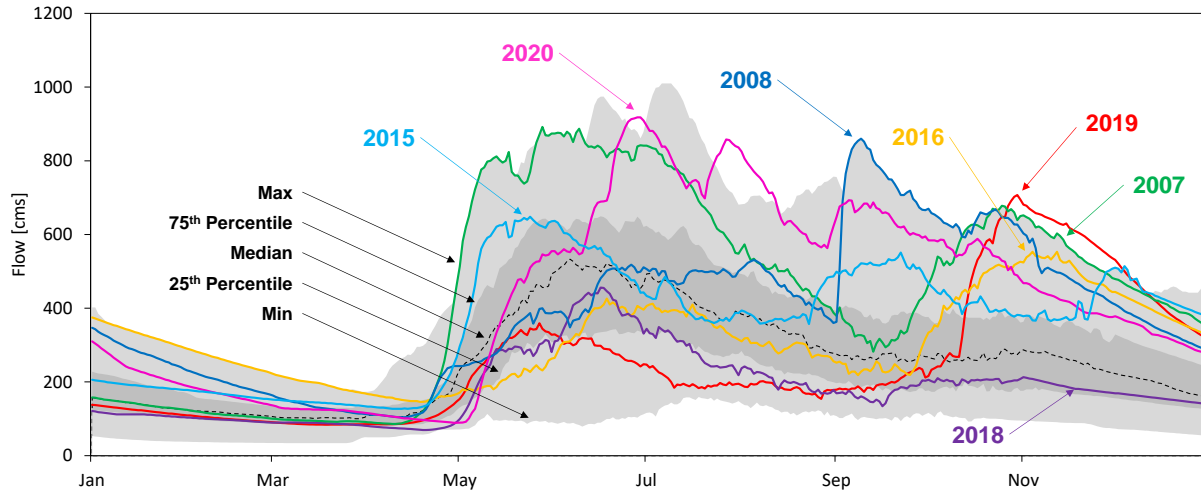
Figure 13. Severn River flow recorded at WSC Station 04CA002

The historical flows recorded at WSC Station 04CA002 at the outlet of Muskrat Dam Lake are shown in Figure 13, with notable recent hydrographs highlighted for discussion. Flow percentiles shown were calculated from the period of record prior to 2019. As shown, the median flow in early November is approximately 290 m³/s. As reported by MNRF in their technical report (MNRF,

2020), the rapid rise in Severn River flow in October 2019 was due to late summer and fall precipitation (rainfall) in the saturated drainage basin. The 2019 hydrograph peaked at 716 m³/s on October 29, and flow remained the highest on record for most of the month of November.

Examination of Figure 13 and Figure 14 reveals that the sudden drop in air temperature in 2019 was concurrent with unprecedented high flow in the Severn River. The low water velocities in Severn Lake permitted the formation of a thermal lake ice cover in early November. The adverse ice conditions which caused the backwater and flooding of Michikan Lake were likely due to two mechanisms, as described below.

Flows in the Severn River were well above the 75th percentile in the spring and early summer of 2020, and were the highest on record in August 2020 (see Figure 13). With the unprecedented flooding of 2019 all but forgotten, the community of BLFN was well aware of the potential ice-induced flooding that could occur if flows remained high through the freeze-up season. Flows and air temperatures were closely monitored in October for advanced warning signs of impending flooding and the need to evacuate.

In reviewing the hydrographs in Figure 13, it is evident that, while 2019 included the highest November flows on record, a few other recent years saw flows of a similar magnitude (e.g. 2007, 2008, 2015, 2016, and 2020). Yet, 2019 was the first time the community was consciously aware of ice jamming at White Sand Rapids (due obviously to the extreme water levels experienced in Michikan Lake and flow reversals at the road crossings).

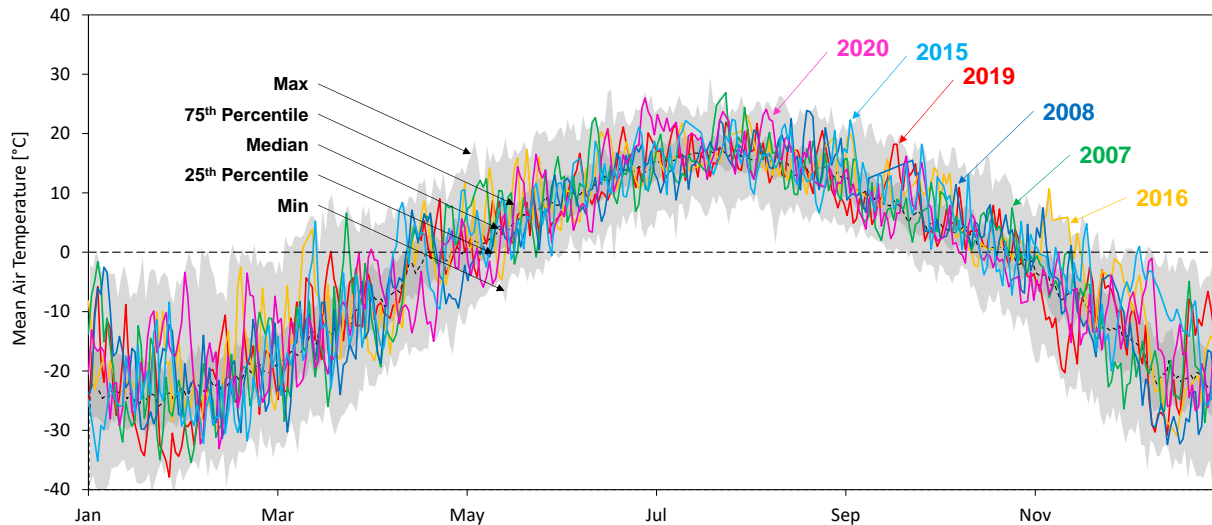
Figure 14. Mean daily air temperature recorded at Big Trout Lake climate station

Historical mean daily air temperatures recorded at Big Trout Lake Climate Station are shown in Figure 14. Notable years are highlighted with the same colour scheme as in Figure 13. As shown, the air temperature in 2019 dropped rapidly in November, reaching approximately -20°C on November 11, 2019.

In Figure 14, it is apparent that the onset of freezing air temperatures in the other years with relatively high flows was more gradual and generally occurred later in November compared to 2019. The cumulative degree-days of freezing (DDOF) computed from the daily mean air temperatures recorded at Big Trout Lake is presented in Figure 17.

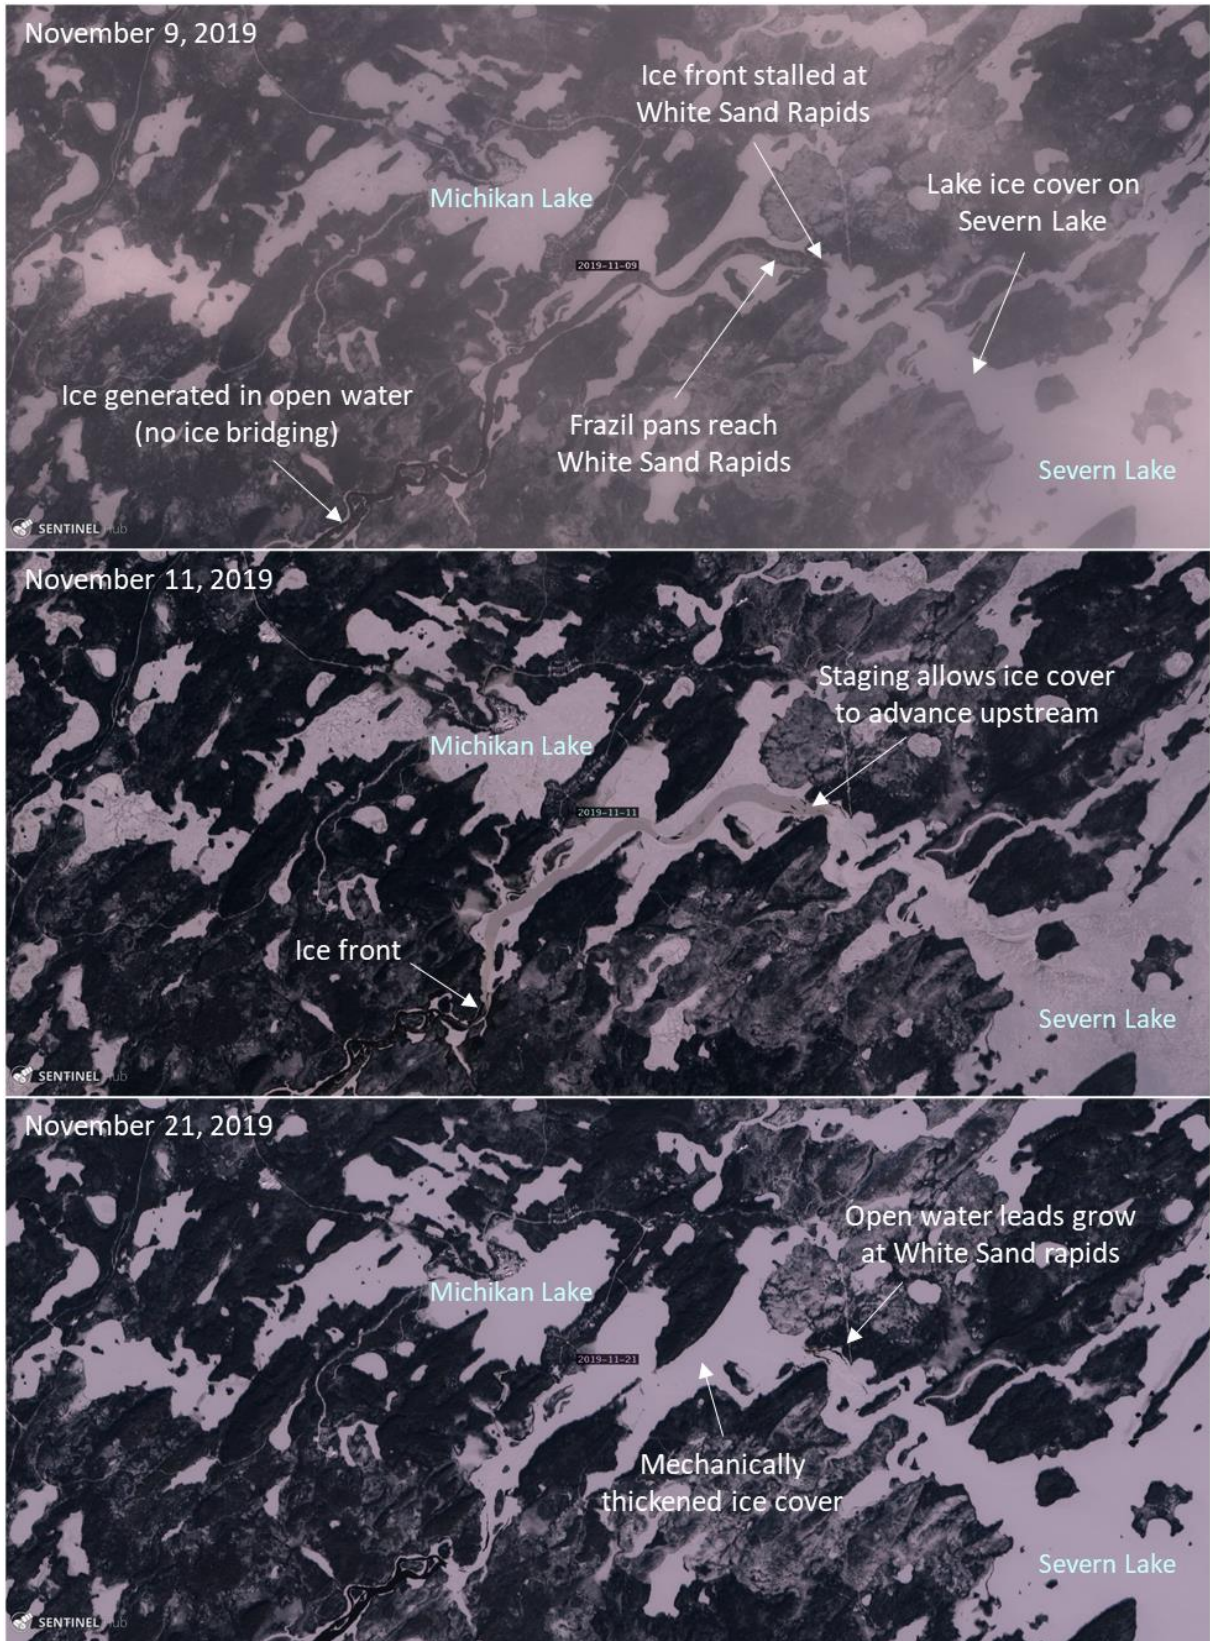
Figure 15. Sentinel satellite imagery showing freeze-up sequence in 2019

The sequence of Sentinel satellite images shown in Figure 15 illustrate these processes during the freeze-up period in 2019. The first panel (November 9) shows frazil ice pans freely moving down river towards the ice cover in Severn Lake that has progressed upstream and stalled at White Sand Rapids. In the second panel (November 11), the water levels have staged to allow the ice cover to advance upstream of the rapids. The light grey appearance of the ice cover indicates it is relatively thin and has not undergone significant mechanical thickening. In the final panel (November 21), the ice cover in the river appears much whiter, indicating that it has thickened. Open water leads through the ice accumulation at White Sand Rapids are also visible; these form as water cuts paths via preferential melting and erosion of the rough ice surface.

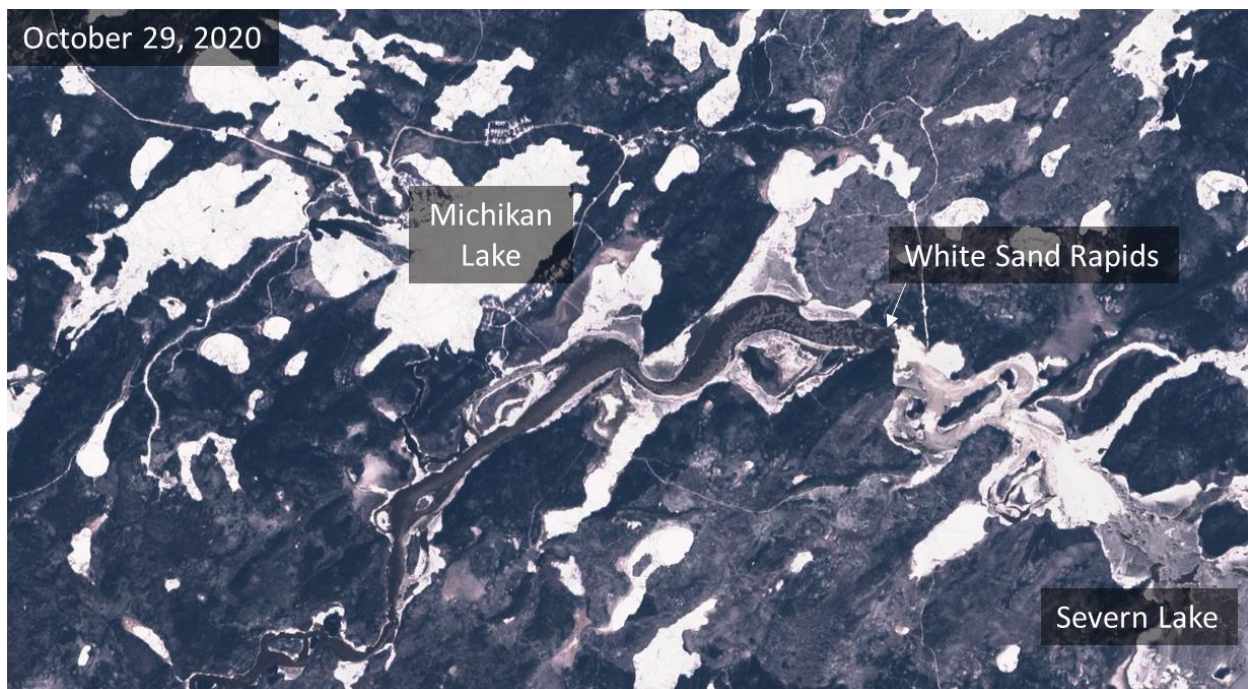
Figure 16. Sentinel satellite image showing onset of freeze-up 2020

Just one year after the record-setting flood of 2019, BLFN residents again watched water levels in the Severn River rise at the onset of freeze-up in late October 2020. Sentinel satellite imagery again pointed to the cause: a long stretch of open water upstream of Severn Lake producing an unrelenting supply of frazil ice to White Sand Rapids, where the ice cover had again stalled (see Figure 16).

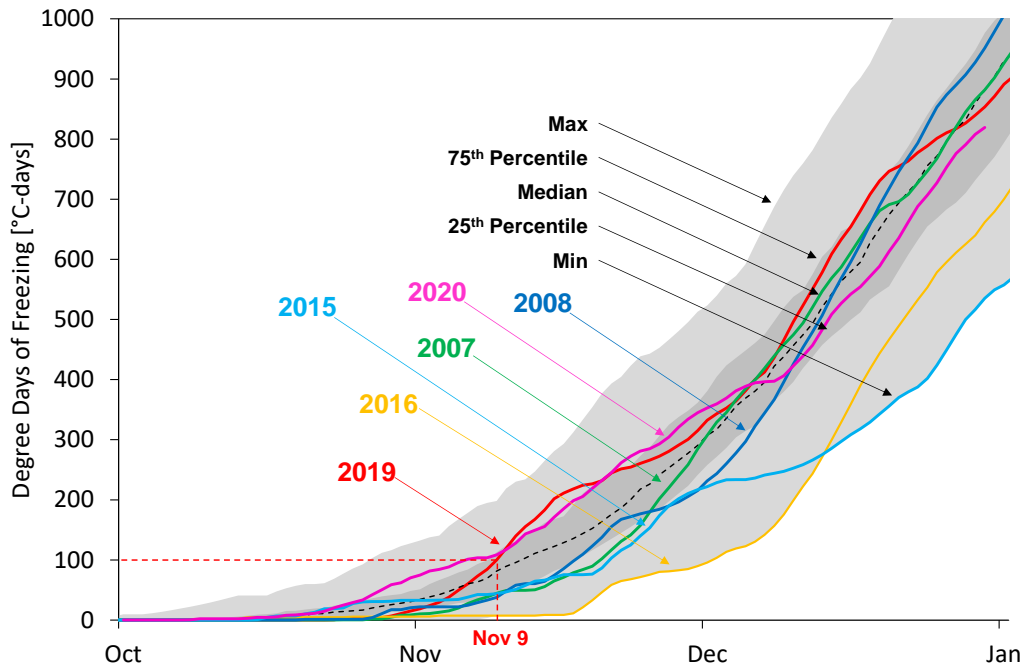
Figure 17. Degree-days of freezing recorded at Big Trout Lake climate station

In 2019, the state of emergency in BLFN was first declared on November 9. At this time approximately 100 °C-days had accumulated, causing enough cooling and ice production to create an ice jam that posed a flood threat. This benchmark of 100 °C-days was used as an indicator to allow a comparison of freeze-up flows for the purpose of highlighting those years where high river flows were concurrent with enough DDOF to potentially cause ice problems.

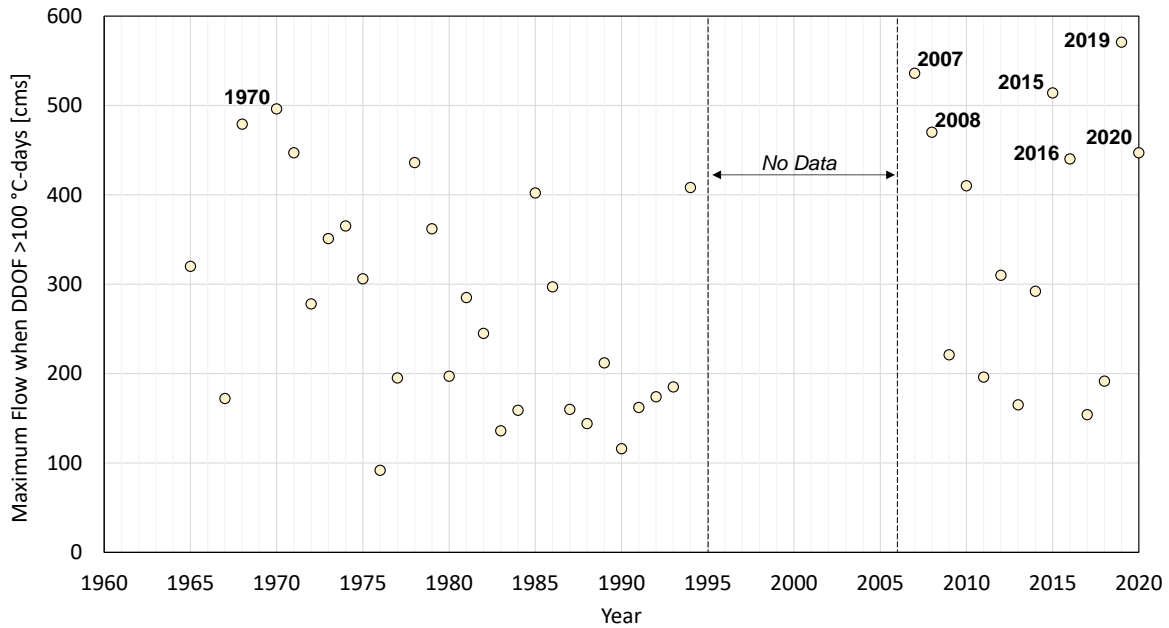
Figure 18. Maximum Severn River flow concurrent with DDOF > 100 °C-days

The maximum Severn River flows concurrent with DDOF > 100 °C-days is plotted in Figure 18 for each year in the period of record back to 1965. As shown, 2019 ranks the highest with a flow of 570 m³/s. However, five other recent years have flows of a similar magnitude: 2007 (536 m³/s), 2015 (514 m³/s), 2008 (470 m³/s), 2020 (447 m³/s), and 2016 (440 m³/s). It is likely that adverse ice conditions developed in these years as well, but not to the point of causing flood conditions at BLFN (i.e. “close-calls”).

A frequency analysis was conducted on the datapoints in Figure 18 to estimate the approximate annual exceedance probability of freeze-up flows that could result in ice jam flooding. A variety of statistical distributions were trialed, with the normal and gamma distributions providing the most reasonable fits to the recorded data. Results are shown in Figure 20.

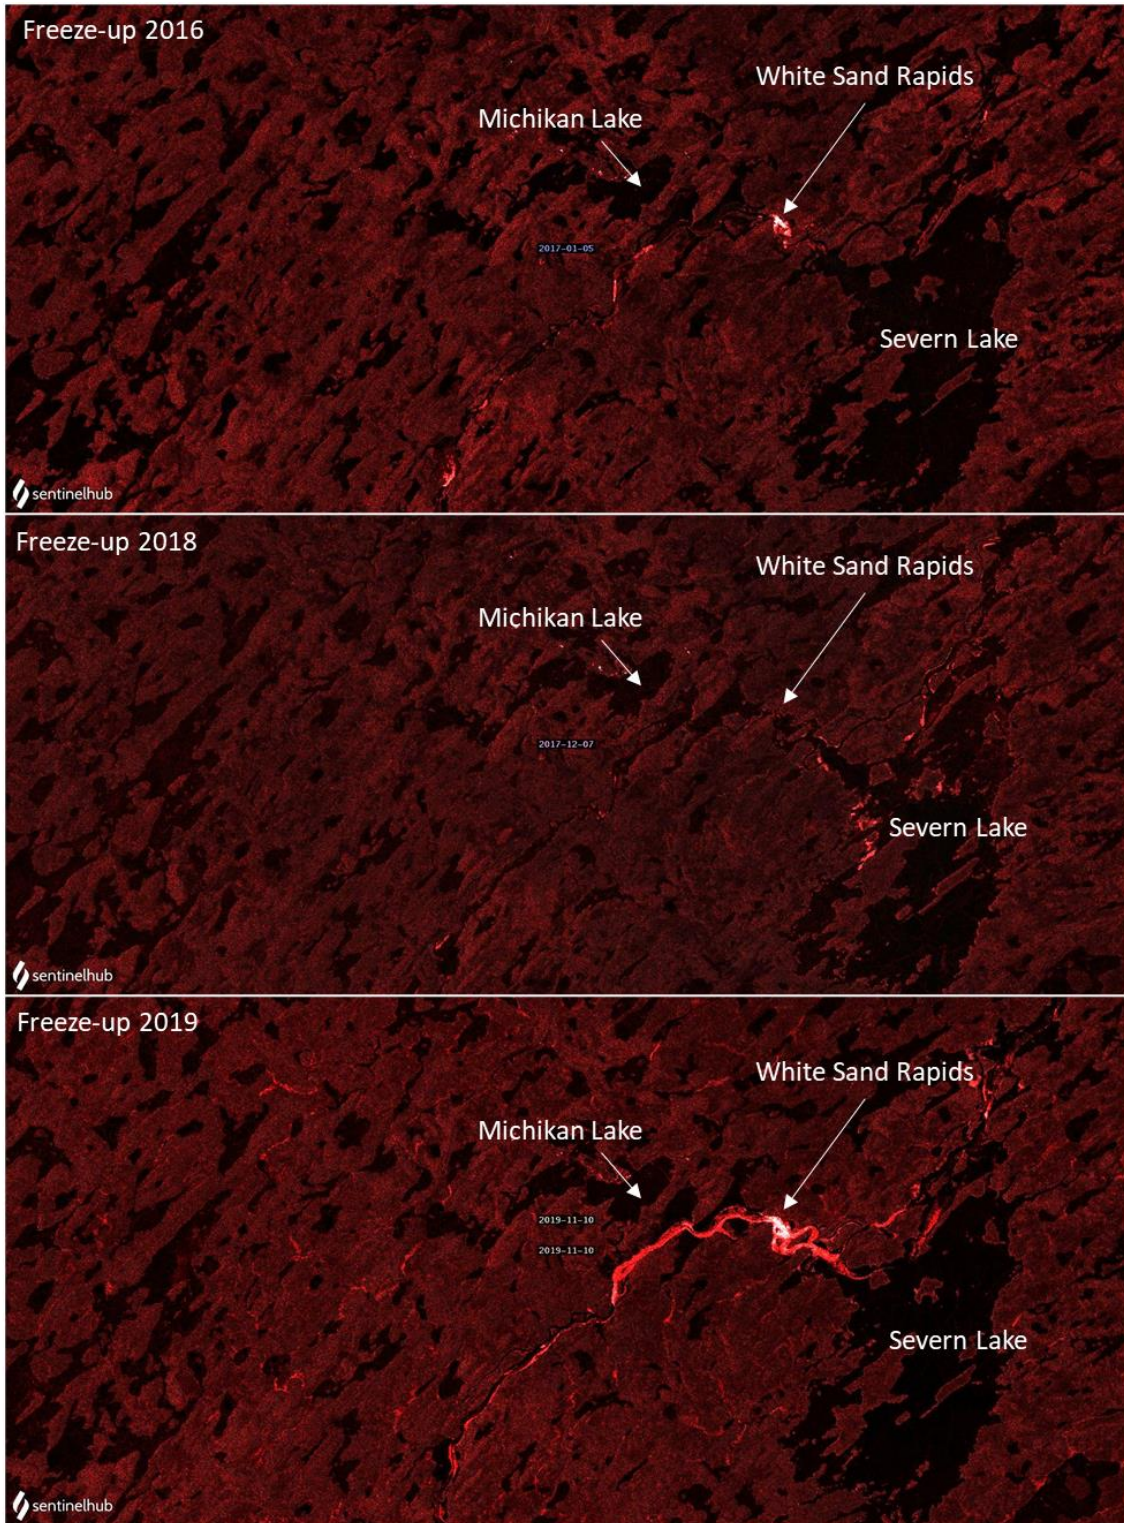
Figure 19. Sentinel radar imagery comparing ice conditions in 2016, 2018, and 2019

Sentinel 1 satellite radar imagery for the freeze-up periods in 2016, 2018, and 2019 are compared in Figure 19. The bright red and white areas in the images indicate a rough (and presumably thick) ice cover, while dark areas indicate a smooth ice cover or open water.

The freeze-up in 2018 occurred under a relatively low flow condition (see hydrograph in Figure 13), resulting in a relatively smooth and uniform ice cover. In 2016, flows were higher and the formation of an ice jam at White Sand Rapids is evident in the satellite image. The extent of the ice jam is limited to the immediate vicinity of the rapids. There are no signs of a rough ice cover upstream of the rapids or in Severn Lake. In 2019, the extent of the rough ice cover is much greater. The brightly coloured areas extend further into Severn Lake, indicating a roughened ice cover likely due to a combination of shoving and deposition of ice beneath the lake ice cover which could lift the cover and create an uneven surface. Upstream of White Sand Rapids, there are signs of a mechanically thickened river ice cover extending upstream of the confluence with the Michikan Lake channel toward Owl Rapids.

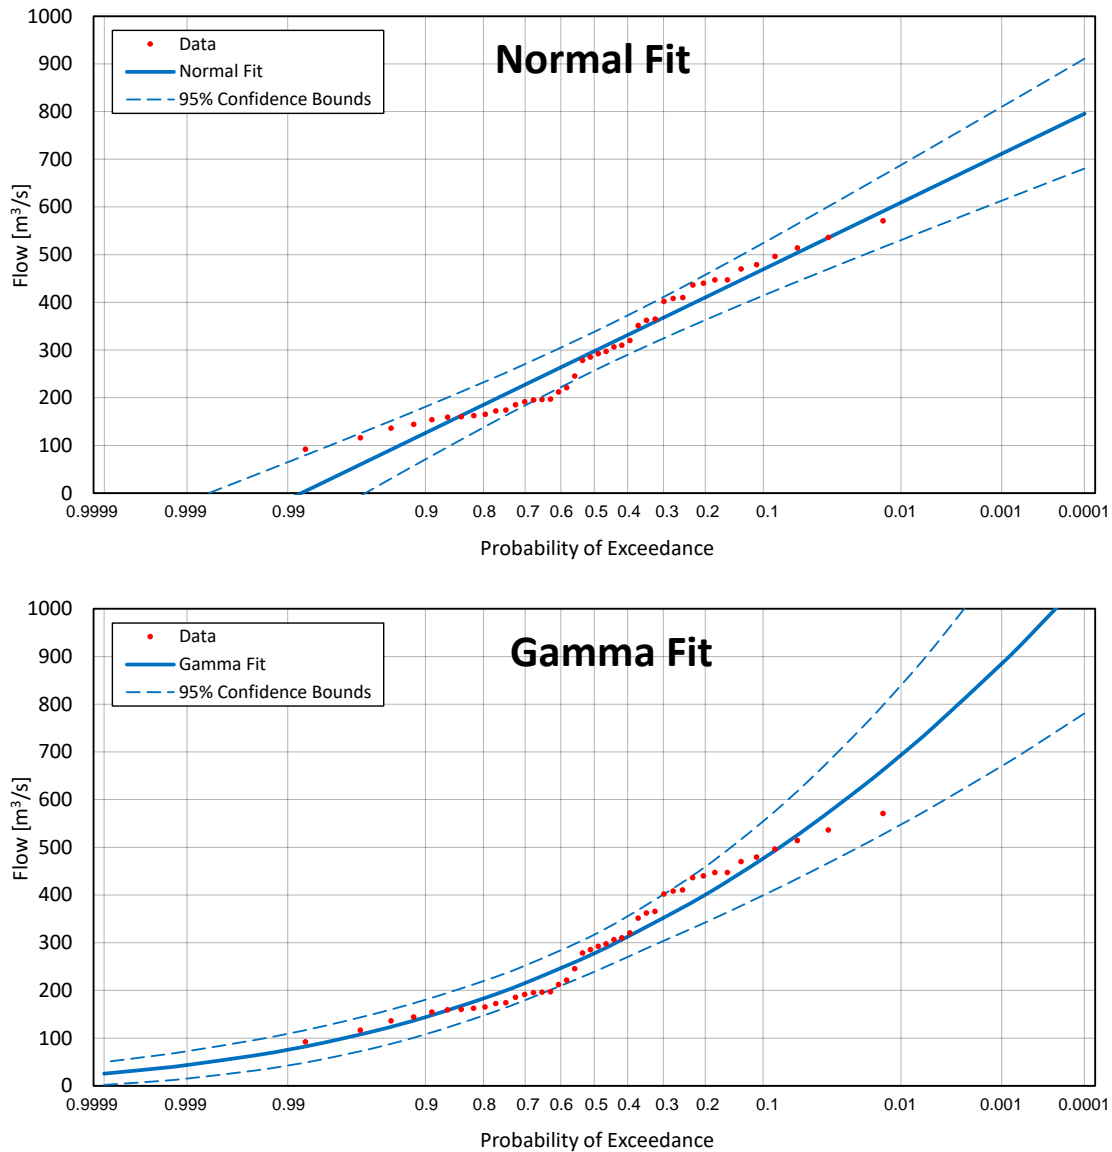
Figure 20. Frequency analyses of Severn River freeze-up flows

Based on these distributions, the freeze-up flow of 570 m³/s experienced in 2019 has an annual exceedance probability ranging from approximately 1:30 to 1:50.
