SIGNIFICANT RIVER ICE PROBLEMS CAN OCCUR EVEN
IN SOUTHERN BRITISH COLUMBIA

by
P.F. Doyle¹

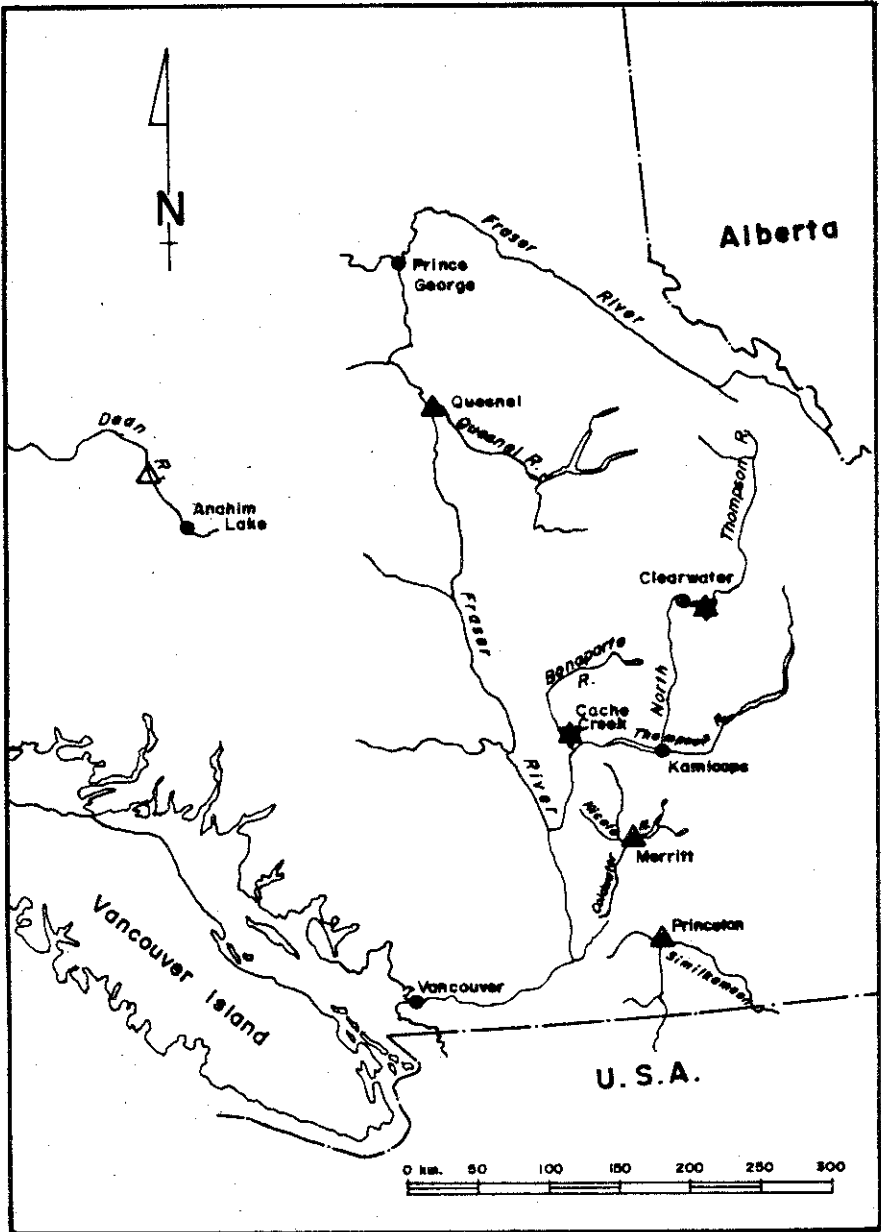
The ice jammed upstream of Clearwater during the night of December 16, 1980 following an unusual warm spell and some heavy rain in the area.³ The location of the jam is marked by a star in Figure 1. On December 17, 1980 I observed the jam from the air and noted the following:

Figure 1. Location of ice jams and icings during past three winters in southern B.C.

Ice jams on the Coldwater River in December 1979 and again in December 1980 resulted in minor overbank flooding in the town of Merritt. A jam on the Similkameen River at Princeton resulted in bankfull conditions in December 1980. A series of 3 jams on the Dean River in December 1980 reportedly caused some erosion of farmland when flow was forced out of the channel. A jam on the Quesnel River at Quesnel in February 1982 created near bankfull conditions. The locations of these jams are denoted by triangles in Figure 1.
