## **Manasan Ice Control Structures**

**Philip D. Wang**

*Manitoba Hydro, Civil Engineering Department*

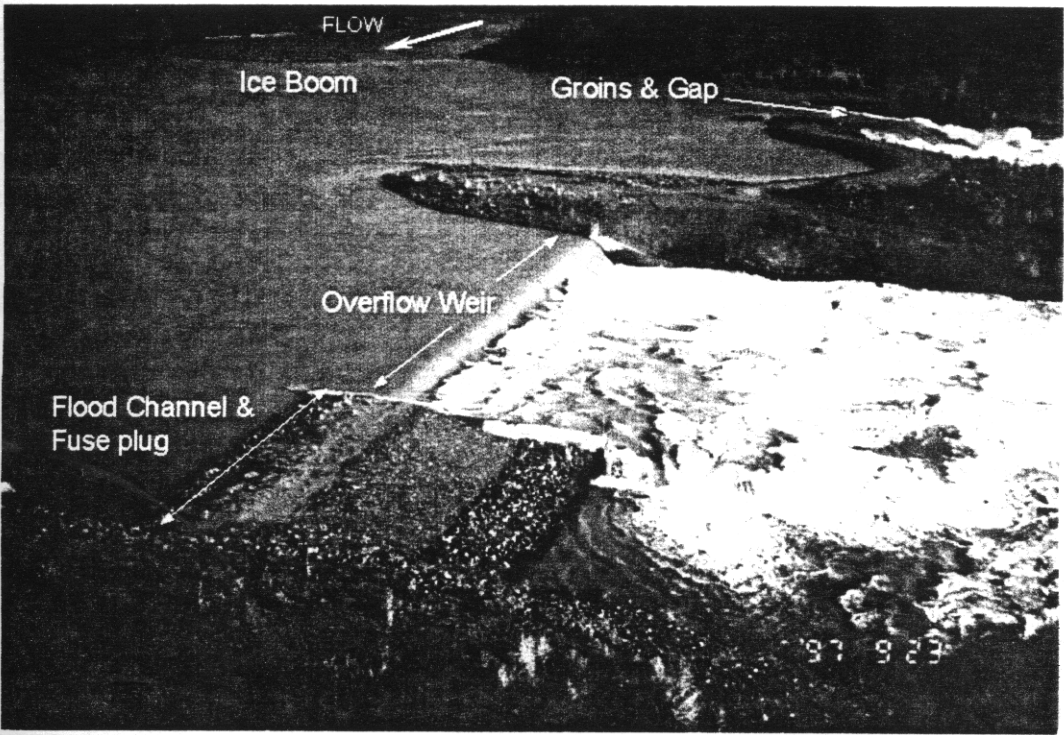
Figure 6 Manasan Control Structure in Operation

While spring floods have generally been light, flooding in 1998 tested the bypass weir to its limit without breaching the fuse plug, with flows reaching approximately  $1,300 \text{ m}^3/\text{s}$  (46,000 cfs). However, pond level control by the groin satisfies the design condition, and the ice cover formation and retention by the boom have worked correctly each winter, as demonstrated in Figure 7.

The bypass channel construction was started in late May, 1988 and completed in early June, 1989. The work involved the construction of an upstream cofferdam, excavation of the material in the bypass channel and flood channel, construction of an erodable fuse plug in the flood channel, and construction of a 85 m (280 ft) control weir. The control weir consisted of a 12.2 m (40 ft) concrete overflow weir and a concrete stoplog weir with twelve 6.1 m (20 ft) sections. A single stoplog in each section was constructed and placed to bring the control weir elevation to 196.6 m (645 ft). The 27.4 m (90 ft) wide fuse plug was constructed of sand and mine slag in the rock cut flood channel to a crest elevation of 197.91m (649.3 ft). The fuse plug was protected with rip-rap on both sides, upstream and downstream. Eight dynamite tubes were installed on the top of the fuse plug for emergency blasting, if required in the future. A satellite Data Collection Platform was installed to transmit water level readings directly to Winnipeg to constantly monitor the upstream water level at the fuse plug. Figures 6 and 7 show a photos of the completed Manasan control structure in operation during open water and winter ice cover conditions. Additional details on the rehabilitation and bypass channel works can be found in the paper by Parkinson and Wang (1991).
